SUBJECT: A county road worker died when a tow rope connection broke loose and struck him in the head.

SUMMARY

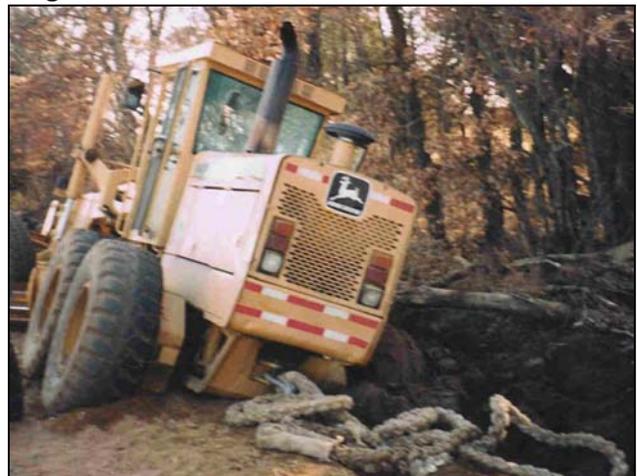
Figure 1. Grader stuck in Ditch

Prior to the incident, the victim was waiting on gravel and preparing to repair a tinhorn on a rural road when his grader got stuck in a roadside ditch (Figure 1). The victim radioed the office to notify them that he was stuck, and another grader was dispatched to remove the grader from the ditch. At the time of the incident, the victim was sitting in his grader with the vehicle running. Weather conditions were excellent, including a clear sky and a temperature of about 60 degrees. The two-man crew that was dispatched was attempting to pull the victim's grader out using their grader as a tow vehicle. The towing grader was equipped with ripper teeth; the purpose of the ripper teeth was to loosen road surface materials. A seven-year old military nylon tow rope, with a circumference of 10 inches was hooked on a ripper tooth on the back of the tow vehicle (Figure 2). The other end of the approximately 50-foot rope was hooked on the hitch pin on the victim's grader. One member of the two-man crew was positioned to the side, on the ground, to watch the operation. The victim's grader was in reverse with the victim facing away from the operation. The tow grader's operator was facing forward, away from the operation as well. As the tow grader began to pull, the ripper tooth on which the tow rope was attached to the tow vehicle broke loose at the bottom where it was connected to the support beam. Because of the extremely tight tension on the rope, the tooth was projected toward the rear window of the victim's grader, hit the victim in the back of the head, and continued out through the front window. The ripper tooth was approximately 18 inches long and weighed approximately 15-20 pounds (Figure 3). The two-man crew called the county maintenance office by two-way radio. A first responder arrived within 20 minutes and determined that they should wait for the ambulance to arrive before administering first aid. Another co-worker started to administer CPR while waiting for the ambulance to arrive. An ambulance arrived within 25 to 30 minutes. The victim was administered shock by an automated external defibrillator and was transported to a local hospital where he was pronounced dead one hour and forty-four minutes following the incident.

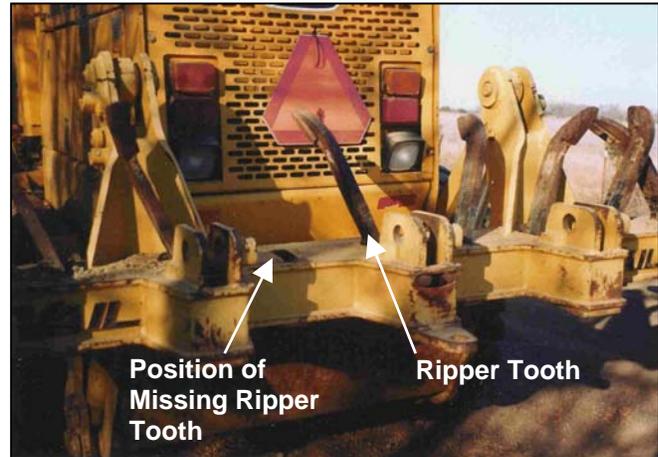
Figure 2. Dispatched Grader with Ripper Tooth Missing

Discussion: There is not an OSHA standard that addresses towing procedures for motor graders. However, a safe towing procedure provides employees and bystanders with protection during towing operations. Towing procedures listed in the manufacturer's operator manual should be followed. In this incident, the tow ropes should have been mounted to the factory equipped hitch on both graders. Instead, the ripper tooth was used, and it broke loose from its position. Employers should establish equipment towing procedures in writing to better ensure compliance.

Recommendation #1: Employers should develop written procedures to safely tow equipment using work practices that provide protection from flying parts that could break loose during the operation.

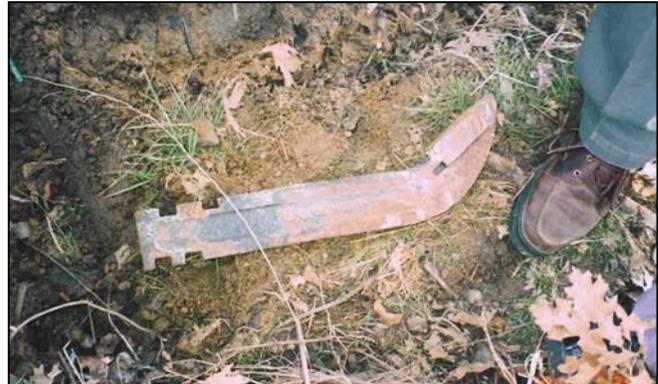
Figure 3. Ripper Tooth
