SUBJECT: Farmer died when she was thrown from the tractor she was operating

SUMMARY

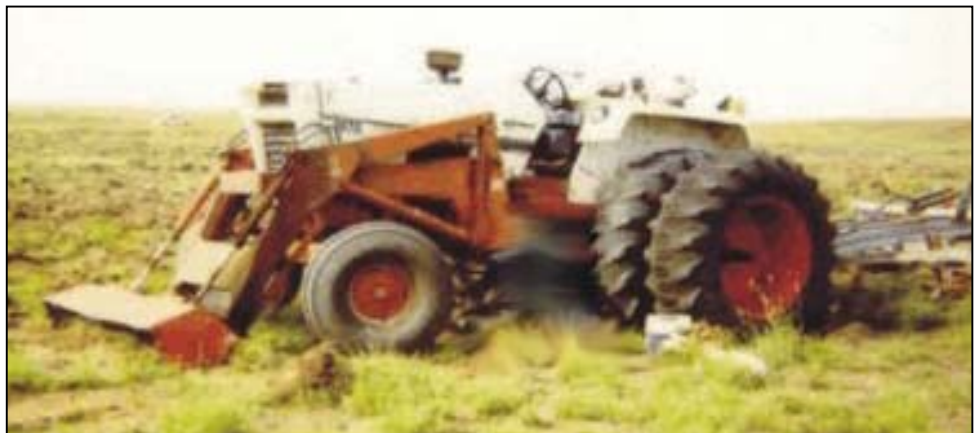
Figure 1. Tractor the Victim was Operating

The temperature at the time of the incident was approximately 80°F. There had been no measurable precipitation for a significant period of time. The decedent's tractor was equipped with a front-end loader, power take-off and rear three-point hydraulic lift to which a seven-shank plow was attached (Figure 1). She was using the tractor to plow a relatively level but rough field of native grass that had not been recently mowed or plowed. The field was located on the north side of a state highway in full view of vehicles traveling on the road. The decedent had worked the field for an estimated two hours and had plowed to a point approximately 100 yards from the highway when the incident occurred.

Discussion: Operator ejection from the driver's seat was a contributing cause of the incident. Although the tractor was otherwise reportedly in good condition, OKFACE investigators determined that the tractor was not equipped with a seatbelt. The tractor the victim was using was originally equipped and delivered from the manufacturer with a seatbelt as standard equipment. The seatbelt had apparently been removed from the tractor involved in the incident. Had the operator been wearing a seatbelt she may have avoided being dislodged from the tractor seat, and the incident may not have been fatal. Employers must ensure that all required safety equipment is installed and in proper working condition before using farm machinery.

Recommendation #2: Employers should retrofit farm tractors with ROPS and a seat belt and ensure that the seat belt is used.

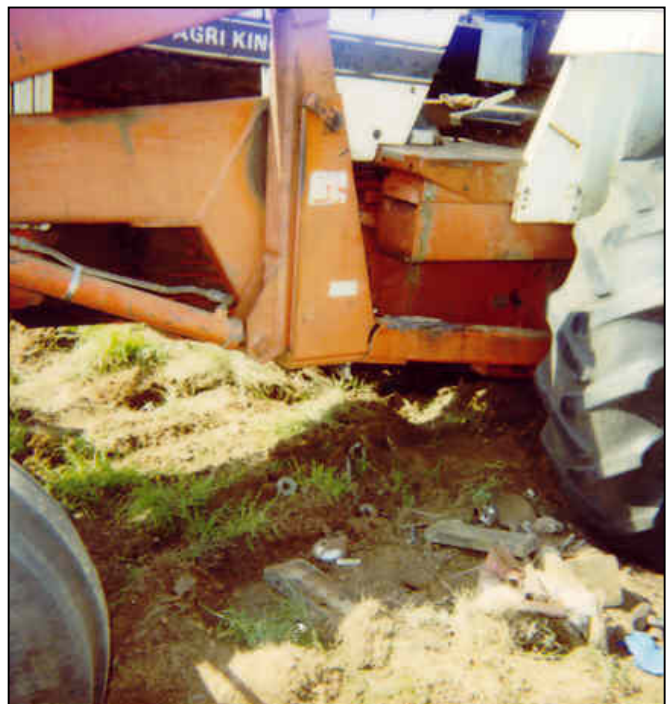
There were no eyewitnesses to the incident, but physical evidence indicated the victim actuated the hydraulic lift and raised the plow from the ground then lowered the front-end loader bucket into the ground while the tractor was still traveling in a forward direction. The bucket struck the soil with force and penetrated the soil to a sufficient depth to completely stop the forward motion of the tractor. The rear wheels continued to spin with the tractor held stationary by the front-end loader bucket. The force of the dual drive wheels and traction tires spinning continuously against the resistance of the front-end loader anchored in the ground caused the tractor to "buck" violently. The decedent fell from the tractor seat, apparently striking her head as she fell. Her leg was caught between the front-end loader arm and the tractor chassis. She hung upside down from the side of the tractor, which continued to rock and lurch in a stationary position. The frame of the tractor broke, and parts of the tractor fell off during the incident (Figure 2).

Figure 2. Broken Parts of the Tractor

Discussion: Although the reason(s) is/are not clear, the decedent lowered the bucket to the ground at an angle that allowed the bucket to penetrate the ground and stop the forward motion of the tractor, and this control error was a contributing cause of the fatal incident. Procedures for the safe operation of tractors are included in manufacturer literature and should always be studied and followed by all farm tractor and equipment operators.

Recommendation #1: Employers and employees should always follow safe operating procedures in the operation of tractors and other farm equipment.
