**SUBJECT:** Mineworker was crushed between the couplings of a rail car and the tractor used to move loaded cars on a rail spur

## SUMMARY

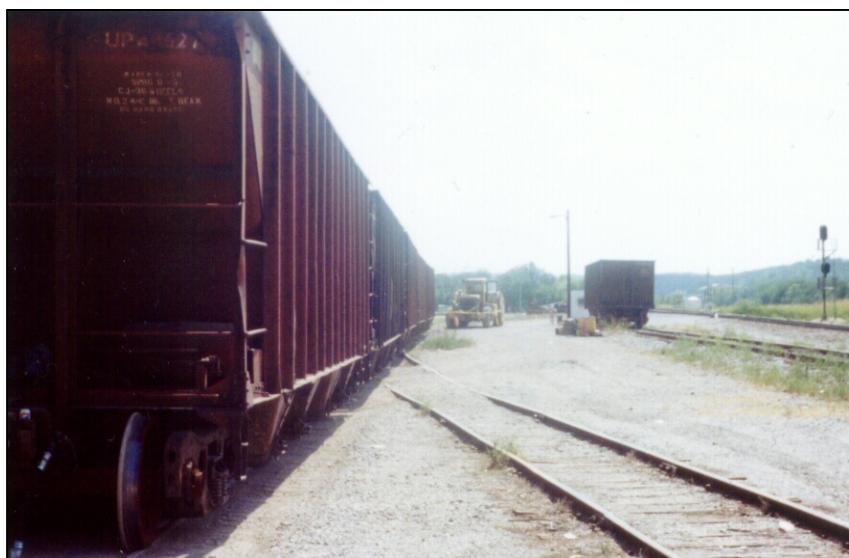
Figure 1. View of the Rail Spur, the Five-Car Cut, and the Tractor

The worker who died in the incident was part of a three-man crew attempting to relocate five loaded rail cars on a rail spur in preparation for their shipment by the rail carrier. The mine operator used the rail spur, located near the mining and crushing operations, to position and load rail cars with crushed stone from the mine. The tracks, rail bed and switches were maintained in good condition; however, there was a dip in the rail bed at the track switches. The rail cars were ballast-type cars, each having a gross weight of approximately 133 tons and were equipped with air-actuated friction brakes. Each Monday, Wednesday, and Friday, the railroad delivered to the mine approximately 20 empty cars that were loaded and shipped each Tuesday, Thursday, and Saturday. Mine employees used a 1964 Caterpillar model 660 pneumatic-tire tractor to move the empty and loaded cars on the rail spur. After purchasing the tractor in 1979, the mine owner had modified the vehicle for use in moving rail cars by adding a Janney automatic railcar knuckle coupler on the front of the vehicle and a compressor behind the tractor cab for charging rail car brakes. A flat metal plate had been welded approximately four inches above the coupler to prevent disengagement of the coupling caused by vertical displacement of the tractor as it traveled on rough terrain; however, the device was reportedly ineffective and accidental uncoupling was a frequent occurrence. The coupler was not equipped with a lever, similar to those mounted to railcars, to permit remote manipulation of the coupling mechanism.

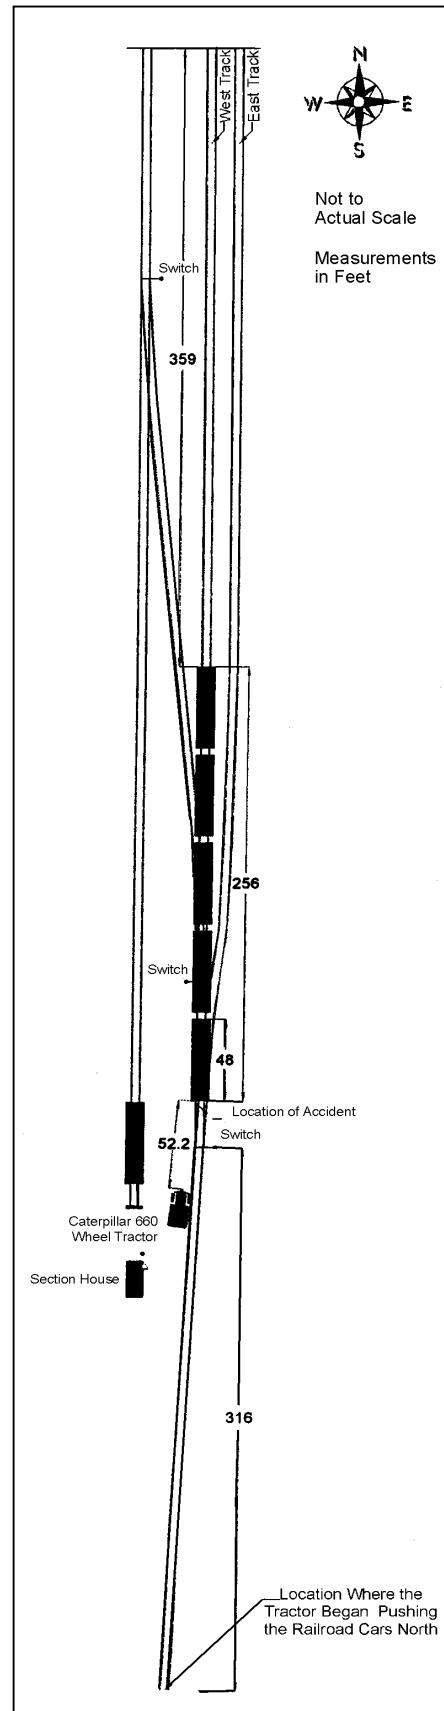
Figure 2. Incident Diagram

The tractor operator positioned the tractor to couple it to the southern-most rail car and then began to push the cut northward up the grade. The tractor rolled into a dip in the rail bed and the resulting vertical displacement caused the tractor to uncouple from the rail car. The decedent directed the tractor operator by use of hand signals to stop and back the tractor away from the cut. The operator began backing the tractor away from the southern-most car and the decedent signaled him to stop the tractor at a point where the knuckles on the rail car and tractor were approximately three feet apart. The decedent entered the space between the tractor and rail car, an area in which he was

not visible to the tractor operator, to open the tractor coupling. When the decedent failed to emerge from the area in front of the tractor, the operator leaned forward to a position where he could see that the decedent had become trapped between the tractor and rail car couplings. The operator backed the tractor approximately 52 feet down the track from the rail car and attempted to summon help by radio.

Discussion: The employee's entry into the hazardous area between the rail car and the tractor was the underlying cause of the fatal incident. Before entering the space between the cut or rail cars and the tractor, the decedent signaled the tractor operator to stop the tractor at a distance of approximately only three feet from the nearest rail car. The decedent was the senior employee on the crew and as such determined the position at which to stop the tractor; however, the point at which he signaled the operator to stop the tractor left a separation of only a fraction of the 50 feet minimum distance recommended by the Federal Railroad Administration. The slack between the 3<sup>rd</sup> and 4<sup>th</sup> and the 4<sup>th</sup> and 5<sup>th</sup> cars released downhill toward the tractor while the employee occupied the hazardous area within the "gauge" (the area between the rails), unexpectedly trapping and crushing him. The proximity of the tractor to the cut of cars was an underlying cause of the fatal incident.

Discussion: The movement of the rail cars while the decedent occupied the area between the cars and the tractor was an underlying cause of the fatal incident. The slight grade in the track allowed the slack between the 3<sup>rd</sup> and 4<sup>th</sup> and the 4<sup>th</sup> and 5<sup>th</sup> cars to release in the direction of the employee, and given his position within the gauge resulted in his being crushed between the cut of cars and the tractor. The brake on the northern-most car had been applied and the 2<sup>nd</sup> and 3<sup>rd</sup> cars had been taunted, but the 4<sup>th</sup> and 5<sup>th</sup> cars were free to roll until all slack had been released. Had the employee inspected the cars and ensured that they were not in motion before and during his entry into the gauge, the fatal incident may not have occurred.

**Recommendation #1: Employers should ensure that any crewmember that enters the space between a cut of cars to adjust knuckles/drawbars does so only after the cars to be coupled are separated by no less than 50 feet.**

**Recommendation #3: Employers should ensure that prior to entering the space between a cut of cars, any crewmember that must enter the hazard area first inspects the cars, applies a sufficient number of hand brakes where necessary to prevent movement of the cars, and determines that the cars are completely stopped.**

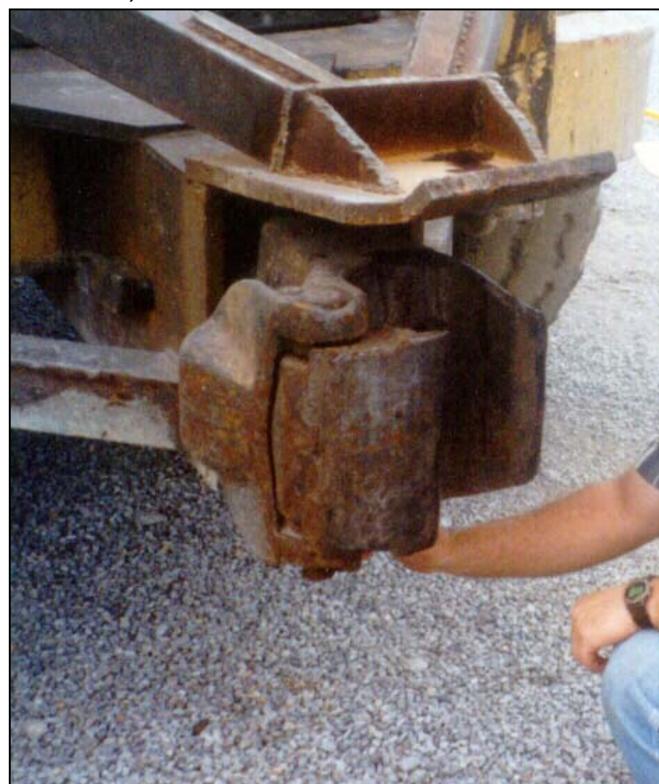
Figure 4. Coupling Knuckle on the Front of the Tractor

Discussion: The employee's entry into the hazardous area between the rail car and the tractor was the underlying cause of the fatal incident. The welded plate above the tractor's knuckle coupling reportedly did not effectively prohibit accidental uncoupling. Accordingly, redesign of the coupling and/or improved maintenance of the rail bed may have prevented the uncoupling incident that necessitated the employee's entry into the hazard area. Additionally, the tractor coupling was not equipped with a control lever similar to those installed on rail cars; therefore, the decedent was required to enter the hazard area to open the coupling and allow re-coupling of the tractor to the rail car. Installation of such a device may have prevented the fatal incident by removing any need for a crewmember to approach the coupler in order to open it.

**Recommendation #2: Employers should ensure that equipment and work areas used by employees are properly designed for their intended use and are safely maintained.**
