SUBJECT: Worker was run over by his tractor as he tried to jump-start it

SUMMARY

A 51-year old farm worker died on March 9, 2001 from injuries received when he was run over by the farm tractor he was operating. FACE investigators concluded that to prevent similar occurrences, employers should:

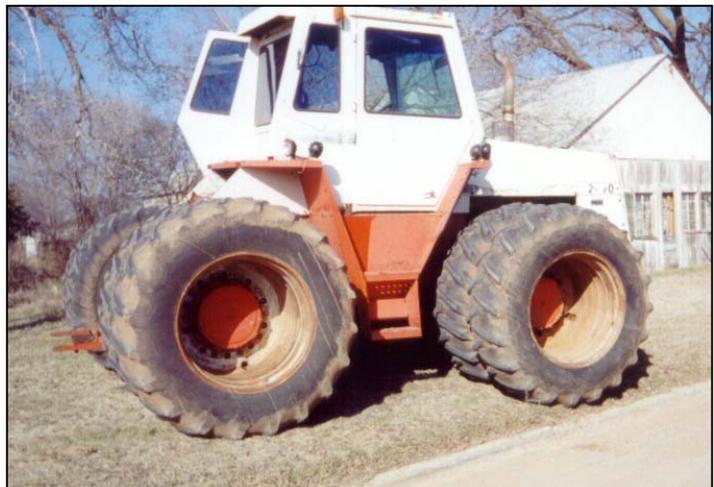
Figure 1. This picture shows the tractor that ran over the worker.

The temperature at the time of the incident was approximately 53°F, the average wind speed was 8 mph, and there had been no precipitation. The deceased was reportedly preparing a Case-IH model 2470 four-wheel drive tractor (Figure 1) for spring crop activities and, in doing so, drove the tractor to a service station in a small community nearby. The service station was located on the north side of a state highway in a rural town. The station had fuel pumps on the west side and the south side of the store. The deceased arrived at the station at approximately 3:00 in the afternoon and positioned the tractor near the west pumps (Figure 2). He filled the tank with diesel, and then drove the tractor around to the pumps at the front of the station to check and adjust the tire pressure in each of the four sets of dual wheels. The worker did not shut off the tractor motor at any time while he was at the station. While the driver was checking the tire pressure, the service station manager went to the south side of the pumps and positioned himself between the pumps and the tractor to record the pump readings.

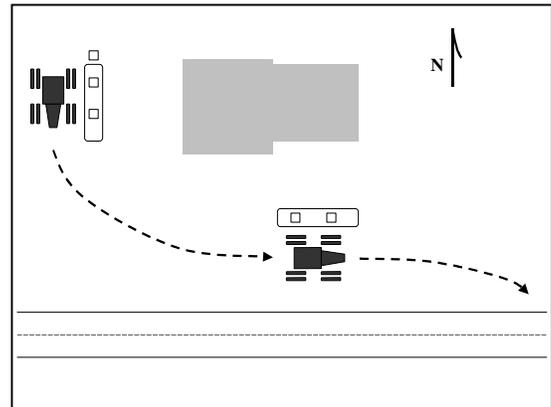
Figure 2. This diagram shows the layout of the service station pumps and the path of the tractor.

After checking and adjusting the tire pressure, the driver climbed into the cab and started to drive the tractor away from the station. With the transmission shifted to a high gear, the tractor died when the driver released the clutch. Because a key had previously been broken off in the ignition switch and the switch had not been repaired, the driver used a jump-start method to start the tractor. He climbed down out of the cab without first ensuring that the transmission was shifted into neutral and walked around in front of the tractor. He used a screwdriver to create an electrical short between the tractor's battery and starter, an operation that required the worker to position himself directly in front of the inner right front wheel while reaching into the engine compartment (Figure 3). The motor fired immediately when the screwdriver shorted the starter to the battery. After a delay of approximately one second during which the vehicle's hydraulic pressure increased to operating level, the tractor lurched forward, running over the driver and proceeding in an easterly direction away from the fuel pumps. The sudden movement of the tractor knocked down the service station manager, who had been leaning against one of the tractor tires while he was recording the pump readings. A service station attendant saw the tractor veering toward the highway and fearing that the vehicle would enter the roadway, ran after the tractor. While the tractor was still moving, he jumped onto the vehicle, climbed into the cab, and popped the clutch to shut down the motor just before it reached the roadway. The tractor came to rest approximately 100 feet from the fuel pumps where it had been started.

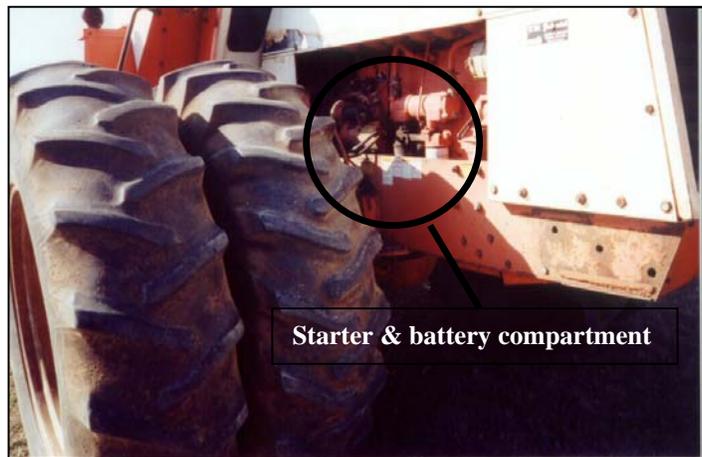
Figure 3. This picture shows a close-up view of the starter and battery compartment of the tractor.

Discussion: Although the tractor was generally in good condition, FACE investigators identified two significant equipment hazards, the correction of either one of which may have prevented the incident. First, a key had been broken off in the starter switch, requiring the operator to use an alternative method to start the tractor. Replacement of the switch would have allowed the operator to start the tractor from within the cab. Second, by jump-starting the tractor, the operator by-passed the transmission/ignition interlock, a manufacturer-designed safety feature that required the transmission to be in neutral for the ignition switch to engage the motor. The manufacturer had designed a shroud to cover the components, thereby discouraging the practice. This retrofit was available but had either been removed or was never installed on the tractor involved in this incident.

Recommendation #1: Employers should maintain tractors and similar farm equipment in safe operating condition, including any original safety-related features and any retrofits designed and recommended by equipment manufacturers.
