SUBJECT: Farmer died when he was crushed within a hay baler

SUMMARY

A 73-year old farmer died on May 2, 2001 from injuries received when he was crushed within a hay baler. OKFACE investigators concluded that to prevent similar occurrences, employers should:

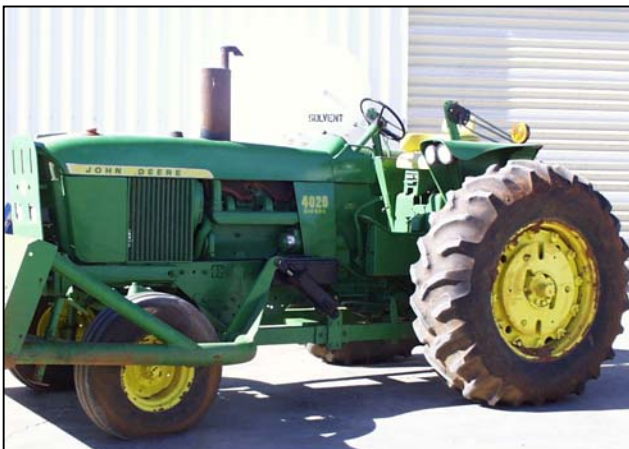
Figure 1. Tractor

The temperature at the time of the incident was approximately 70-75°F, and the wind was out of the north-northeast at an average speed of 20 mph with gusts up to 36 mph. There had not been any measurable precipitation for at least 10 days. The decedent was operating a tractor (similar to the one shown in Figure 1), to which was connected a large round hay baler (similar to the one shown in Figure 2). His plan was to bale hay that had been cut on a 25-acre alfalfa field located along a state highway approximately two miles north of a nearby city. The hay baler was equipped with hydraulic cylinders, which were connected to the tractor's hydraulic system. These hydraulic cylinders operated the rear gate and the bale tying mechanism. The farmer was a widower and operated the farm by himself. His last contact with a family member occurred two days before he was found dead.

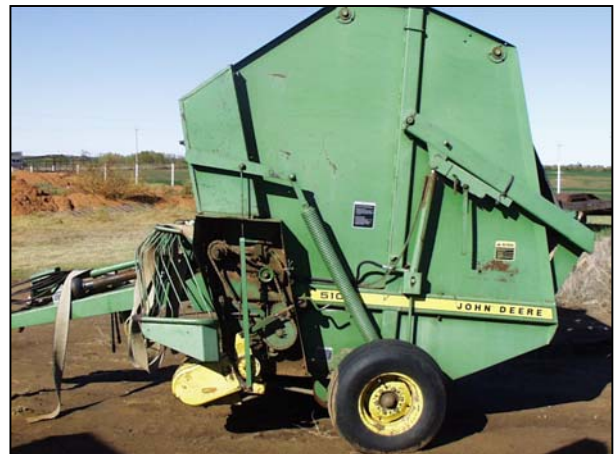
Figure 2. Hay baler

At the time of the incident, the victim had been operating a farm tractor that was pulling a hay baler. The hay baler, manufactured no later than 1982, was unavailable to OKFACE investigators for inspection. OKFACE investigators identified no objective evidence that the farm operation had a formal safety program.

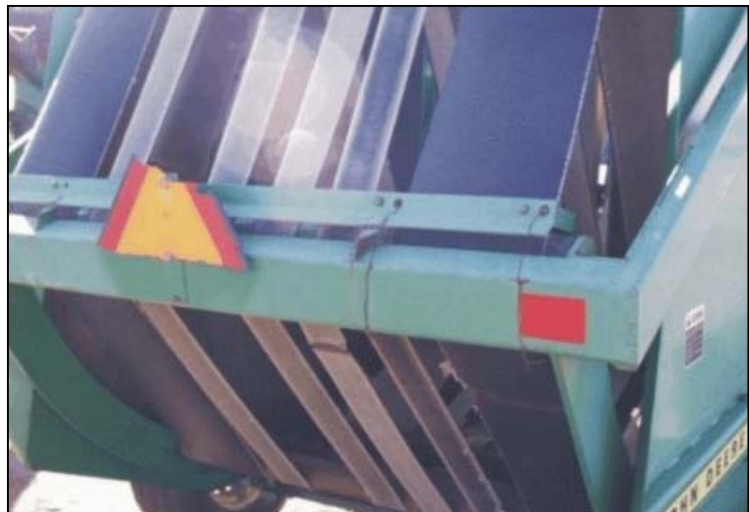
Figure 3. Hay baler rear gate

There were no eyewitnesses to the incident. Physical evidence indicated the victim had begun baling the hay that morning and had completed six bales before experiencing an undetermined difficulty. He ejected a seventh partial bale and climbed down from the tractor, leaving the vehicle's motor running, the power take-off (PTO) engaged, and the hydraulically operated rear gate in the open or "up" position. He then walked to the back of the baler (similar to the one shown in Figure 3) and was standing beneath the elevated gate when apparently the gate suddenly descended, crushing him between the belt rollers (which are connected to the gate on each end by stabilizer bars) and the floor of the baler. The tractor ran out of fuel and was not running at the time the farmer's body was discovered. The key was found in the "on" position, and the PTO control was engaged. One of the large flat belts on the baler had been cut by a sharp object and was partially lying on the ground beneath the baler.

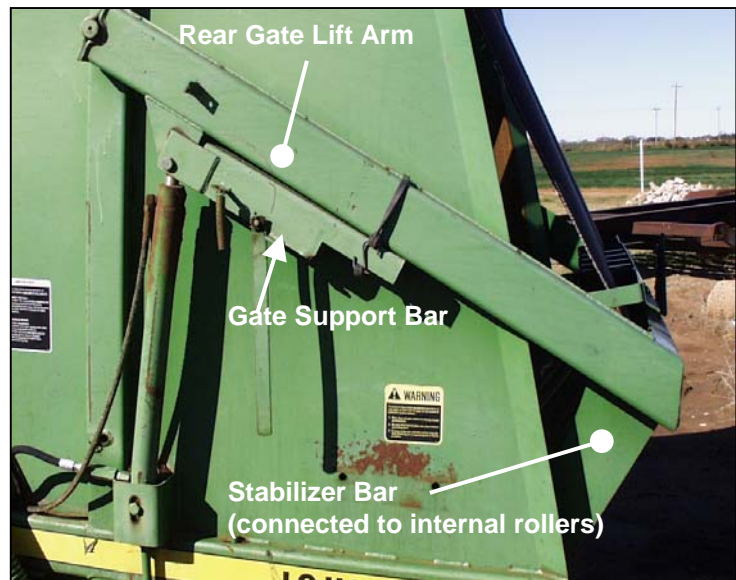
Figure 4. Side view of the rear gate lift arm

Discussion: Failure to observe warnings and follow safe work procedures recommended by the equipment manufacturer was the underlying cause of the fatal incident. Evidence at the scene indicated the decedent engaged the tractor's hydraulic system to open the hay baler's rear gate then approached the back of the machine without first setting a manual support bar (Figure 4) in place. The support bar is designed to hinge down onto the extended hydraulic cylinder to prevent compression of the cylinder and closure of the gate. By failing to set the support bar, the operator relied on the tractor and implement hydraulic systems to hold the heavy gate open. Use of the support bar may have prevented the fatal incident.

A factory-installed decal on the hay baler clearly relates the hazard presented by moving parts and instructs the operator to “disengage PTO and shut off engine” to avoid being pulled into the machine. With the tractor turned off and the PTO disconnected, the operator would have had to use the support bar to keep the baler's rear gate open while he was in the hazard area. Failure to follow the warnings and reliance on the operating hydraulic systems to hold the gate exposed the operator to the hazard of moving parts.

Recommendation #1: Employers should maintain tractors and similar farm equipment in safe operating condition and follow manufacturer recommendations when using, maintaining, and servicing powered equipment.
