SUBJECT: Truck driver died when concrete mixer truck overturned

SUMMARY

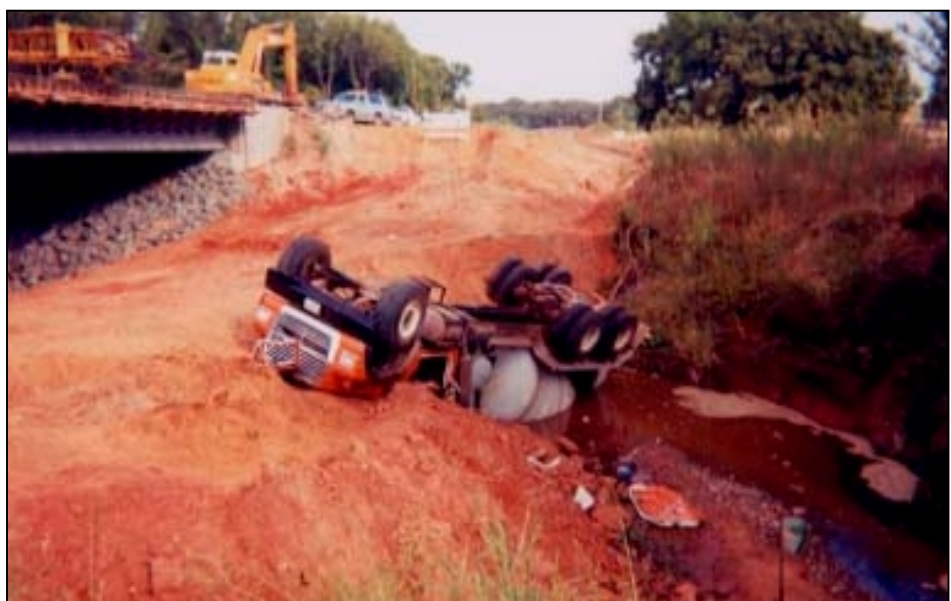
Figure 1. Overview of Worksite

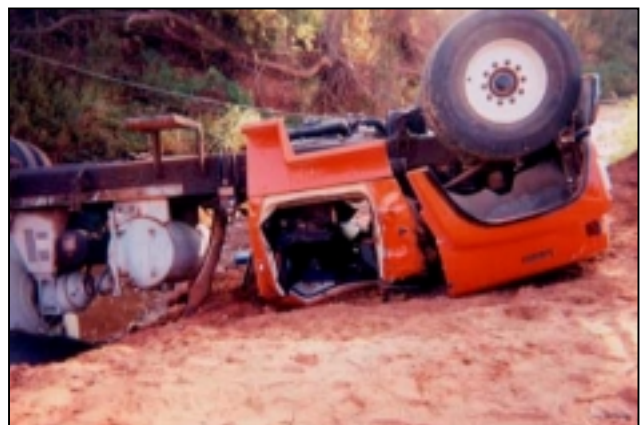
The incident occurred on a low water temporary "haul" road that was constructed approximately four months prior to the incident on the east side of the bridge as a means to move equipment and materials across the creek between the north and south sides of the project. The low water bridge consisted of a three-foot diameter culvert positioned in the creek bed. It was 318 feet in length, ranged from 19 to 24 feet in width, and was constructed of compacted indigenous earth to a level approximately four feet above the top of the culvert (7-8 feet above the creek bed). Post-incident analysis of the haul road materials indicated a 57% sand and 43% percent clay mixture (Unified Soil Classification System Type sandy clay soil). Post-incident penetrometer tests indicated relatively good compaction toward the center of the road but extremely low shear strength at the shoulder. Investigators found that the material at the edge of the road crumbled easily to the touch.

Figure 2. Close View of Crushed Truck Cab

Low shear strength at the road shoulder, the underlying cause of the incident, was attributable to a lack of cohesion resulting from the absence of moisture in the road material. The area was experiencing a serious drought at the time with the last significant rainfall having occurred in July. A crane (100,000 pound estimated gross vehicle weight) and a truck carrying the bridge beams (112,000 pound estimated gross vehicle weight) had crossed the haul road on September 27, a concrete mixer truck had used the road on October 2, and a concrete pumper truck (82,000 pound estimated gross vehicle weight) had crossed the road earlier on October 5, all apparently without incident. Although witness accounts described some superficial work on the haul road performed by a dozer immediately prior to the incident, OKFACE investigators could find no objective evidence that the temporary road had been specifically engineered for the environmental or use conditions to which the road was to be subjected nor that it had been routinely inspected or maintained.

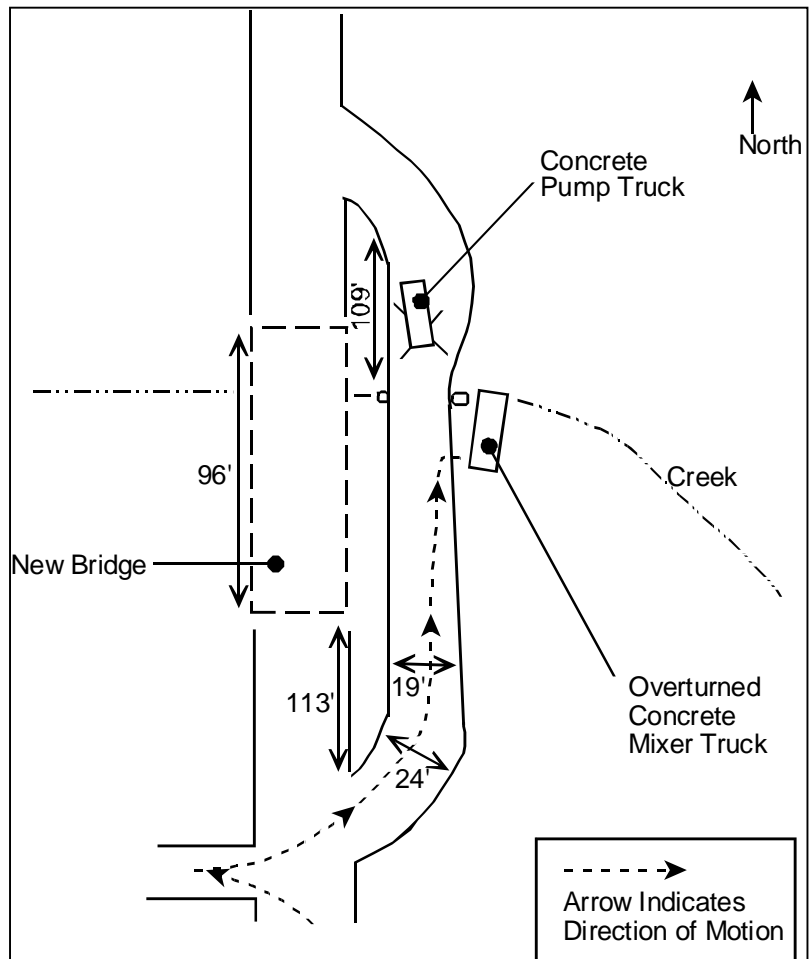
Figure 3. Bridge Project Haul Road and Vehicle Positions

bridge. The driver positioned his vehicle squarely in the haul road and began backing down the incline toward the low water bridge. There was conflicting information on whether or not someone was guiding him as he backed the truck. As the truck reached the low water bridge, a bridge contractor employee observed the truck backing at an angle to within three feet of the east edge of the road, and he shouted a warning as the truck began to slide toward the edge of the road. The second mixer truck driver, who had exited his truck to position the chute, saw the first truck starting to slide and saw the driver attempt to exit the vehicle on the passenger side. The truck hesitated, then rolled over into the creek bed as a section of the road, measuring approximately twelve feet in length and five feet in width, sheared off the road shoulder and collapsed into the creek (Figure 1 and 2). The mixer drum flipped completely over, landing upside-down in the creek bed and slamming the cab into the steep (approximately 45°) creek bank. The impact crushed the roof of the cab and trapped the driver inside the vehicle. The incident occurred at approximately 7:55 a.m.

Discussion: OKFACE investigators determined that rehabilitation of the road surface did not correct defects in the road structure caused by the long drought and consequent absence of moisture in the soil. The width of the road and the width of the truck provided a 5.5-foot clearance on both sides of the vehicle, but the shear strength of the road declined dramatically toward the road's edge. As the truck veered from the middle of the road toward the east edge of the road, the combined weight of the vehicle and load imposed on the road shoulder in its structurally compromised condition caused the collapse of the road and consequent overturn of the vehicle. The high center of gravity of the truck and load caused the vehicle to rotate 180° into the creek bed, and the height of the mixer created a fulcrum that allowed the weight of the front of the vehicle to slam the roof of the cab into the creek bank. The driver was consequently crushed inside the cab of the vehicle.
