SUBJECT: Oilfield trainee died after being struck by a bull plug, needle valve and gauge assembly blown out of a wellhead connection

SUMMARY

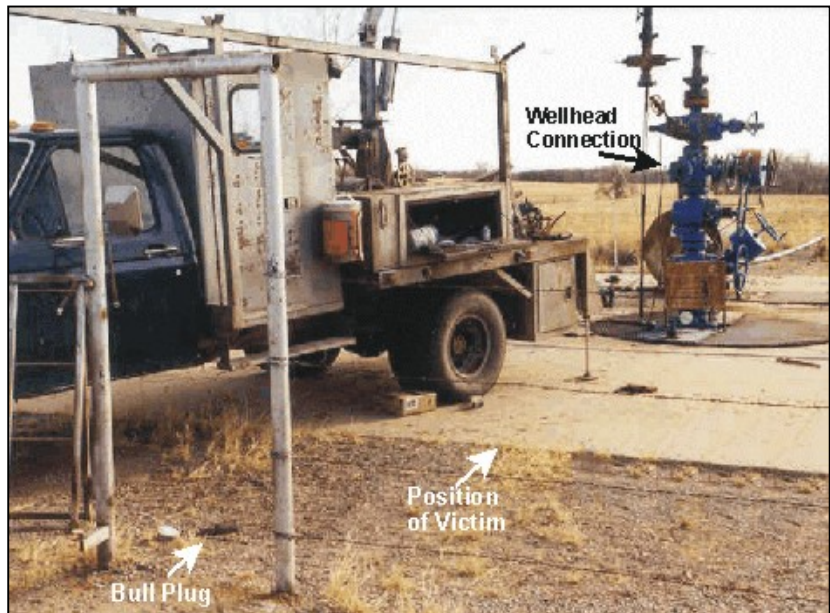
Figure 1. Position of victim in relation to the wellhead and location of bull plug after it flew out of the wellhead and struck the victim.

Before the incident occurred, the wireline crew had made one run into the well and had pulled back out of the well to change tools. At approximately 10:30 a.m., while the wireline crew was changing tools near their truck, the well operator and the chemical company operator attempted to gauge the well pressure (later estimated to be approximately 1400 psig). The chemical company operator inserted a gauge assembly, consisting of a bull plug, needle valve and pressure gauge, into a threaded flange on the wellhead and tightened the assembly until it was snug. The well operator, who had been in his truck using a mobile phone, came back to the wellhead, noticed that the gauge rigging was in place, and proceeded to open the gate valve to conduct the pressure check. The wireline crew trainee was standing next to his crew truck approximately 15 feet from the wellhead in direct line with the wellhead connection (Figure 1). When the gate valve was

Discussion: The physical location of the decedent with respect to the wellhead connection was an underlying cause of the fatal incident. The victim may not have been aware that he was standing in a location subject to a flying projectile when the gauge assembly was blown out of the wellhead connection. Worksites should be laid out with vehicles and adjoining work spaces positioned out of direct line with any connections to be used during the day's activities and with hazardous areas well marked to prevent persons from inadvertently walking into an area in direct line with any connection in use. Signs or barricades that cordoned off the danger zone may have deterred the victim from being in a position where he could be struck when the gauge assembly was blown out of the well connection.

- Until connections are adequately tested, the responsible employer on oil well locations should place signs or barricades in areas that lie in direct line with wellhead flanges and connections that may be subject to flying debris in the event of a system failure.

Recommendation #2: Until connections are adequately tested, the responsible employer on oil well locations should place signs or barricades in areas that lie in direct line with wellhead flanges and connections that may be subject to flying debris in the event of a system failure.

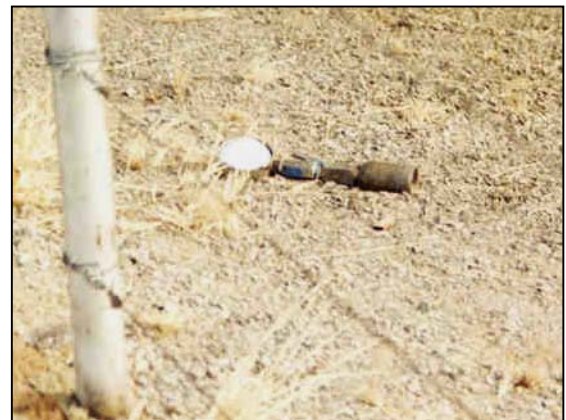
Figure 2. Bull plug, needle valve and gauge assembly

opened, the sudden pressure dislodged the bull plug and blew the plug, needle valve and gauge assembly out of the flange in the direction of the wireline operator trainee, striking him in the head and neck (Figure 2). The force of the impact knocked the trainee into the wireline operator who had been standing a few feet away.

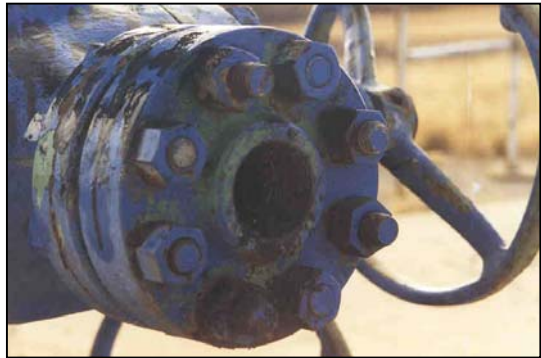
Figure 3. Wellhead connection

Investigators determined that the chemical company operator had inserted a standard 2-inch pipe bull plug into a 2-3/8 inch eight round external upset threaded flange which may have appeared to accept the connection (Figure 3). However, only the crown of the threads were in contact with each other and none of the threads were actually engaged. The mismatched threads did not hold the assembly in place when the wellhead valve was opened. The well operator did not inspect the gauge assembly before opening the gate valve.

Discussion: The insertion of mismatched threads on the bull plug, needle valve and gauge assembly into the wellhead flange was an underlying cause of the fatal incident. The improper connection was reportedly identifiable by visual or physical inspection by an experienced worker. The improperly threaded connection evidences a lack of understanding regarding the equipment, the task, or the hazards presented by the use of the wrong fitting in the wellhead connection. The knowledge and skills of all workers should be assessed and adequate training provided by the employer before assigning them to perform critical tasks. Additionally, training in hazard recognition and control should be provided to all workers who

Recommendation #1: The responsible employer on multi-employer worksites should monitor critical safety activities performed by contractor employees, particularly personnel whose background and skills may be unknown or uncertain.

Recommendation #5: Employers should ensure that all employees are properly trained and skilled to perform each task that they are assigned, including training in hazard recognition and control.
