SUBJECT: A roller operator and a work crew foreman died when they were struck by a motorist in a highway work zone.

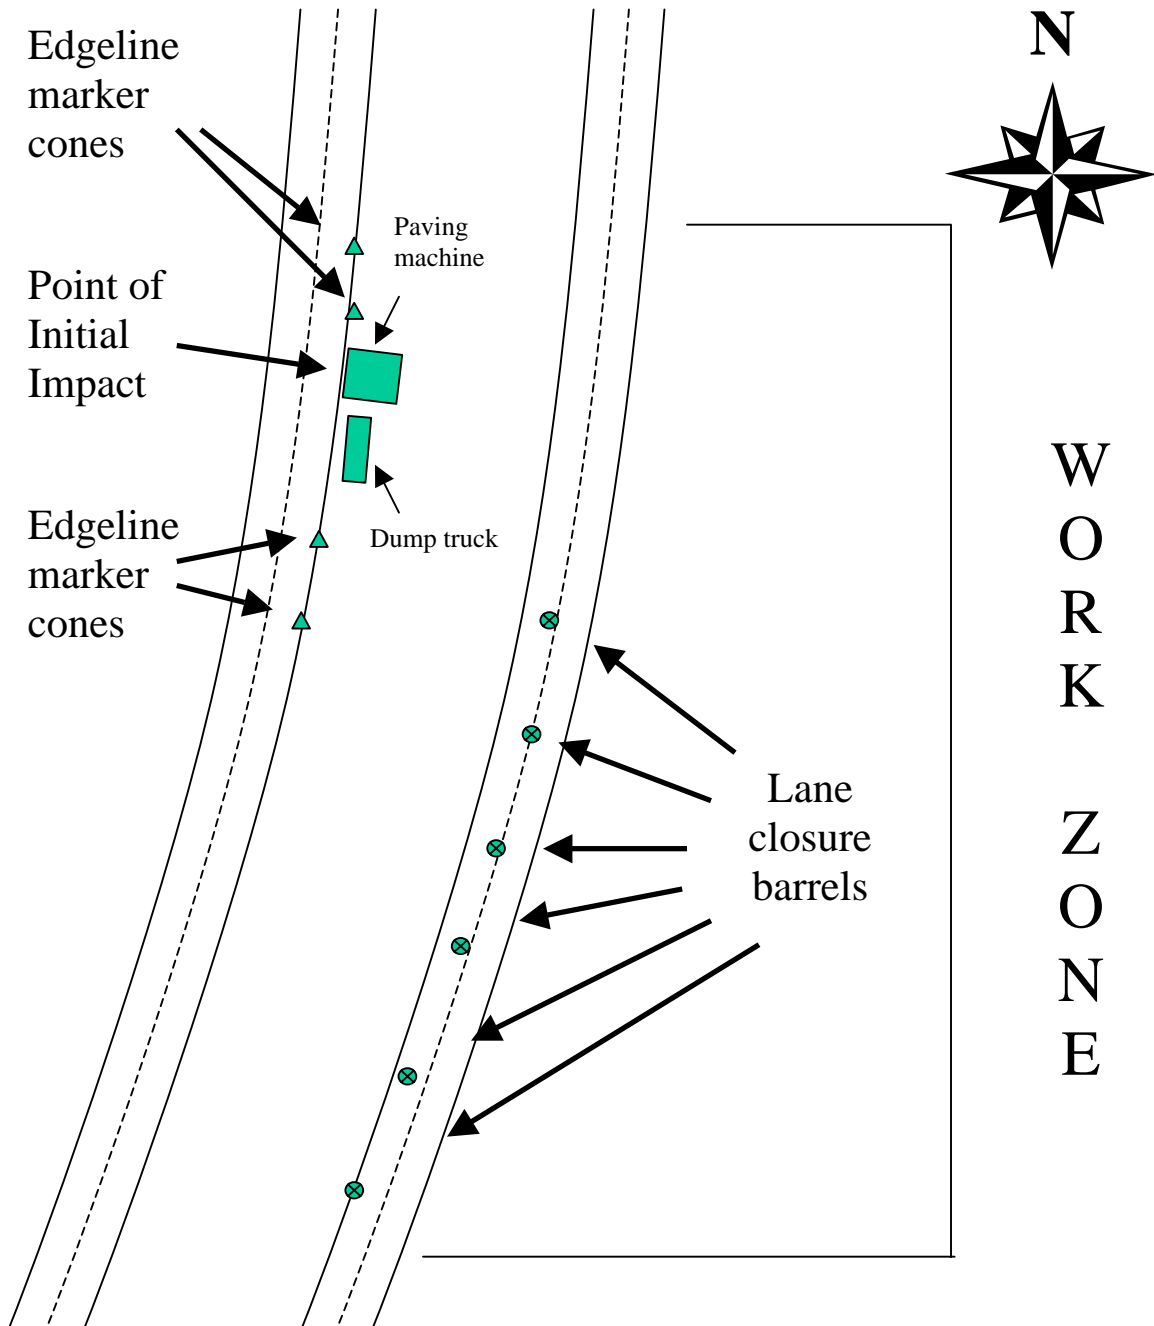
Figure 1. Work zone diagram (not to scale).

warning barrels to permit truck entry into the work zone. Signs had not been installed for southbound traffic nor had the southbound inside lane been closed. Plastic cone markers had instead been set at the inside edgeline of the southbound lanes (generally in accordance with the Manual on Uniform Traffic Control Devices, Part VI, Figure TA-6 "Shoulder work with minor encroachment") to demarcate the work zone (Figure 1).

and the paving machine operator, who was inspecting the paving process as the asphalt was being laid in place, was standing next to him. Both crewmen, wearing bright orange vests, were standing on the existing roadway on the median side of the inside roadway edgeline. The dump truck, positioned on the south side of the paving machine and also facing south, was pouring paving materials into the paving machine. One crewmember had been standing near the two victims but had stepped away from the roadway immediately before the incident occurred.

The 17-year-old driver had stopped from a westbound direction at the intersection 0.65 miles north of the scene of the incident and had turned and proceeded southbound toward the work zone behind a truck in the inside lane. The driver accelerated from a complete stop reportedly to a high rate of speed, reached down to turn down the volume on his vehicle radio, and veered to the left into the work zone. His pickup struck the foreman approximately 3.5 feet inside the roadway edgeline, traveled approximately 3 feet and struck the operator, traveled approximately 1 foot and struck the paving machine, traveled approximately 30 feet and struck the dump truck, then traveled approximately 273 feet before coming to a complete stop in the median approximately 48 feet inside the roadway edgeline. The final position of the foreman was approximately 14 feet south and 3 feet west of the point of impact. The operator was carried on the hood of the pickup to a position approximately 139 feet south of the point of impact and 22 feet inside the roadway edgeline. Both victims were killed on impact.

Discussion. Physical separation of the worker from the hazard of moving traffic (lateral buffer zone) in accordance with the MUTCD provides an important means to reduce the risk to personnel in a work zone. Although lane closures impede traffic flow and are consequently an unpopular hazard control, employers should close the adjacent lane whenever workers must be positioned close to the roadway edgeline.

Discussion. The plastic cones used as channelizing devices to demarcate the work zone at the point of the fatal incident did not gain the attention of the driver of the intruding vehicle. The use of barrels as channelizing devices for closing the lane at the entrance to the work zone may serve to better attract the attention of a driver to the impending hazard posed by the roadside work. This type of device must be positioned at a sufficient distance from worker positions so that flying debris does not strike workers should an a motor vehicle strike the device.
