## Investigation Report

99OK01801

Assemblyman dies from injuries received in the failure of a gasket during a hydrostatic test.

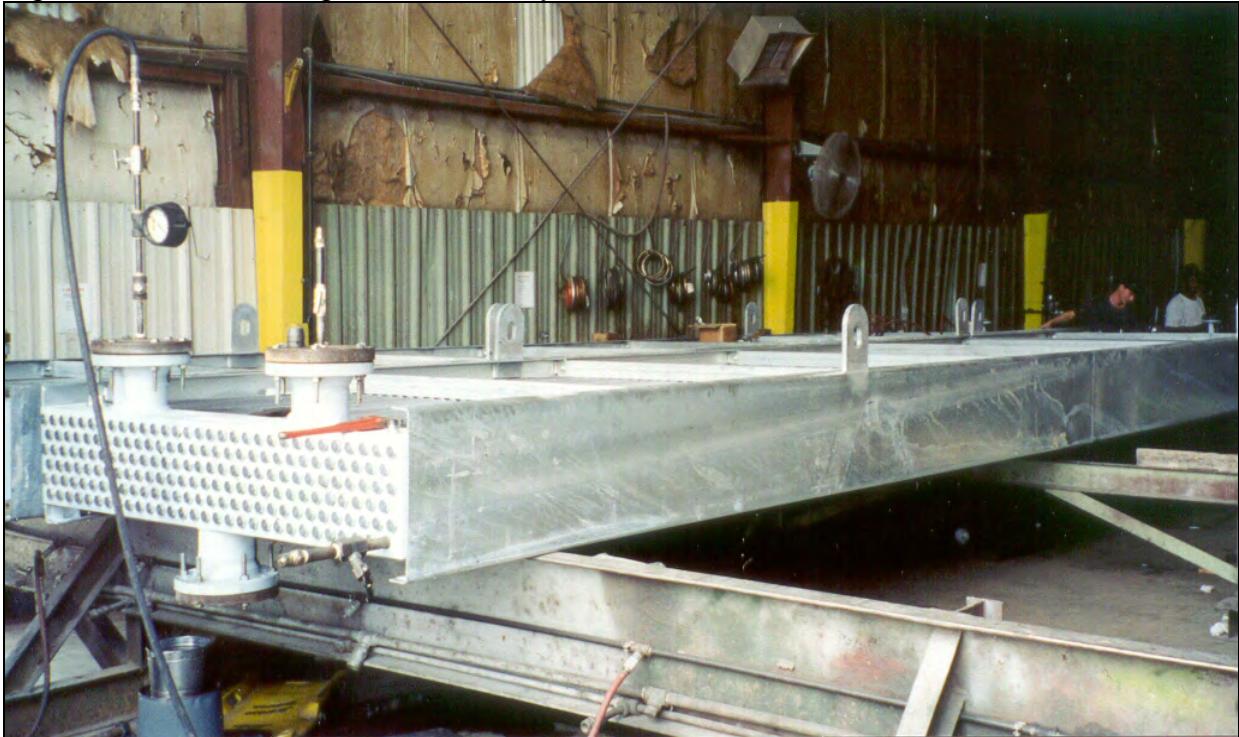
Figure 1. Heat exchanger coil with a hydrostatic test connection

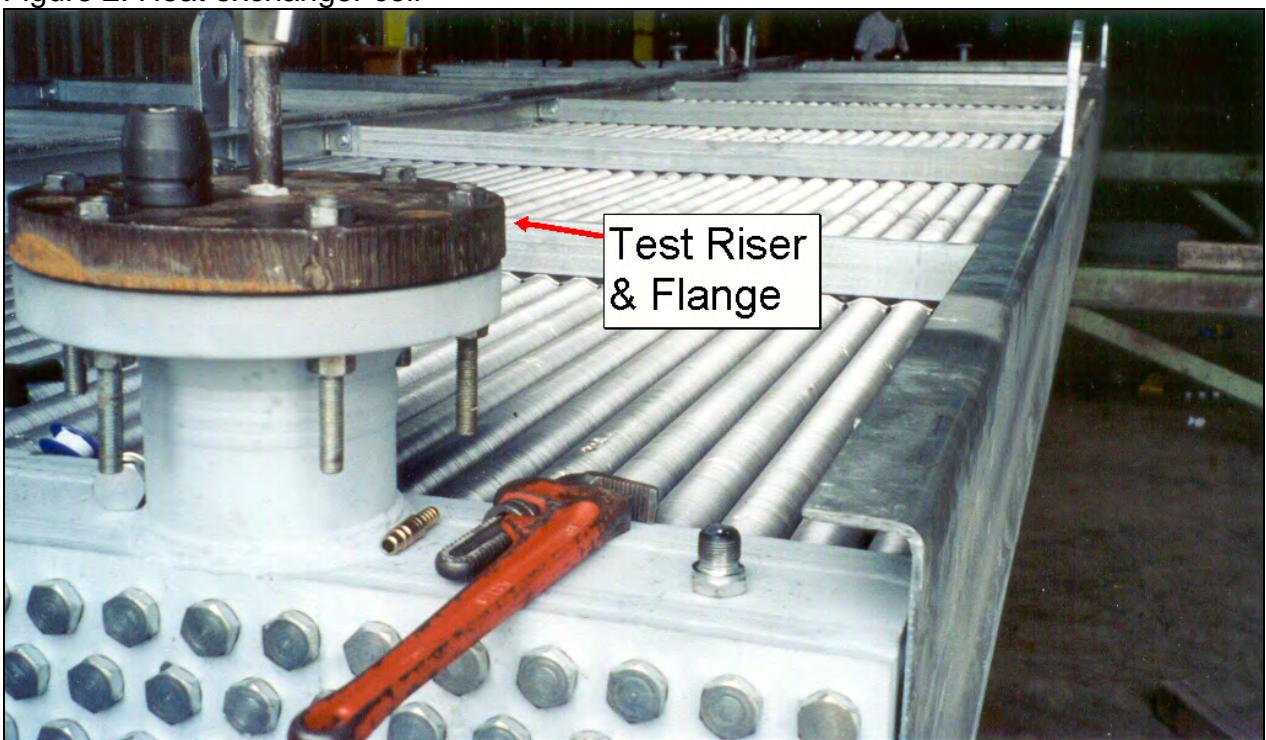
Figure 2. Heat exchanger coil

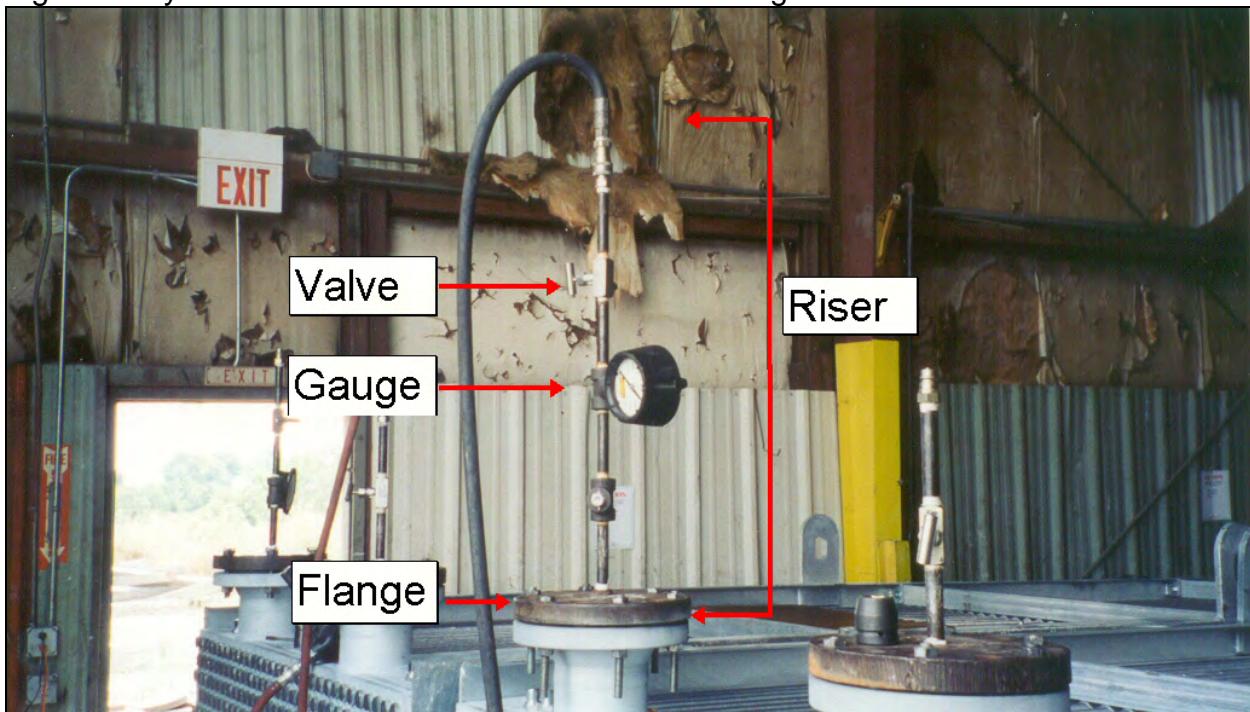
**Discussion:** The riser connection and isolation valve represent key opportunities for structural failure during a hydrostatic test. Employees who must work in close proximity performing such activities as operating the valve are at increased risk of serious injury in the event of a failure. The use of a structural barrier with the use of a remote controlled valve may be an alternative safety measure in some instances. The use of personal protective equipment should be considered for employees who cannot be protected by such a barrier. They might include a hard hat with face shield to protect the head and face and penetration-resistant vests to protect the torso.

Figure 3. Hydrostatic test connection to a heat exchanger

**Recommendation #4: Employers involved in hydrostatic tests of large heat exchangers and similar equipment should provide barrier protection for employees who must work in close proximity to potentially weak points in the hydrostatic test system or provide a remote control to physically separate the employee from the high-risk area.**
