**Investigation Report
April 4, 2000
99OK00901**

Construction laborer dies from injuries received in a 33-foot fall through a skylight opening.

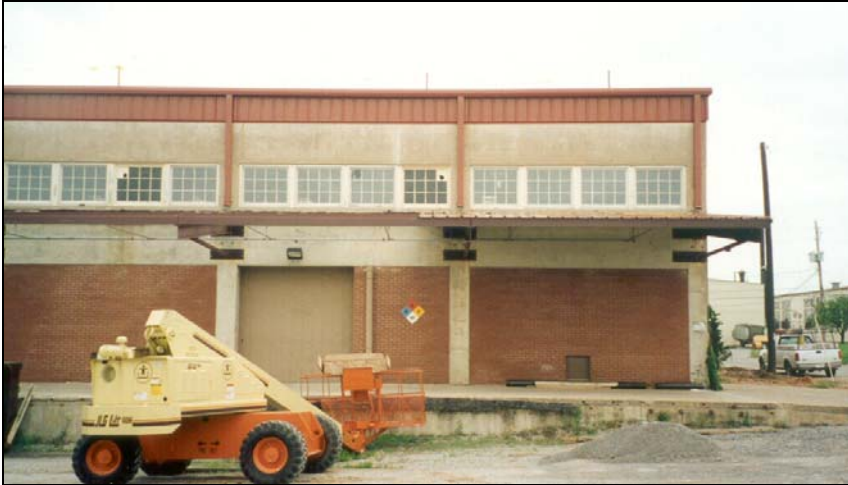
Figure 1. Building elevation

At the time of the incident the work crew was installing sheet metal upper decking above a sheet metal sub-deck on a 0.75:12 slope. The deceased laborer had worked on a crew that had installed an 8-foot by 4-foot sheet of 1/2-inch plywood on each of the 16 skylight openings, all of which measured 9.5 feet long by 34 inches wide, in the roof of the building. The covers were anchored in place with sheet metal screws, but as the roofing project progressed, each cover had to be re-oriented transversely to the opening in a manner that left half of the opening exposed in order for work crews to install the roof decking and skylight components. A member of the work crew was designated to serve as safety monitor whenever operations were proceeding near the roof edge. The skylight work was proceeding well inside the roof edge and thus the safety monitor was not involved in the monitoring task. Weather conditions at the time of the incident included a clear sky, cool temperature, and light or no wind.

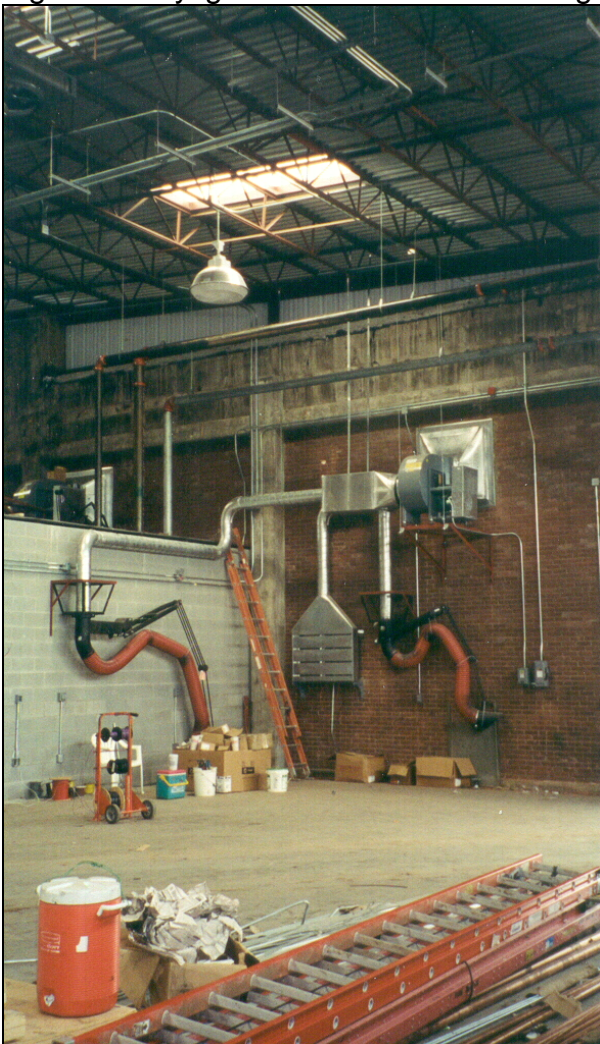
Immediately prior to the incident, the victim and a co-worker had re-oriented the cover onto the up-slope half of the first of the 16 openings and laid metal decking up to the down-slope edge of the opening. The skylight pan, the lower component of the plastic skylight, had been installed in the opening, and the two laborers were applying sealing tape to the up-slope edge of the newly installed roof decking at about 8:30 a.m. Another member of the work crew, the roof edge safety monitor, was located approximately 30 feet from the skylight opening at the time of the incident where he was obtaining measurements in preparation for work to be performed after the installation of the skylight. He was not acting as safety monitor since the work was being performed away from the roof edge. As the victim installed the sealing tape near the edge of the skylight opening, the co-worker was working approximately 10 feet away from the opening. The evidence suggests that the victim installed the sealing tape to the edge of the skylight opening, stood to re-position himself on the other side to continue the task, turned 90 degrees to his left, and stepped into the opening. The unsecured plastic skylight pan flexed under the weight of the worker and slipped out of the skylight frame allowing the victim to fall 33 feet to the floor of the building. The co-worker heard the noise generated by the collapse of the skylight pan and turned to see the victim slip through the opening. Both workers on the roof stated that the victim made no sound as he fell. Both men immediately descended to the floor of the building and checked the victim but could find no pulse. Emergency medical services responded within five minutes of the emergency call, which was made immediately following the incident, and transported the victim to a local hospital where he was pronounced dead two hours and seven minutes following the incident.

Figure 2. Skylight the decedent fell through

Recommendation #2: Employers should consider installing skylight fixtures that are sufficiently strong to support at least twice the weight of employees, equipment, and materials that may be imposed on the fixture at any one time. These skylight fixtures should be secured and marked to provide warning of the fall hazard.
