FACE Investigation Report

October 5, 1998

SUBJECT: Construction worker dies of crush injuries after being struck by falling concrete form – Oklahoma.

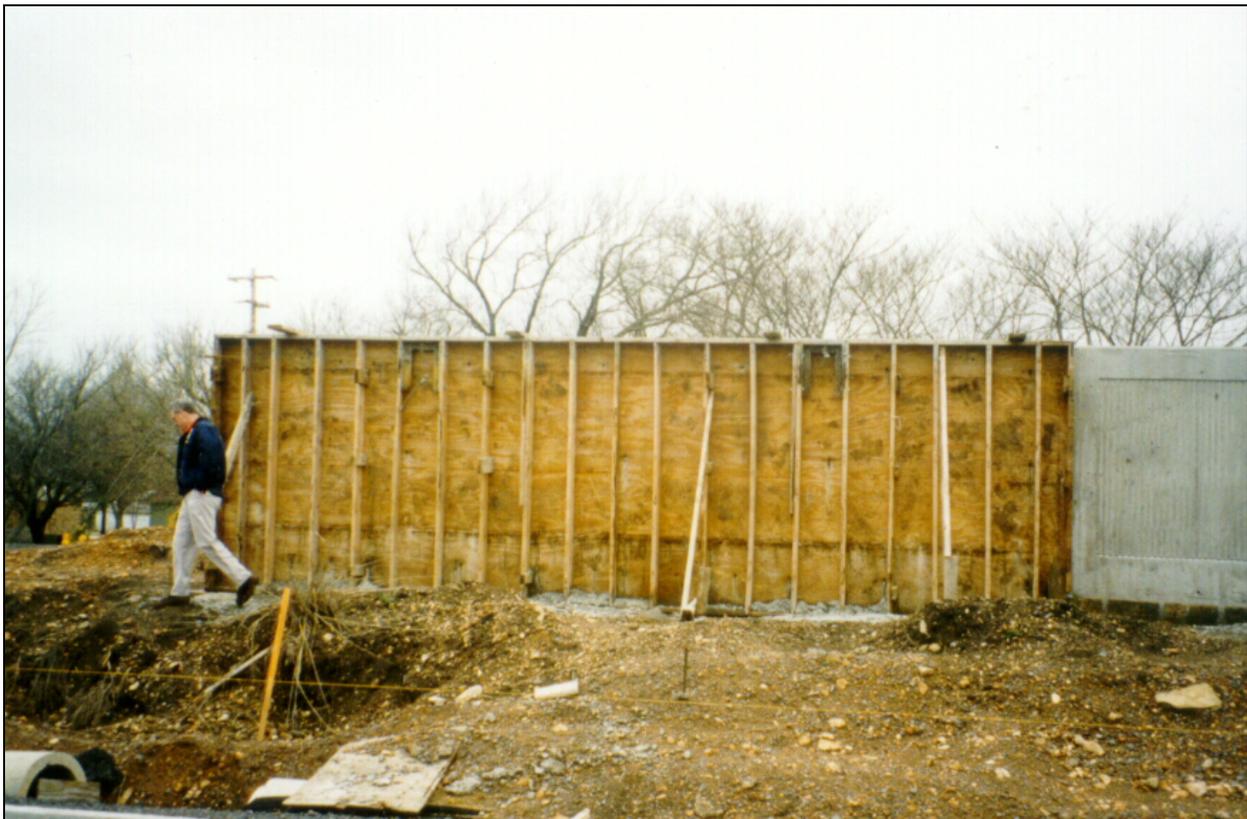
Figure 1. Front view of the form.

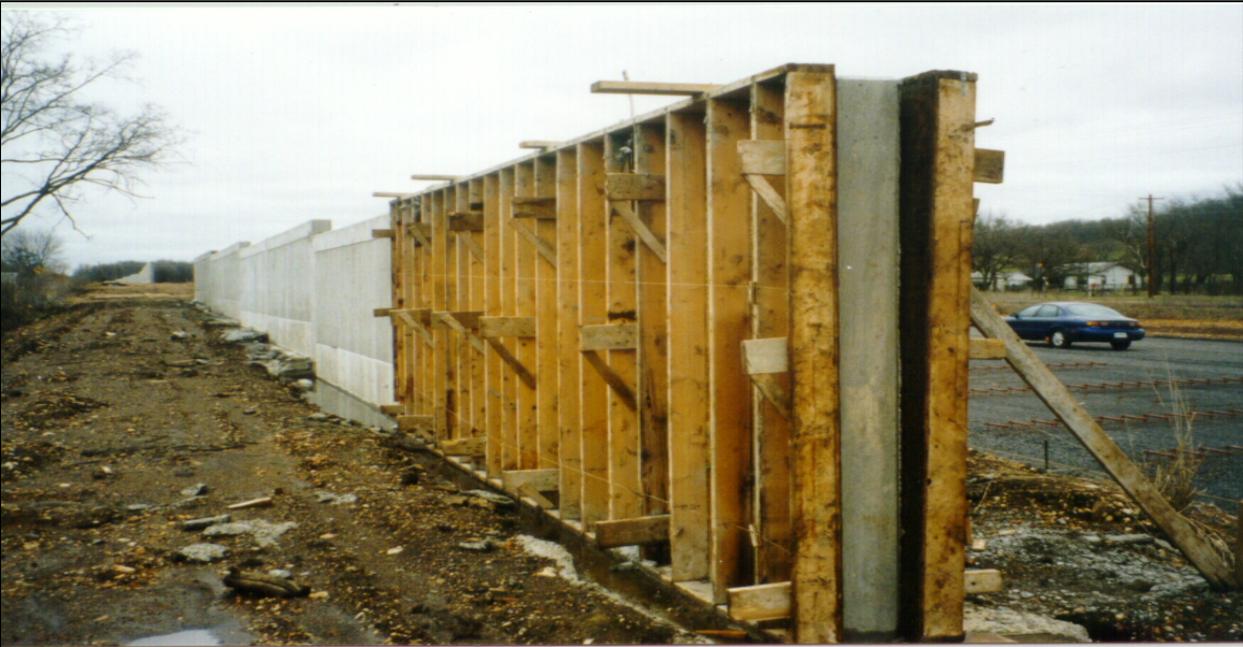
Figure 2. Back view of form

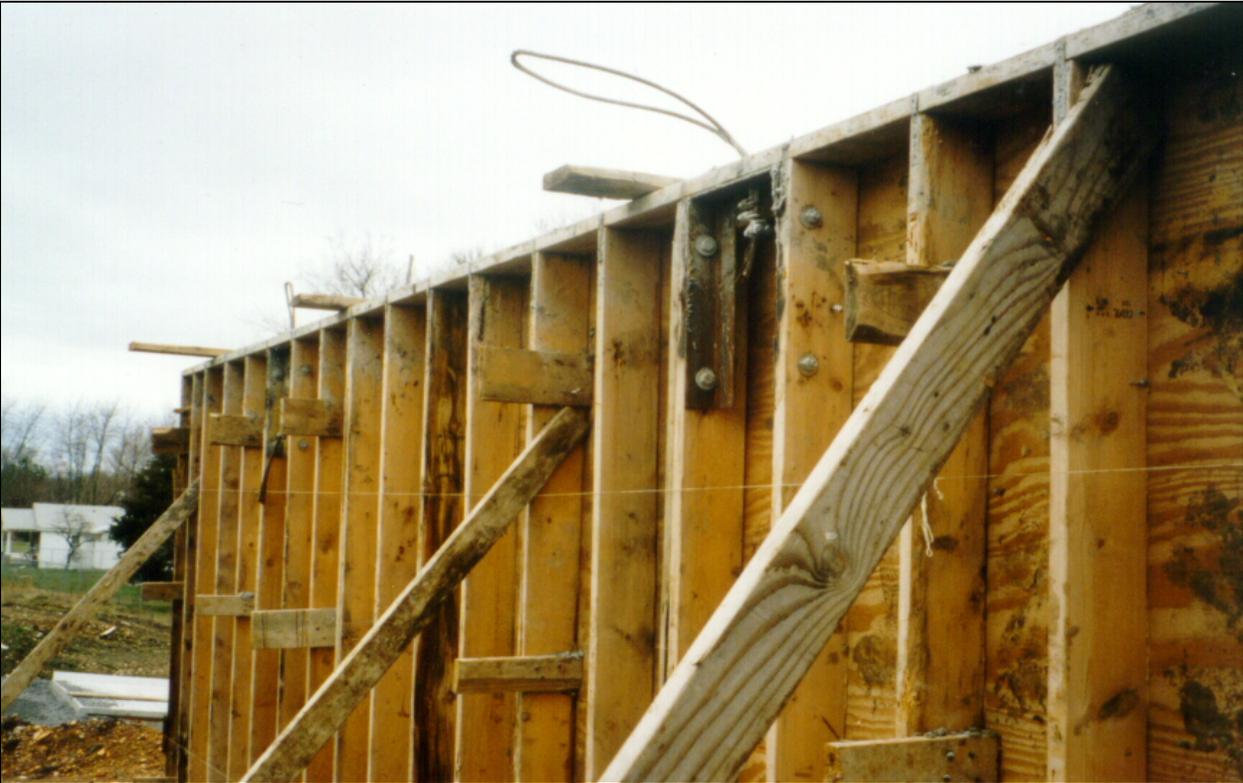
Figure 3. Braces and crane cable connections.
