## Worker Dies After Being Pinned Between Wheel And Bed Of Flat-Bed Trailer

MN FACE Investigation 02MN002

Date: August 26, 2002

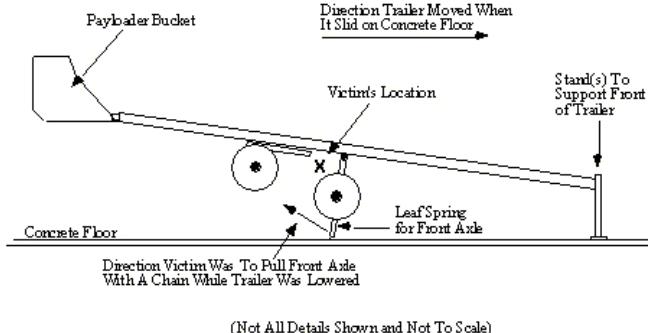
[Figure 1](#) shows the trailer position while it was being worked on by the victim and his brother. The trailer's front axle was attached to two leaf springs, one adjacent to each wheel of the axle. The ends of the leaf springs were attached with metal pins to the trailer's steel frame. These pins were worn and were being replaced as part of the maintenance being performed on the trailer. Prior to raising the back end of the trailer, the pins holding the back end of the front axle's leaf springs were removed. When the back end of the trailer was raised, the front axle swung to the position shown in [Figure 1](#). This provided the victim and his brother with an unobstructed area between the front and rear axles to work on the trailer's axles and suspension components.

Figure 1. Side view of trailer, back end raised by payloader bucket.

While the victim was between the wheels, the trailer suddenly slid forward and the back end fell allowing the trailer to drop and come to rest on all four wheels and the front end stands. When the axles were in position for use and the trailer was on the ground, the space between the bottom of the trailer bed and the top of the wheels was only 4-5 inches. The victim was pinned between the top of the front axle wheel and the frame/bed of the trailer. After the trailer fell, the victim's brother called to the victim but did not hear a response. He climbed down from the payloader and walked around to the side of the trailer where he discovered his brother pinned between the trailer and the wheel. He returned to the payloader and raised the back end of the trailer to free the victim. After raising the trailer, he removed the victim and laid him on the concrete floor. He placed a call to emergency personnel who arrived shortly after being notified. They examined the victim and determined that he had died instantly of severe head trauma when the trailer slid forward and fell to the floor.

**Recommendation #1: Workers should only use machines and equipment for tasks for which they were intended and designed.**

**Discussion:** During this incident, an industrial payloader equipped with a front-end bucket was used to lift and support the back end of the trailer while various repairs and maintenance tasks were completed. Although the lift capacity of the payloader was in all likelihood more than adequate to lift and support the trailer, its use as a lifting device is not a purpose for which it was intended and designed. In addition, the physical size of the payloader may have contributed to the occurrence of the incident. If the back end of the trailer had been raised using traditional lifting devices such as mechanical or hydraulic jacks, the workers would have been in direct visual contact with each other while the trailer was being lowered. The physical size of the payloader and its front-end bucket prevented direct visual contact from being
