Farmer Dies After Becoming Entangled In A Power-Take-Off Shaft

MN FACE Investigation 01MN004

July 25, 2001

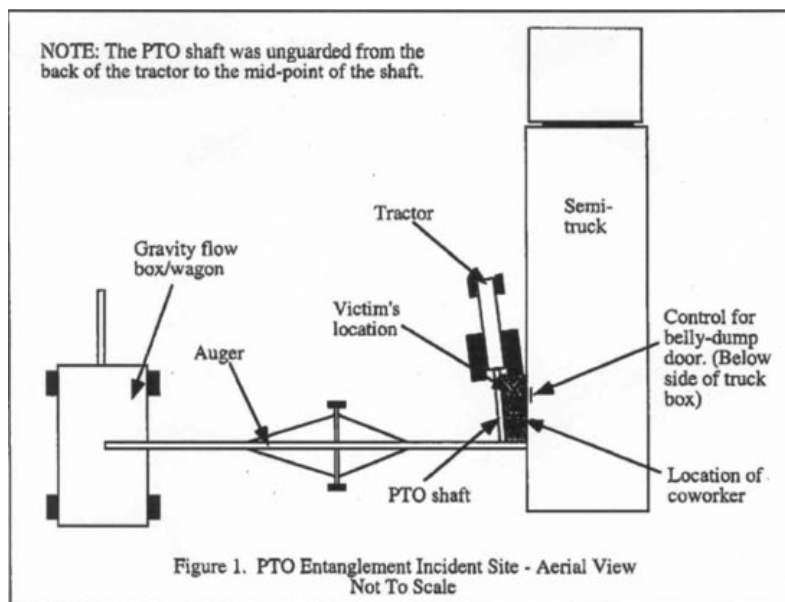
The auger's PTO shaft was originally fitted with a two-piece telescopic tubular safety shield to protect workers from the rotating PTO shaft. Although the tubular shield rotated with the PTO shaft, if a worker contacted the tubular shield, it would immediately stop rotating while the enclosed PTO shaft continued to spin. However, at the time of the incident one-half of the tubular shield that enclosed the PTO shaft was missing. This resulted in the PTO shaft being unguarded from the point where it was connected to the tractor to the mid-point of the shaft.

The tractor was positioned nearly parallel to the left side of the truck box as shown in Figure 1.

The physical configuration of the equipment at the scene created a small restricted work area (shaded area of Figure 1) that was bound by a portion of the side of the truck box, a portion of the auger, the auger's PTO shaft and one-half of the back of the tractor. The size of the restricted area was approximately 6-7 feet long, 4-5 feet wide at the back of the tractor and 3-4 feet wide at the narrower end of the area. The configuration of the equipment required a worker to be in this restricted area to access the control mechanism to open and close the horizontal unloading door of the truck's rear compartment.

The victim and the truck driver were standing in the restricted area at the approximate locations indicated in Figure 1. When the rear compartment of the truck was empty, the truck driver moved toward the victim to reach the mechanism for closing the rear compartment unloading door. The victim apparently stepped slightly back toward the PTO shaft to provide additional room for the truck driver. When he stepped back, the end of the jacket sleeve on his right arm became entangled in the rotating PTO shaft. He sustained multiple trauma as he was thrown against the ground and against parts of the tractor by the rotating shaft. In addition, his right arm was completely amputated at the shoulder before the tractor's PTO shaft could be stopped. The truck driver initially tried to grab the victim's legs to free him. He then got on the tractor, stopped the PTO shaft and placed a call to emergency medical personnel. They arrived shortly after being notified and freed the victim. They transported him by air ambulance to a nearby major medical facility where he died later on the day of the incident.

Recommendation #1: All rotating shafts should be covered by shields to prevent workers from becoming entangled.

Discussion: Exposed rotating shafts are hazardous situations that can cause serious injury or death to workers. All rotating shafts that workers are exposed to should be covered by properly designed guards and shields. In this incident, a grain auger was being driven by a power-take-off shaft of a farm tractor. In this case, the PTO shaft was unguarded from the point where it was connected to the tractor to the mid-point of the shaft. As a result, one half of the rotating horizontal shaft between the tractor and the auger was exposed and resulted in the victim becoming entangled in it.

Recommendation #2: All equipment shields and guards should be kept in good condition and in place.

Discussion: Shields and guards protect workers from moving components that can cause serious injury or death. During this investigation, it was learned that the auger's PTO shaft was originally fitted with a two-piece telescopic tubular safety shield to protect workers from the rotating PTO shaft. However, at the time of the incident one-half of the tubular shield that enclosed the PTO shaft had apparently been previously damaged and was missing. All damaged equipment shields and guards should be immediately repaired to provide workers adequate protection from rotating shafts and moving machine components. In addition, whenever any safety shields and guards are removed from equipment to perform necessary maintenance or repairs, they should be properly reinstalled before the equipment is used.
