Worker Dies After Being Crushed Between Rock Spreader And Pneumatic Roller in Minnesota

MN FACE Investigation 00MN03001

DATE: April 25, 2001

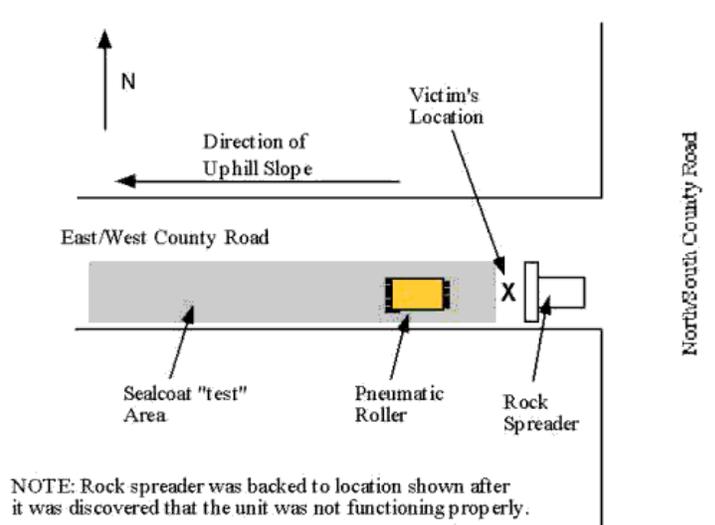
Figure 1. Paved Road Sealcoat Site (Not To Scale)

The incident occurred on the first day that a crew of workers arrived to begin the 16 mile resurfacing project. The incident site (Figure 1) was within 150 feet of a T-intersection created by an east/west paved county road and a north/south paved county road. The east/west road was being resurfaced beginning at the point of its junction with the north/south road and continuing west/south-west for 16 miles. The east/west road had a slight up-hill slope of approximately 10-12 degrees beginning at its junction with the north/south road and continuing for approximately one-quarter mile.
