DATE: June 2, 1999

FROM: Minnesota Fatality Assessment and Control Evaluation (MN FACE)
Program Minnesota Department of Health

SUBJECT: MN FACE Investigation 98MN06401
Maintenance Technician Dies After Falling Eight Feet From Ladder

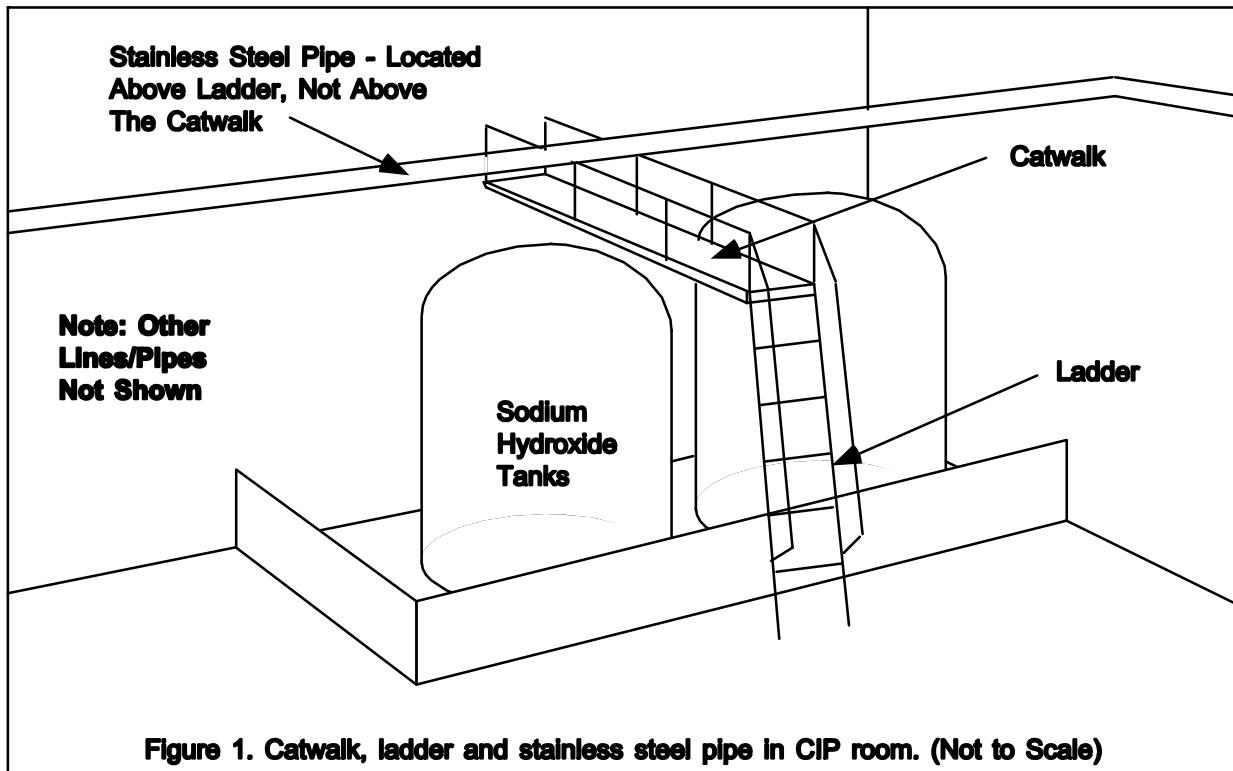
Figure 1. Catwalk, ladder and stainless steel pipe in CIP room. (Not to Scale)

gallon tanks that were used to store sodium hydroxide. Located between and slightly above the tops of the tanks was a stainless steel catwalk that was used to access service valves in the chemical lines (Figure 1). One end of the catwalk was fastened to the concrete block wall of the room. The other end of the 94 inch high catwalk was supported by steel framing setting on the floor of the CIP room. The sides of the catwalk were equipped with guard rails that had a top rail that was 37.25 inches above the surface of the catwalk. The guard rails however did not have mid-rails between the surface of the catwalk and the top of the guardrail.

A fixed stainless steel ladder was fastened to the end of the catwalk to provide access to it. The ladder was not vertical but was inclined at an angle of 70 degrees when measured from the floor of the room to the back side of the ladder. The ladder was 24.5 inches wide and had five rungs that were 16 inches apart. The bottom rung was 31.25 inches above the floor. A 7 foot long handrail was fastened to one side of the ladder. A 2.5 inch diameter stainless steel pipe was located horizontally near the ceiling of the room. The pipe was located 40 inches above the surface of the catwalk and 16 inches out or away from the top of the ladder. The location of the steel pipe was nearly directly above the head of workers whenever they climbed the ladder.

During the investigation, it was learned that the victim sustained blunt force injuries to both the top and the back of his head. Based on the location of the injuries and the configuration of equipment in the room, it is thought that the following scenario most probably occurred. The victim climbed the ladder to reach the catwalk after the coworker left the room. The 16 inch spacing of the ladder rungs may have caused the victim to exert greater force while ascending the ladder. When he neared the top of the ladder, he apparently struck the top of his head on the stainless steel pipe mounted overhead. The collision with the pipe caused him to fall to the base of the ladder where he apparently fell backward and sustained an injury to the back of his head.

Discussion: The fixed stainless steel ladder that provided access to the catwalk was not designed and built in accordance with established safety standards and regulations. The ladder rung spacing of 16 inches exceeded by four inches the maximum allowed spacing of 12 inches for fixed ladders. In addition, the ladder did not have enough clearance on the climbing side as required in OSHA Standard 29 CFR Part 1910.27. Current OSHA regulations require that the perpendicular distance from the centerline of the rungs to the nearest permanent object on the climbing side of the ladder shall be at least 30 inches. In this case, a horizontally mounted stainless steel pipe was located 40 inches above the surface of the catwalk and 16 inches out or away from the top of the ladder. The location of the pipe was nearly directly above the head of workers whenever they climbed the ladder. If the ladder dimensions had been in compliance with established standards and if adequate clearance had existed on the climbing side of the ladder, this fatality probably would have been prevented.

Discussion: Although the guard rails on the stainless steel catwalk did not directly impact or contribute to the occurrence of this incident, the railings were not in compliance with established regulations. All elevated walking and work platforms should be equipped with guardrails that are not less than 36 inches or more than 42 inches high as required in OSHA Standard 29 CFR Part 1910.27. In addition, a mid-rail should be provided that is half way between the surface of the platform and the top of the guardrail. Although individual situations may prohibit the installation of guardrails that are higher than 36 inches, for an added degree of worker safety it is recommended that guardrails be 42 inches high whenever possible.

Recommendation #1: Ensure all fixed ladders are designed and built in accordance with established safety standards and regulations.

Recommendation #4: Ensure all elevated platforms are equipped with adequate guardrails.
