DATE: June 7, 1999

FROM: Minnesota Fatality Assessment and Control Evaluation (MN FACE)
Program Minnesota Department of Health

SUBJECT: MN FACE Investigation 98MN06301 and 98MN06302
Two Electricians Die When A Bolt Bin Falls 8 Floors At Construction Site

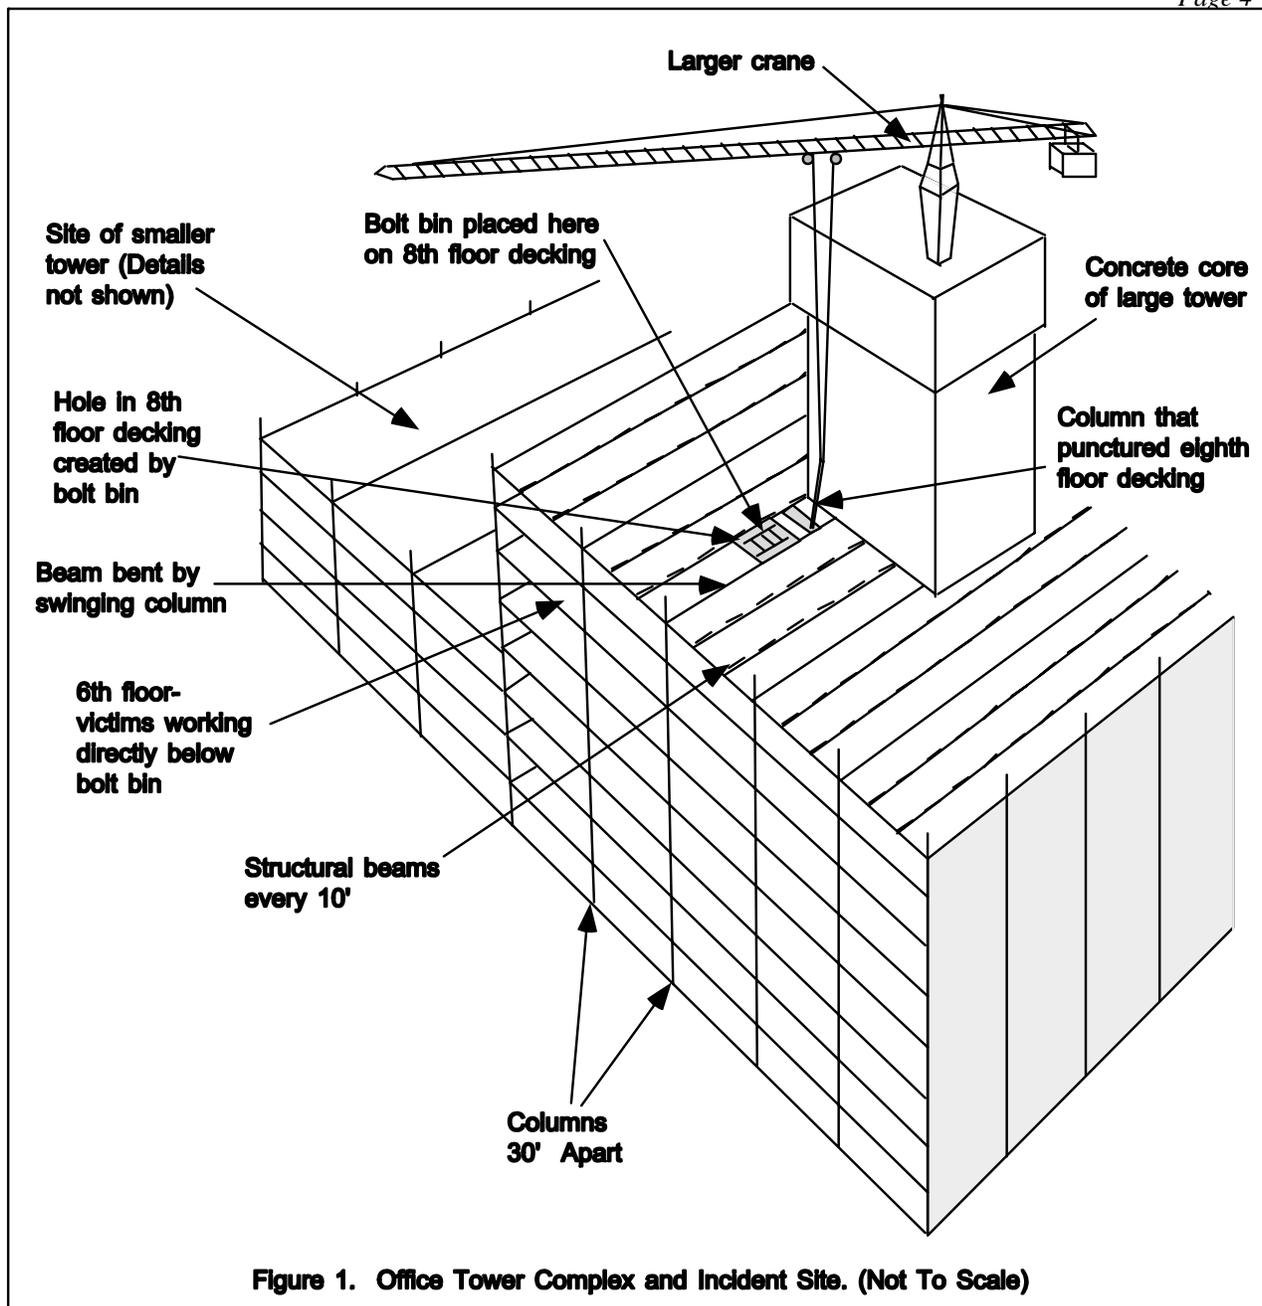
Two fixed mast construction cranes were used to lift construction equipment and materials from ground level to the various working levels at the site. One crane was positioned along the outer edge of the smaller tower and a second larger crane was centrally located within a concrete core (Figure 1) of the 30 story tower. Construction of the concrete core progressed ahead of the structural framing for the office towers. At the time of the incident, the core extended 60-70 feet above the eighth floor of the larger tower. The larger crane had a horizontal boom that was capable of being rotated 360 degrees and extended 142 feet from the crane's mast. It had a lift capacity that ranged from 15,430 pounds at the end of the boom to a maximum of 26,450 pounds at a distance of 85 feet or less from the center of the crane mast. At the time of the incident, the vertical distance from the eighth floor to the boom of the large crane was approximately 100 feet.

In addition, the bin was placed near a 45 foot long seam in the steel decking (See Figure 1).

When the column approached a nearly vertical position, the lower end of it slipped from the dunnage and the column punched through the decking (See Figure 1) near one of the parallel eighth floor beams. The column dropped approximately seven feet before the attached cables stopped it's fall. It swung nearly ten feet to the right and created a three foot by ten foot hole in the decking before swinging to the left and striking the beam that supported the ends of the decking sheets that the bolt bin was on. The force of the swinging column bent the beam causing the ends of the decking sheets to fall from the beam. The bolt bin and it's contents fell through the eight floor decking and continued to slam through each of the lower floors until it reached the first floor. The two victims who were working on the sixth floor directly beneath the falling bin were apparently struck by it and also fell to the first floor. Emergency medical personnel were immediately called to the scene and arrived shortly after being notified of the incident. The victims were removed from the scene and a county medical examiner determined that both victims died within moments of falling to the ground floor with the bolt bin.

Recommendation #1: Employers should ensure that heavy items placed on preliminary flooring are placed over structural beams that can adequately support the weight of the items.

Discussion: During new construction at large commercial construction sites, the use of corrugated steel decking provides preliminary flooring which allows workers to be able to work while structural framing continues above them. The steel decking, which eventually becomes part of each level's permanent floor, was installed to provide a surface for workers to walk on as well as to protect workers on lower levels from falling materials. If materials that exceed the load bearing capacity of the decking must be placed on the decking it is necessary to place them over structural beams that can adequately support their weight. The ironworkers' bolt bin involved in this incident was mounted on two I-beam skids that were long enough so that when the bin was placed on a floor, the skids would extend across two of the parallel structural beams. On the day of the incident, the bolt bin was not placed with its I-beam skids extending across two parallel structural beams, but instead was rotated 90 degrees and placed on the eighth floor decking with its skids parallel to the beams. If the bin had been rotated 90 degrees and had been placed with its skids over structural beams, rather than having its entire weight resting directly on only the steel decking, the bin probably would not have fallen and these fatalities would have been prevented.

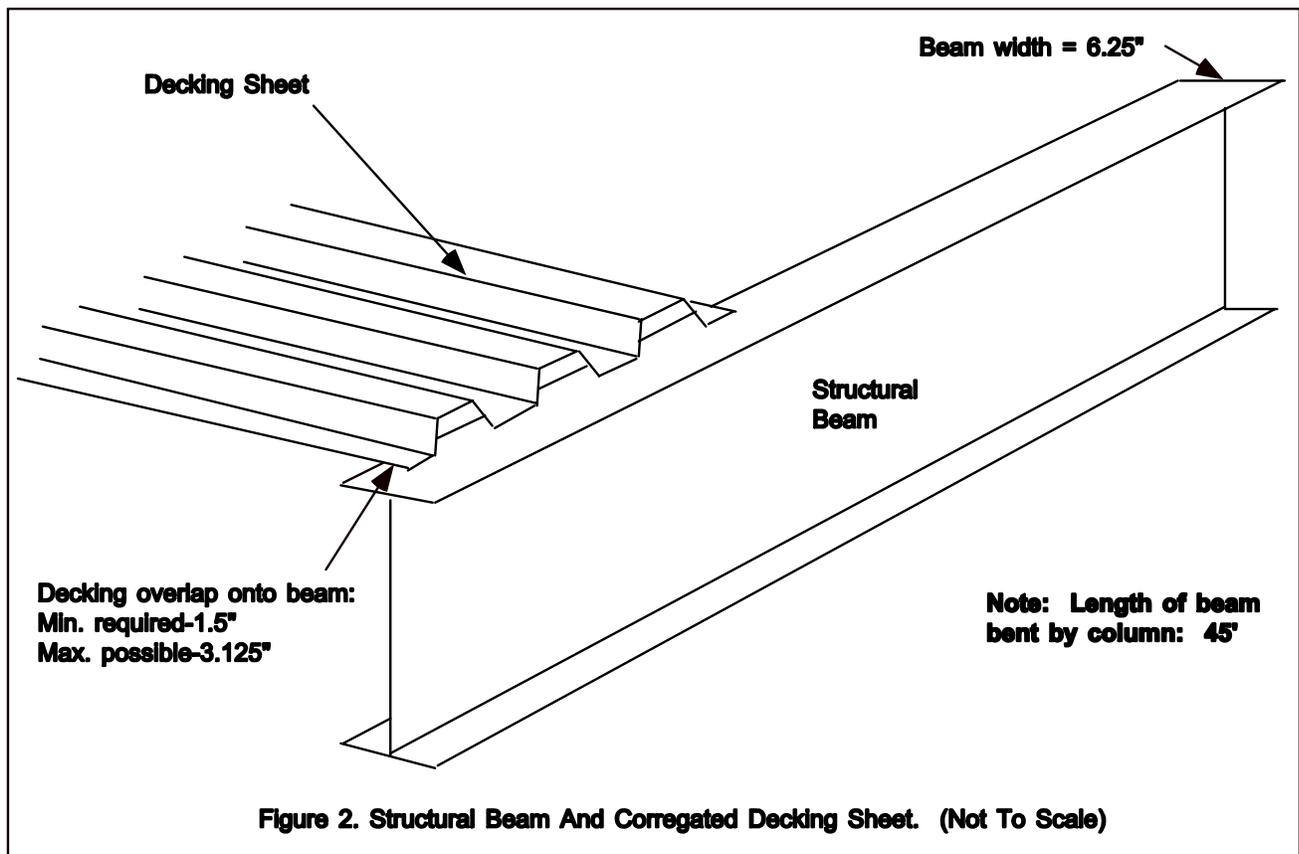
area of an individual floor. The sheets of decking were not staggered when they were installed nor was the installation of individual bundles of decking offset in any manner. This resulted in seams at the ends of the decking every 30 feet from the outer edge of the tower with the seams at every third structural beam of each floor. This is a standard method of decking installation used within the construction industry. Although this method results in continuous end seams above certain structural beams versus random seams scattered throughout each floor, it results in 30

feet by 45 feet areas on each floor that do not contain any seams between the ends of the sheets of decking. The central portions of these areas provide safer locations for the placement of heavy materials and equipment than would exist if the sheets were staggered resulting in a random scattering of three foot seams at the ends of the decking sheets. In addition, construction standards do not require the ends of the sheets to extend to the center of the structural beams but are only required to overlap a minimum of 1.5 inches onto the beams (Figure 2).

Recommendation #3: Employers should ensure that construction materials “such as columns” are placed in the safest locations available if they cannot be stored on the ground.

Discussion: During new construction, as discussed earlier, the use of preliminary flooring, (i.e. steel decking) allows workers to work at lower levels while structural framing continues above them. The corrugated steel decking, which eventually becomes part of each level’s permanent floor, is installed to provide a surface for workers to walk on as well as to protect workers on lower levels from falling materials. The decking, is installed in a manner that results in continuous seams at the ends of the sheets every 30 feet from the outer edge of the building with seams at every third structural beam of each floor. Although this method results in continuous seams above certain structural beams versus random seams scattered throughout each floor, it creates 30 foot by 45 foot areas on each floor that do not contain any seams between the ends of the sheets of decking. The central portions of these areas may be safer than the areas near the seams for the placement of heavy materials and equipment. In this incident, the structural column was placed horizontally on the eighth floor decking with the bottom end of the column near a 45 foot long seam in the steel decking rather than in a central portion of the decking. If the column had been placed with its lower end in a central area of the decking, the decking may not have collapsed when the structural beam was bent and these fatalities may have been prevented.

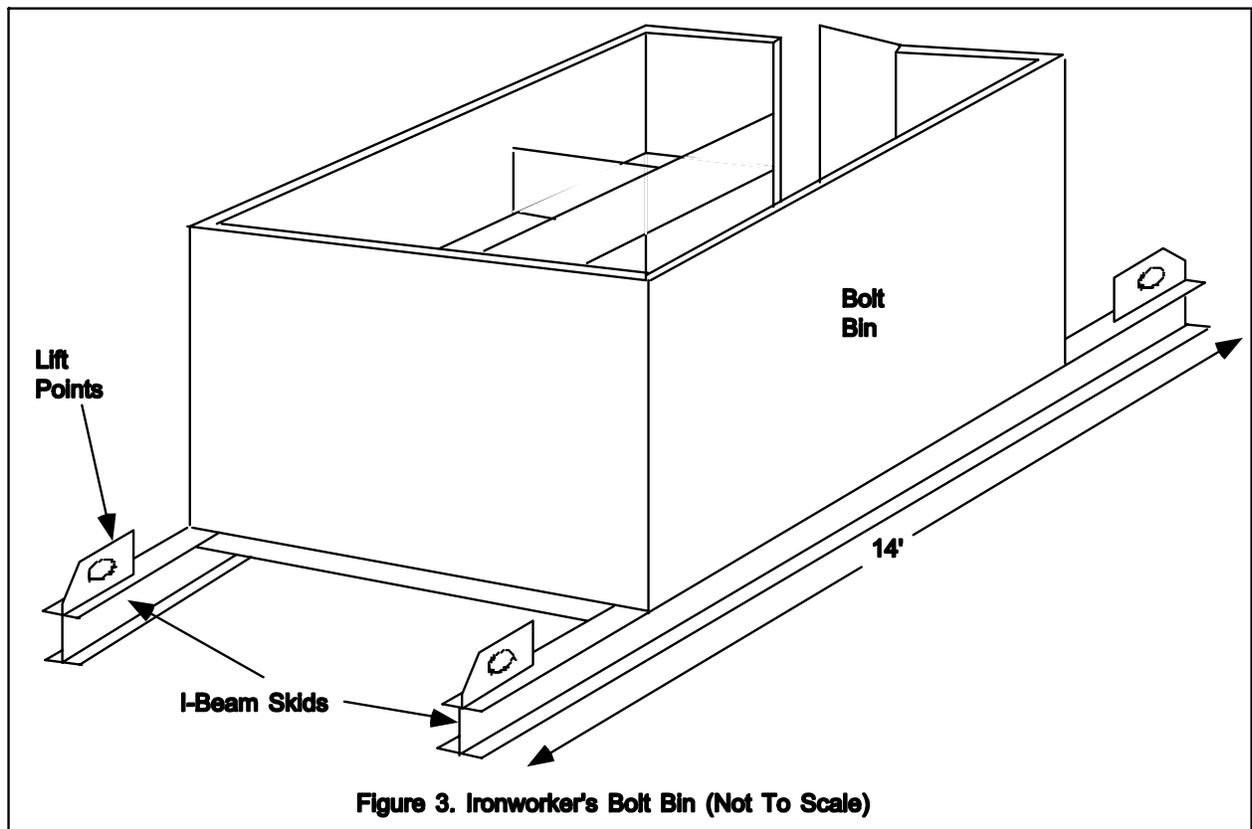
On the day of the incident, an ironworker's bolt bin had been placed on the eighth floor of the planned thirty story tower. The bolt bin (Figure 3) had been fabricated for the construction project to provide bolts and other small items that the ironworkers used to assemble the steel framing of the office towers.

The bin was 8 feet long and was mounted on two I-beam skids that were approximately 14 feet long. The skids were long enough so that when the bin was placed on a floor of the office towers, the skids would extend across two of the parallel structural beams that were spaced 10 feet apart on each floor. On the top side of each end of both skids, a steel plate containing a circular hole was welded to provide four lift points. The bin was periodically filled with bolts at ground level and lifted by the crane to the floor where the ironworkers were working. The bin and its contents weighed approximately 9000 pounds when it was full. At the time of the incident, the combined weight of the bin and its contents was approximately 6000 pounds.

During each day of construction, the bolt bin was routinely moved several times to various locations to accommodate specific work being done by the ironworkers. When it was last moved prior to the incident, it was not placed with its I-beam skids extending across two of the 10 feet apart parallel structural beams but instead was rotated 90 degrees and placed on the eighth floor decking with its skids parallel to the beams. This resulted in the entire weight of the bin and its contents resting "directly" on only the steel decking and not directly over two structural beams.
