**DATE:** September 28, 1998

**FROM:** Minnesota Fatality Assessment and Control Evaluation (MN FACE)  
Program Minnesota Department of Health

**SUBJECT:** MN FACE Investigation 98MN03901  
Farmer Dies After Becoming Caught In Barn Cleaning System

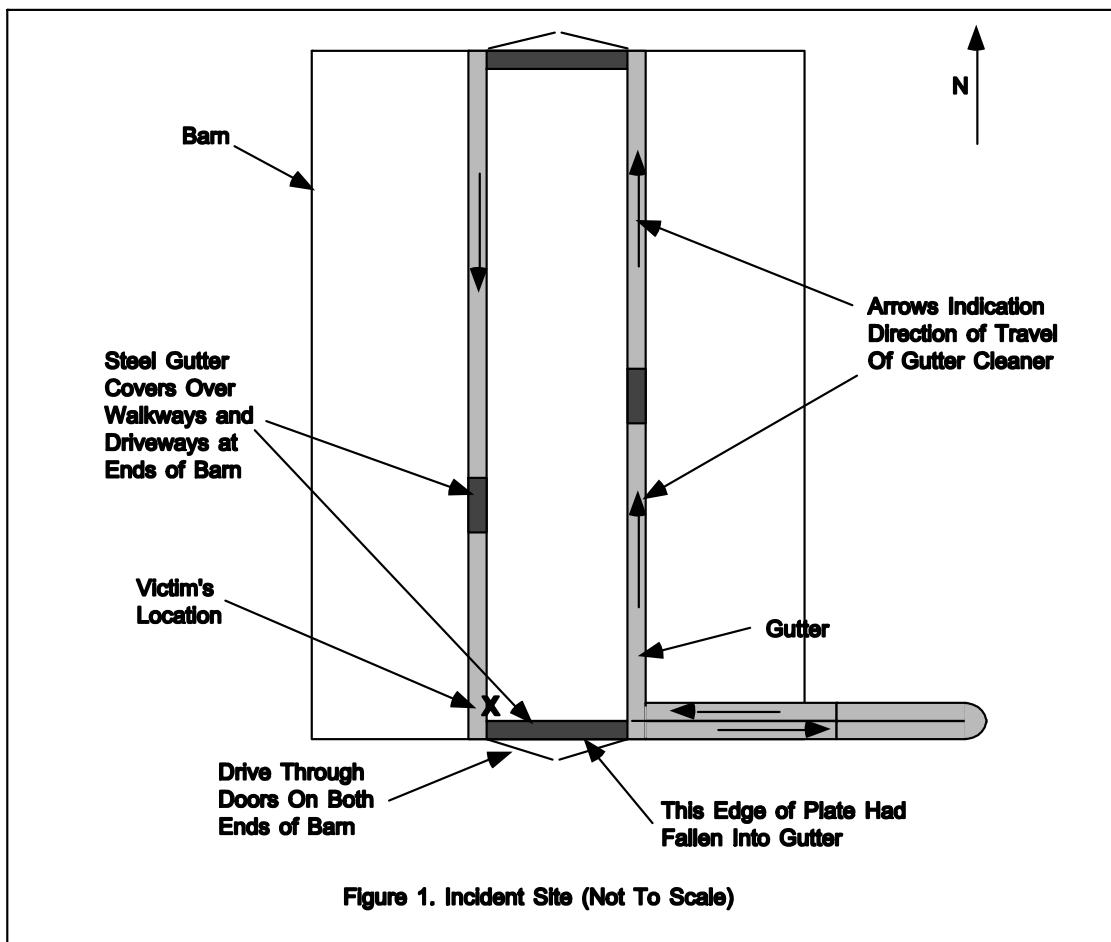
On the day of the incident, the victim was cleaning a small barn that was used for approximately 25-30 young cows. The barn's gutter (Figure 1) was equipped with a mechanical cleaner that consisted of a large continuous chain with metal bars fastened to it. The bars acted as scrapers to remove manure from the gutter and were spaced every 16-18 inches along the chain. The gutter was approximately 18 inches wide and 18 inches deep. At the ends of the barn, steel panels were used to cover the gutter so tractors or other vehicles could be driven into and out of the barn. The steel covers were approximately 24 inches wide and 7 feet long. They were not secured to the concrete barn floor but instead laid loosely over the gutter openings adjacent to the doors at each end of the barn. The gutter was also fitted with two smaller steel covers for workers to walk across while working inside the barn.

While the victim worked inside the barn he apparently used a shovel that was found near him to push manure into the gutter while the gutter cleaner was operating. Photographs taken shortly after the victim was discovered showed that he became caught in the cleaner at one end of the steel plate that covered the gutter on the south end of the barn. However, it could not be determined exactly why he became caught in the gutter against the edge of the steel plate. He may have slipped and lost his footing on the wet floor and struck his head as he fell. The steel gutter cover was found slightly out of position with its outside edge no longer on the concrete edge of the gutter but instead it had fallen at an angle into the gutter. This may have occurred after the victim fell into the gutter and his body was forced against the end of the steel plate by the scrapers of the gutter cleaner.

**Recommendation #2:** Safety panels should be securely fastened in place to prevent accidental displacement.

**Discussion:** Whenever panels, grates or any type of shield is used to cover openings and prevent workers from being exposed to hazardous conditions, they should be securely fastened in place. In this incident, steel panels were used at several locations to cover the gutter opening and enable both pedestrian and vehicular movement across the gutter. However, none of the panels were secured to the concrete floor to prevent them from accidentally being displaced. Each panel should be secured with hinges along one edge to enable them to be opened to access the gutter cleaner for necessary service and repair. Although this incident wouldn't have been prevented if the steel panels had been secured to the floor, the risk of workers being injured would be reduced and the accidental displacement of the panels would be eliminated by securely fastening the panels to the concrete floor.
