# Worker Dies After Being Run Over By A Front-End Loader

Minnesota FACE Investigation 98MN030 Date: September 28, 1998

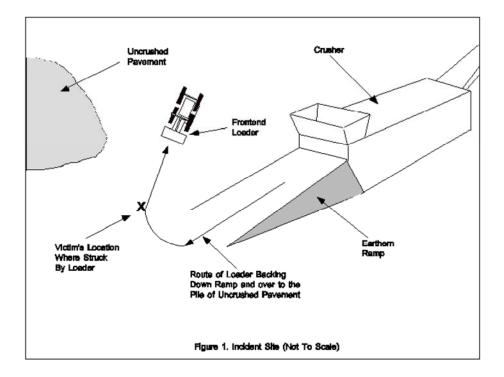
On the day of the incident the victim and several other workers were working at a construction site where highway surface materials, asphalt and concrete, were recycled. At the site, chunks of asphalt and concrete were pulverized by a crusher to be used for new road bases. One of the workers had been operating a large front-end loader equipped with a bucket to transport the highway material to the crusher. The loader operator would pick up uncrushed material and drive up an earthen ramp where he would dump it into the crusher (Figure 1). The operator would then back down the ramp, across the work site, and pick up additional material.

Shortly before the incident, the operator of the loader dumped material into the crusher and backed down the earthen ramp. After reaching the bottom of the ramp he turned the loader (Figure 1) and continued to back across the work site. Although he knew that the victim was in the general work area, he was not aware that the victim was walking in the area where he was operating the loader. As the operator turned the loader and continued to back across the work site, he felt the right front wheel of the loader strike something. He continued to back a short distance and then observed the victim lying on the ground in front of the loader. He stopped the loader and notified another worker at the site to place a call to emergency personnel. They arrived at the site shortly after being notified and pronounced the victim dead at the scene.

Approximately two weeks prior to the incident the audible back-up warning device on the loader began to malfunction. When the loader was driven in reverse the warning device would make a steady sound rather than its normal intermittent sound. The loader operator stated during an interview immediately after the incident that he disabled the back-up warning device by cutting the alarm's wire. The wire remained cut at the time of the incident.

Recommendation #1: Mobile equipment should be equipped with an audible back-up warning device as well as sensing units to detect pedestrian workers in the blind spots of the equipment operator.

Recommendation #2: Employers should ensure that equipment is always maintained in the proper working condition.

Recommendation #3: Employers should ensure that equipment is driven in a forward direction as much as possible.

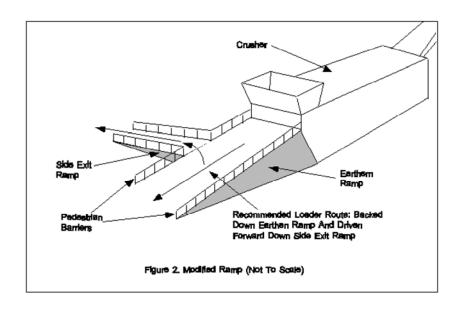
Discussion: When equipment is driven in reverse, pedestrian workers are at greater risk of being run over. Whenever feasible, equipment should be driven forward to reduce the likelihood of workers not being seen. In this incident, the loader operator backed down an earthen ramp and across a work site when the victim was run over. If the earthen ramp had been built with a side exit ramp (Figure 2), the operator would have had to operate the loader in reverse only while going down the ramp. He then could have driven the loader forward down the side exit ramp and increased the likelihood of observing and avoiding pedestrian workers in front of the loader. An additional measure of safety could be provided by erecting barriers along the sides of the ramps to prevent workers from walking on the ramps. Pedestrian barriers would limit ramp usage to equipment entering the main ramp or leaving the side exit ramp.
