**DATE:** March 11, 1998

**FROM:** Minnesota Fatality Assessment and Control Evaluation (MN FACE) Program  
Minnesota Department of Health

**SUBJECT:** MN FACE Investigation 98MN00101  
Construction Employee Dies After Falling From Building Roof

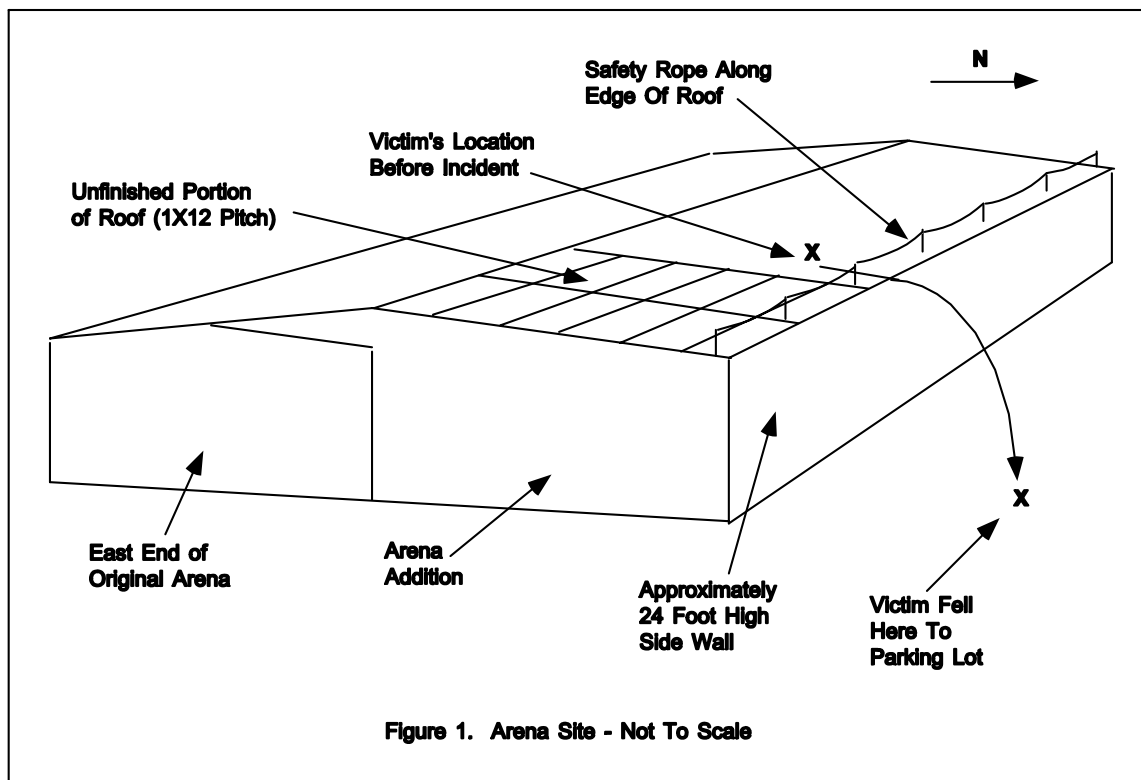
The victim and his coworkers had been on the roof of the building for about fifteen minutes and were getting ready to begin working for the day. Before they began to install additional roof panels, they distributed various tools and equipment along the roof near the unfinished portion of it. The victim carried an impact wrench and a safety harness as he walked to a location near the unfinished portion of the roof. He was not wearing the safety harness at the time. He gently slid his impact wrench down the relatively flat roof toward the roof's edge. Apparently the workers had done this on previous occasions to position tools where they would be need along the roof. Typically, the wrenches would only slide a short distance before coming to a stop on the roof. However, because of frost on the metal roof the wrench did not slow down and the victim may have realized that it was going to slide off the roof. One of the coworkers saw the victim run and then dive toward the wrench in an attempt to grab it. The victim slid under the safety rope and off the edge of the roof. He fell to the paved area along

the side of the building. The coworkers descended from the roof of the building and rushed to the victim. A call was placed to emergency medical personnel who arrived at the scene shortly after being notified. The victim was transported to a local hospital where he died from his injuries the next day.

**Recommendation #1:** Whenever work is performed at an elevation where the potential for a fall exists, fall protection equipment should be used.

**Discussion:** Whenever work is performed at an elevation where the potential for a fall exists, workers should use appropriate fall protection equipment. The victim was working at an elevation where the potential for a fall that would result in serious injury existed. OSHA Standard 29 CFR 1926.28 (a) states that "the employer is responsible for requiring the wearing of appropriate personal protective equipment in all operations where there is an exposure to hazardous conditions." Adequate fall protection equipment, such as lifelines, safety belts and lanyards, should always be used whenever the potential for a fall exists. In addition, in situations where the use of a traditional safety belt/lanyard combination is impractical, an alternate form of fall protection (e.g., safety nets as specified in OSHA Standard 29 CFR 1926.105) should be used. If the victim had been using fall protection equipment (i.e., lifeline, safety belt, and lanyard), this fatality probably would have been prevented.
