DATE: September 24, 1997

FROM: Minnesota Fatality Assessment and Control Evaluation (MN FACE) Program
Minnesota Department of Health

SUBJECT: MN FACE Investigation 97MN019
Excavation Laborer Dies After Being Run Over By A Caterpillar

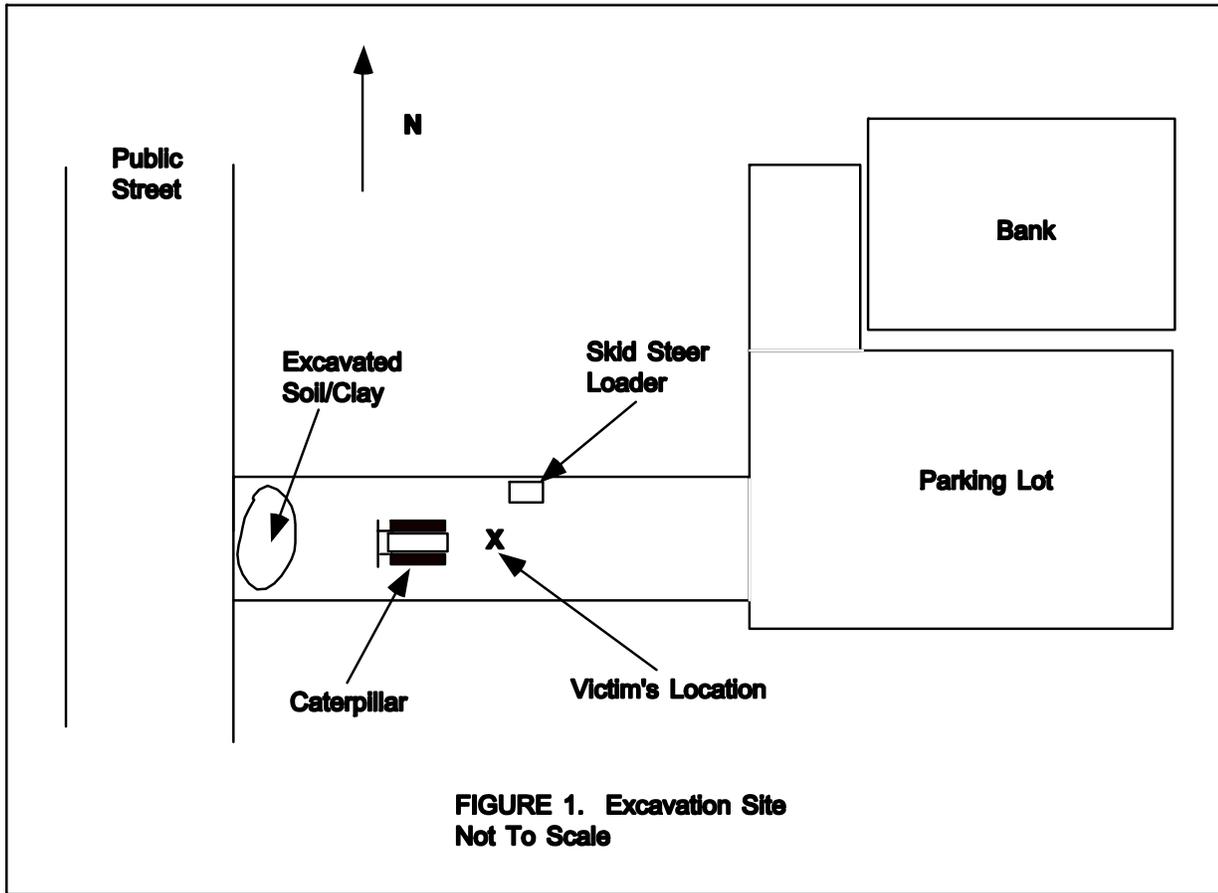
1

The workers began removing soil and clay from the site on the morning of the incident. They had nearly completed the excavation process and were removing small amounts of clay along the driveway area. The victim used a measuring stick to check the grade along the driveway to ensure that it was excavated to the proper depth. A few moments before the incident, the caterpillar operator drove to the west end of the driveway and the victim walked to a position in the center of the driveway about fifty feet behind the caterpillar. While the victim checked the grade of the area, the operator shifted the

caterpillar into reverse and began backing it toward the east end of the site. The operator did not see the victim and continued backing until he saw the victim laying in front of the caterpillar. Since no one saw the victim get run over, it could not be determined whether he was struck by the caterpillar and got knocked to the ground before being run over or whether he stumbled and fell in an effort to move away from the caterpillar. A call was immediately made to emergency personnel. They arrived shortly after being notified and pronounced the victim dead at the scene.

Recommendation #1: Mobile equipment should be equipped with sensing units to detect pedestrian workers in the blind spots of the equipment.

may become de-sensitized to audible back-up alarms because they sound whenever the equipment is moving in reverse. In this incident, it is possible that the victim heard the back-up alarm but may not have realized how close the caterpillar was to him until it was too late for him to move to a safe location. Equipping mobile equipment and vehicles with sensing units such as radar activated back-up alarms to detect the presence of pedestrian workers in the blind spots of equipment and warn both the operator and the pedestrian would provide an additional margin of safety.
