DATE: February 24, 1997

FROM: Minnesota Fatality Assessment and Control Evaluation (MN FACE)
Program Minnesota Department of Health

SUBJECT: MN FACE Investigation 96MN08001
Operator Dies After Being Crushed Inside A Side-loading Waste-Hauling
Truck

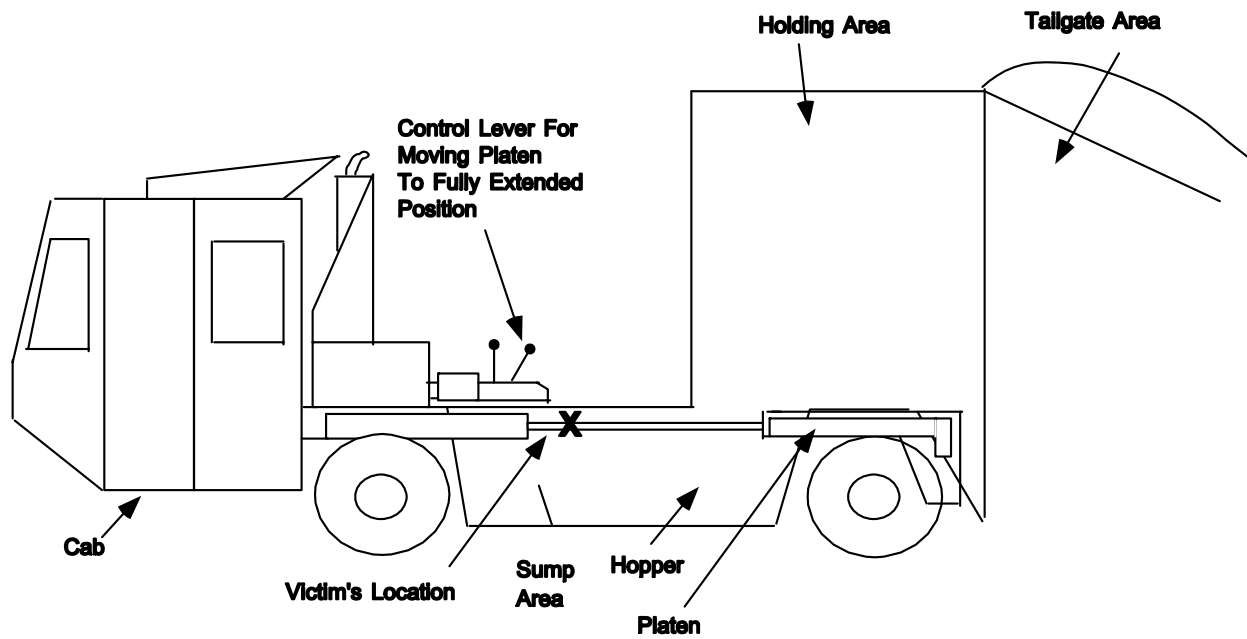
The manual mode is used to fully extend the platen and expel garbage from the holding area at a disposal site (Figure 1). It may also be used when the holding area is nearing full capacity because it allows the platen to compact garbage deeper into the holding area. After the operator selects the manual mode, a manual control lever is pulled to activate the hydraulic system that moves the platen. In the automatic mode, the operator pushes a "platen cycle" button, which causes hydraulic cylinders to push the platen to compact garbage into the holding area of the truck. The platen then returns to its resting position (Figure 2) after completing the compaction process and allows the operator to refill the hopper. When the automatic mode is selected during routine operation, pneumatic "air" pressure prevents operation of the manual control lever. However, before adequate air pressure is established when the trucks are started each day, the manual control lever can be operated even when the system is in the automatic mode.

access the sump area of the truck through an opening that was 36-40 inches wide. He leaned over into the hopper and began to remove garbage from the sump area while the truck was running. Since the selectable switch was in the automatic compaction mode, when adequate air pressure developed in the system as the truck was running, the system's pneumatic cylinders activated and in turn operated the hydraulic control valves. The platen returned to its resting position in approximately three seconds and crushed the victim. A coworker pushed the emergency stop button which allowed him to move the platen away from the victim and remove the victim from the truck. A 911 call was placed to emergency rescue personnel. The victim's coworkers performed cardiopulmonary resuscitation until emergency rescue workers responded several minutes after being called and pronounced him dead.

**Figure 1. Side-loading Waste Hauling
Truck With Platen Fully Extended To Unload The Truck
(Not To Scale)**

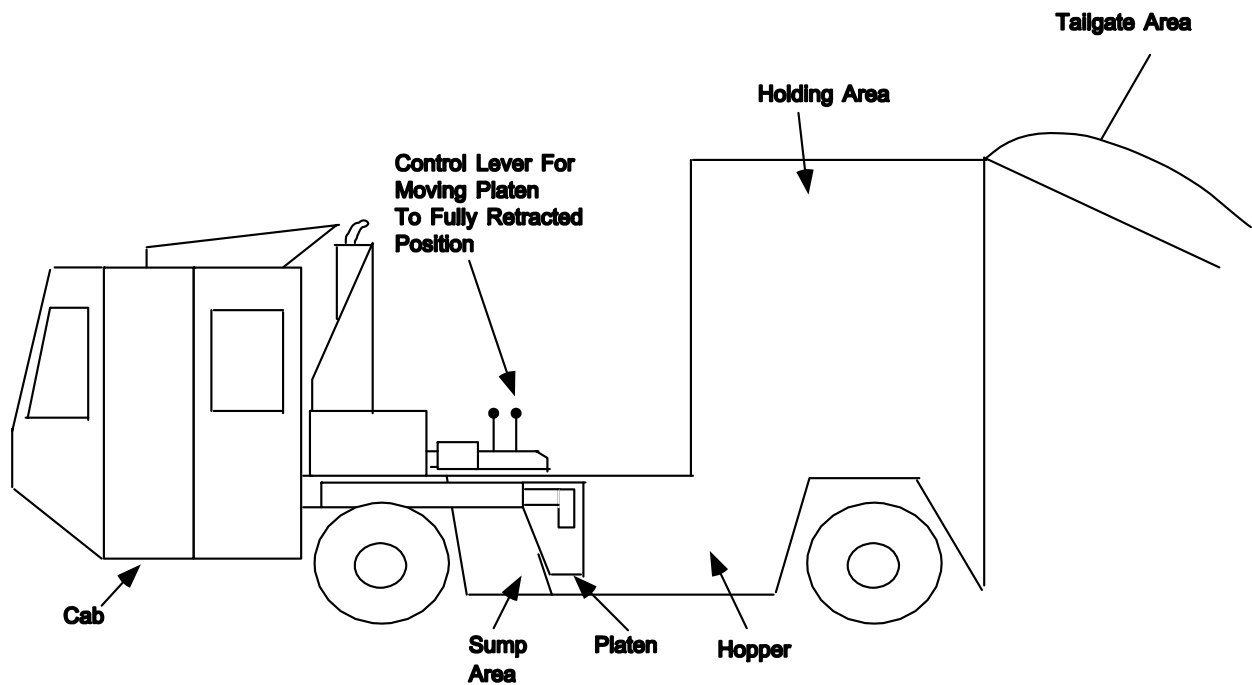
**Figure 2. Side-loading Waste Hauling
Truck With Platen In Fully Retracted (Resting) Position
(Not To Scale)**

Discussion: The victim was cleaning the sump area of the waste-hauling truck while the engine was running when the platen engaged. The platen engaged because the controls that operated the compaction unit were left in the automatic mode and the truck was running. The low air pressure in the truck, due to it not being warmed up, allowed the victim to fully extend the platen while the compaction unit was in the automatic mode. In the automatic mode the platen automatically returns to its resting position after compacting garbage into the holding area. If the compaction unit is placed in the manual mode and the truck is shut off, there is no residual pressure left in the hydraulic cylinders that would cause the platen to return to its resting position from the fully extended position. If the controls that operated the platen had been in the manual mode, and the truck had been shut off, the platen would not have returned to its resting position and this fatality would have been prevented. Although the truck engine could have been stopped in this case, some equipment may need to be operating during maintenance activities. In those cases, employers should ensure that the equipment is placed in the proper mode of operation before maintenance is performed.

Recommendation #1: Employers should ensure that workers perform maintenance on equipment only when it is not operating.
