DATE: May 29, 1996

FROM: Minnesota Fatality Assessment and Control Evaluation (MN FACE)
Program Minnesota Department of Health

SUBJECT: MN FACE Investigation 96MN00101 and 96MN00102
Two Employees Die After Steam Line They Were Repairing Was Re-
energized

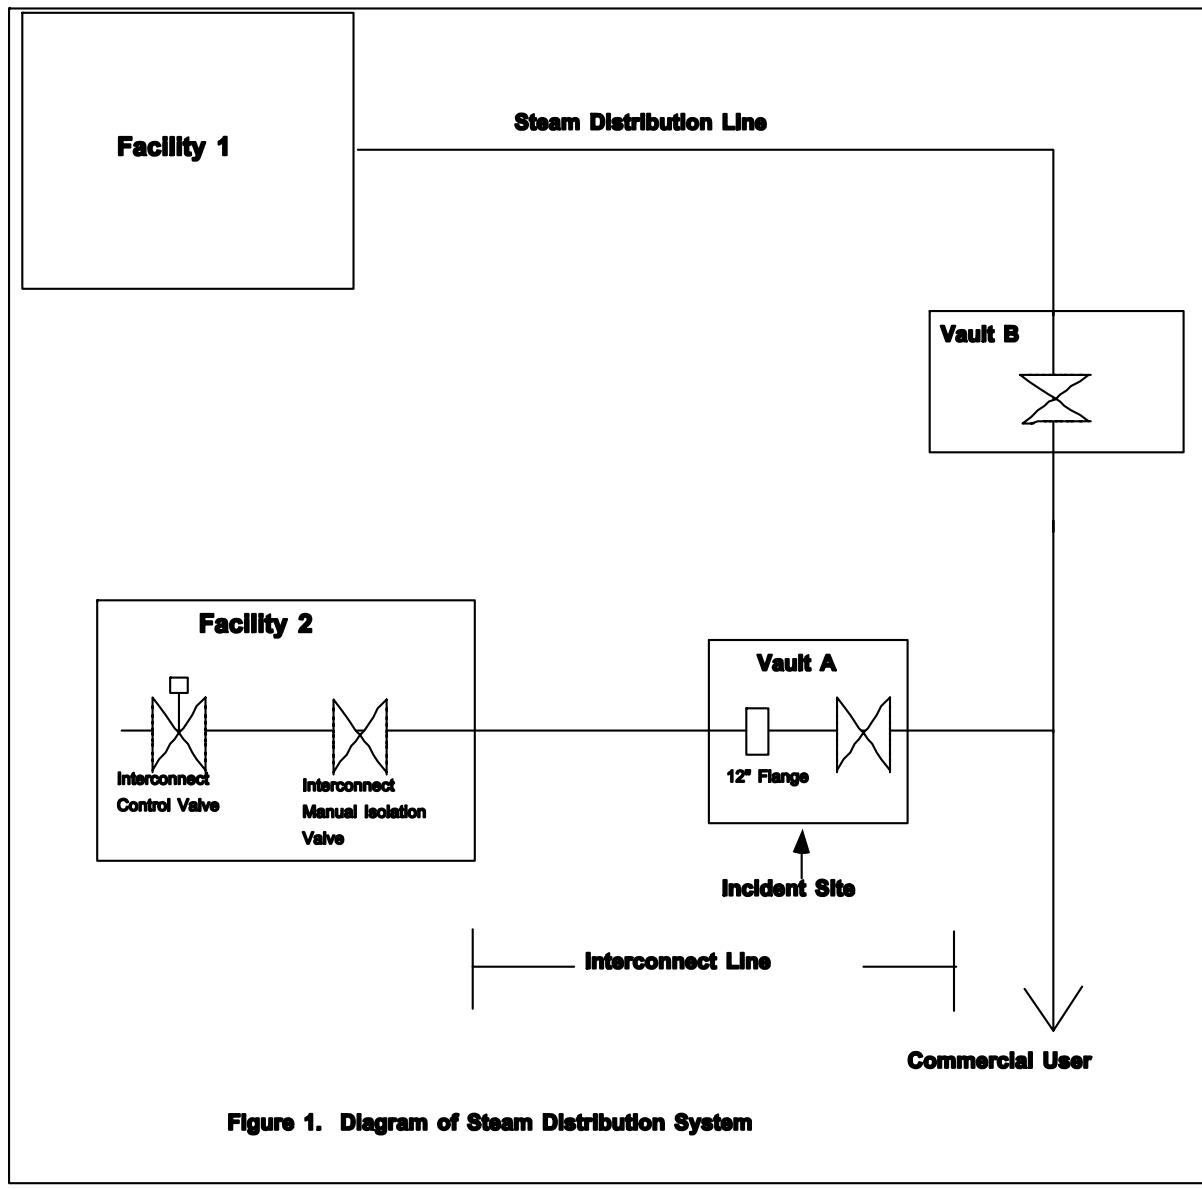
Figure 1. Diagram of Steam Distribution System

The crew removed the manhole cover and started mechanical ventilation of the underground vault. While the vault was being ventilated, they went to vault B, another underground vault, and shut off the isolation valve in that vault (Figure 1). This isolated the facility 1 side of the leaking flange. After the steam was cleared from vault A, the workers shut the isolation valve located inside the vault. With the isolation valve shut in vault A, one of the workers returned to vault B and opened the isolation valve there in order to return the steam supply to a major facility in the downtown area.
