DATE: December 29, 1995

FROM: Minnesota Fatality Assessment and Control Evaluation (MN FACE)
Program Minnesota Department of Health

SUBJECT: MN FACE Investigation 95MN05501
Window Washer Dies After Falling 35 Feet When Suspension Scaffold
Collapsed

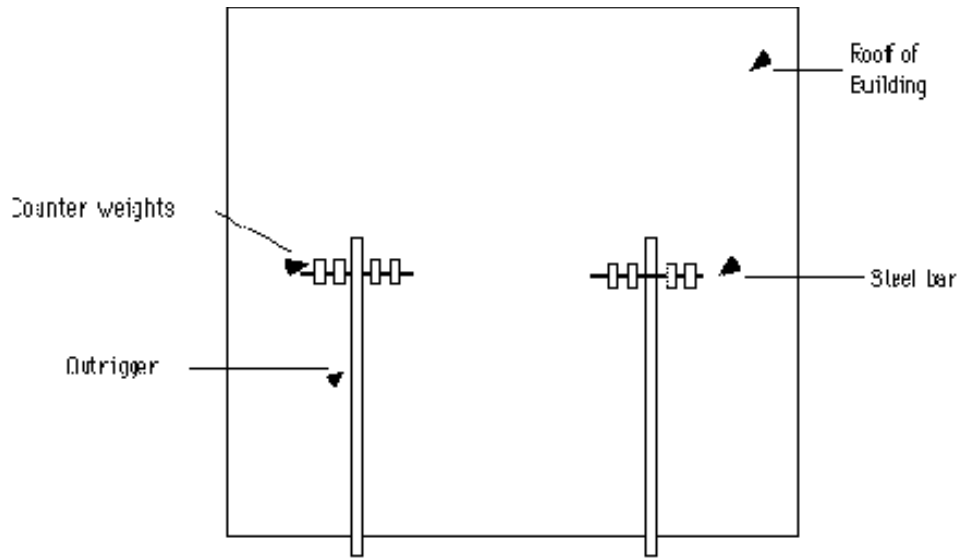
In this incident the steel bar used to connect two counterweights to each side of the two outriggers was properly pushed through the hole in one of the outriggers. On the other outrigger the steel bar was pushed through the counterweights on each side of the outrigger, but it was not pushed through the hole in the outrigger itself. The outrigger was positioned underneath the steel bar and therefore was not properly secured (Figure 1 and Figure 3). According to the formula that the Minnesota Occupational Health and Safety Administration uses for determining the appropriate number of fifty pound counterweights to use, neither outrigger was set up with an adequate amount of counterweight.¹ Minnesota OSHA requires that a safety factor of four be used when calculating the appropriate amount of counterweight. According to the formula, eight fifty pound counterweights should have been attached to each side of each outrigger (Figure 2). In this incident a safety factor of two existed with four fifty pound counterweights on each outrigger.

Figure 1.* Top View Of Building
Set Up Incorrectly

Discussion: When counterweights are used with outriggers supporting a suspension scaffold, counterweights should be sufficient to balance four times the intended load. Counterweights should be securely fastened to the outriggers with the steel bar pushed through the hole in the counterweights as well as through the hole in the outrigger. This recommendation is in accordance with Minnesota Rules 5205,0065 (2) (D).

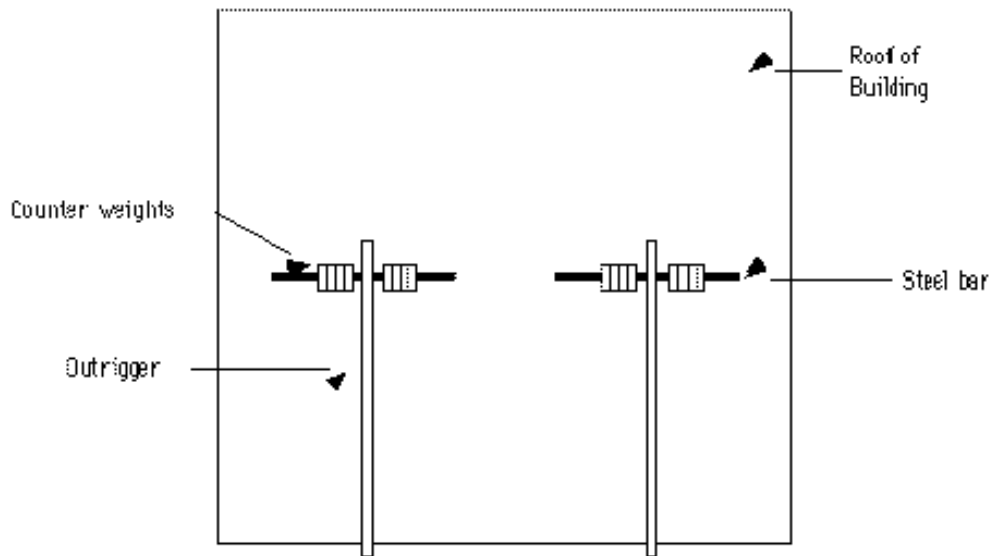
Figure 2.* Top View Of Building
Set Up Correctly

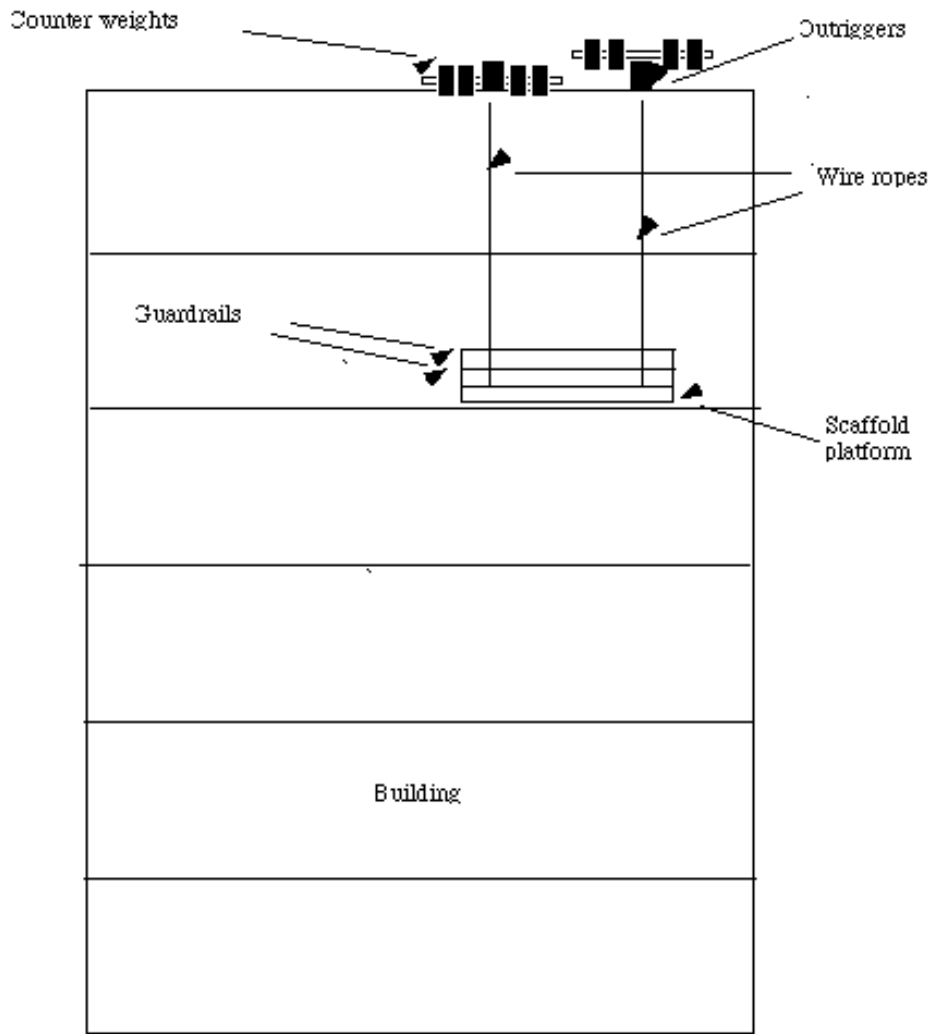
Figure 3
Side View of Building *

Although the steel bar was not pushed through one of the outriggers, the weight of the bar pushed through the counter weights and placed on top of the outrigger temporarily kept it from falling. While the scaffold was being pulled up, an even pressure was applied that kept the outrigger in place. After the workers completed washing a section of windows on one story of the building, they would lower the scaffold to the next story. Each time the scaffold was lowered it would stop abruptly, gradually displacing the outrigger from underneath the bar and counterweights. When they reached the third story, the scaffold collapsed and both workers fell to the ground. Two employees who were arriving to work at the office building discovered the workers and called 911. Emergency medical personnel arrived at the incident site shortly after being called. One of the workers was conscious when he was discovered but died from severe head trauma on the way to the hospital. The other worker was hospitalized with a broken bone in his back, a broken femur and hip and the possibility of vision loss in his right eye due to laceration
