DATE: February 27, 1996

FROM: Minnesota Fatality Assessment and Control Evaluation (MN FACE)
Program
Minnesota Department of Health

SUBJECT: MN FACE Investigation 95MN05001
Bridge Inspector Dies After Falling From Seawall

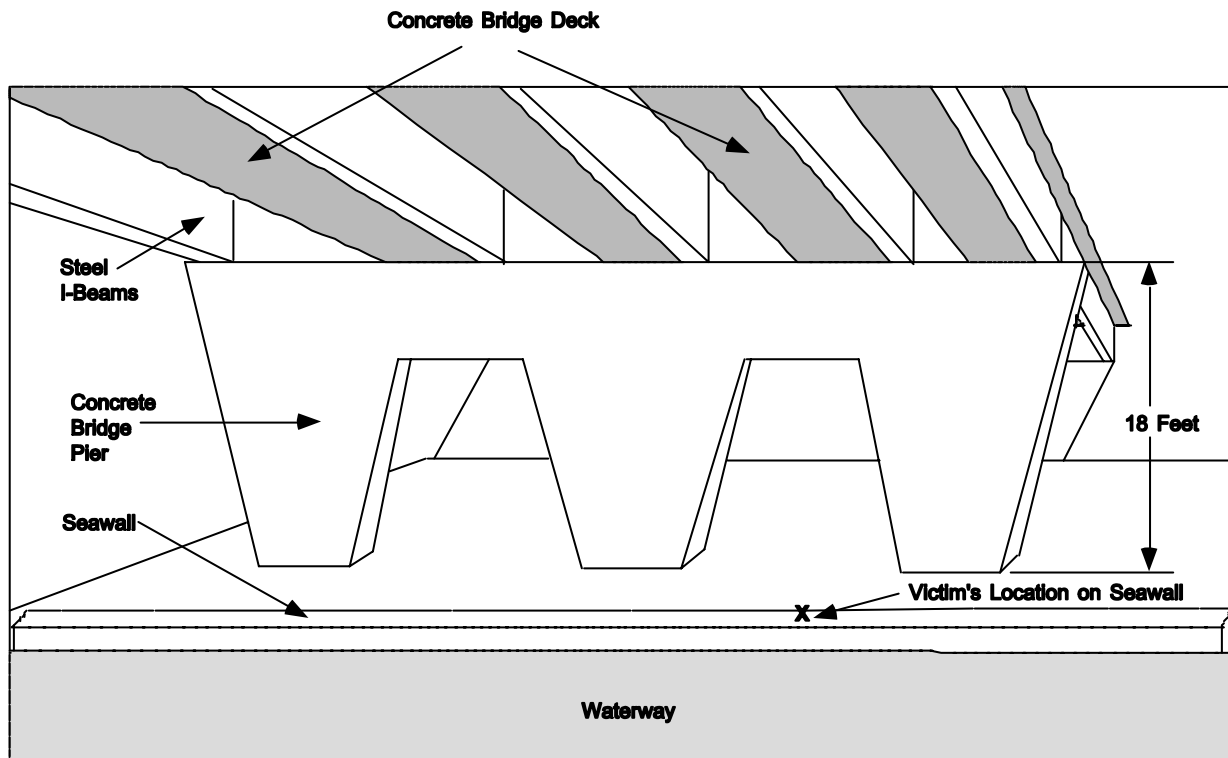
**Figure 1. Bridge Inspection and Incident Site
Not To Scale**

The bridge was approximately 200 feet long and 60 feet wide. The concrete bridge deck was supported by steel I-beams that rested on concrete bridge piers that were 18 feet tall. The base of the bridge pier in the vicinity where the incident occurred, (Figure 1) was 12 feet from a concrete seawall that existed along the edge of the waterway. The bridge inspectors were working at ground level on one side of the waterway. A level area, approximately 60 feet square directly under the bridge and adjacent to the seawall was dry and provided a safe work area for the inspectors. The concrete seawall was 14.5 inches wide and the top of it was approximately 12 inches above the water. The top of the seawall was wet and slippery due to waves striking it. The growth of algae in the water also caused the top surface of the seawall to be more slippery than if it were just wet.

The bridge versus small cracks that do not affect the structural safety of the bridge. After inspecting the underside of the bridge in an area further from the waterway, the victim walked to the edge of the water. The coworker remained in an area approximately 40-50 feet from the waterway. The victim stepped onto the seawall and stood on it with his back toward the water. He was wearing a pair of general purpose "tennis" type shoes. From this position he apparently looked up to inspect the underside of the bridge deck that was directly above him. The coworker did not see the victim fall from the seawall but heard the victim strike the water. The coworker rushed to the edge of the water and briefly saw the victim in the water before he disappeared beneath the surface. Rescue personnel were immediately called to the scene and located the victim under water. After removing him from the water, resuscitation efforts were performed as the victim was transported to a local hospital where he was pronounced dead a short time later.

Recommendation #1: Ensure that personal flotation devices are available and used when employees work near or over water where the danger of drowning exists.

Discussion: Whenever employees are working over or near water where the danger of drowning exists, a U.S. Coast Guard approved life jacket or buoyant work vest should be worn. In this incident, the victim fell a distance of approximately 12 inches from a seawall that served as a boundary between the shore and the waterway. When he quickly disappeared beneath the surface of the water, he could not be seen nor could an attempted rescue be made by his coworker. If he had been wearing an approved personal flotation device, he probably would have remained at the surface of the water and been safely rescued by either his coworker or by emergency personnel who were called to the scene.
