# Building Renovation Contractor Electrocuted When Scaffold Contacted 8,000 Volt Overhead Power Line

DATE: October 27, 1995

MN FACE Investigation 95MN04201

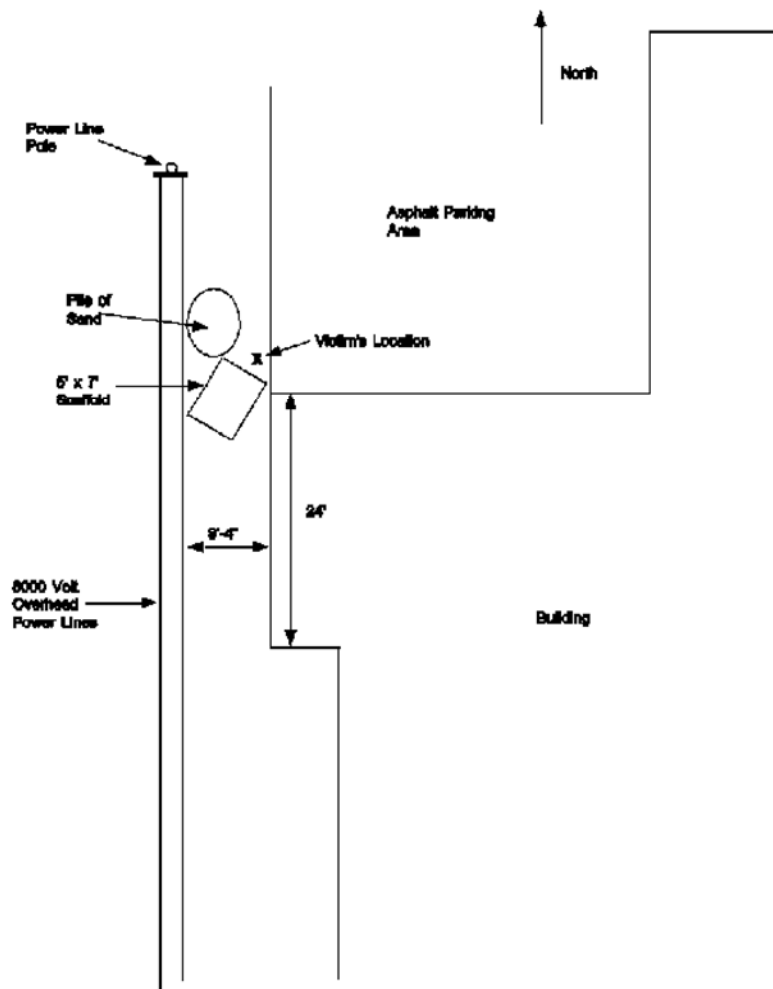
Figure 1. Building Renovation Site (Aerial View)

The victim and a coworker moved a steel pipe scaffold along a 24 foot long section of the west side of a building (See [Figure 1](#)). The scaffold was 25 feet tall and had a 5 foot by 7 foot footprint. It consisted of five sections that were each 5 feet tall. Each corner of the scaffold was mounted on an adjustable screw jack and caster. The casters were 7 inches in diameter and allowed the scaffold to be moved by rolling it on the ground. The screw jacks allowed each corner of the scaffold to be independently adjusted to level the scaffold on uneven surfaces. The screw jacks/casters, when adjusted to their lowest position, held the bottom of the corner scaffold pipes 17 inches above the ground.

Parallel to the west side of the building was an 8,000 volt overhead power line. The power line was approximately 9 feet – 4 inches away from the side of the building. The line was approximately 28 feet high at a line pole that was 25 feet north of the point where the scaffold contacted the line. The line sagged approximately 18 to 24 inches at the point where the scaffold contacted it. At the time of the site visit, the old power line that broke when the incident occurred had been replaced with a new line. The new line was covered with insulating blankets along the west side of the building.

The scaffold was moved to the north end of the 24-foot wall and was being moved around a corner and up onto an asphalt parking area along the north side of the building. When the workers reached the northwest corner of the building wall, the scaffold was positioned at an angle with respect to the building. The caster nearest the building (northeast corner of scaffold) was approximately 18 inches from the building, along a line extending from the corner of the building and forming a 30-degree angle with the edge of the asphalt. A second caster (southeast corner of scaffold) was at a location approximately 4 feet 3 inches south and 4 feet 1 inch west of the building's northwest corner. The caster on the northwest corner of the scaffold had rolled into several inches of sand along the edge of a pile of sand. The scaffold had to be raised approximately 6.5 to 7 inches from the ground up onto the asphalt.

While the scaffold was moved, the victim walked backward and pulled on the scaffold while the coworker pushed it across the ground. When it was in the position shown in Figure 1, the victim lifted the leading edge of the scaffold to get the caster closest to the asphalt up and onto the asphalt. When he lifted the front of the scaffold, it tilted toward the power line and the southwest corner of it contacted the power line. A path to ground was completed through the victim and he momentarily remained in contact with the scaffold until the power line broke. When the line broke, the victim was thrown several feet from the scaffold and he landed on the asphalt parking area. The coworker who was pushing the scaffold received an electrical shock but was not seriously injured.

**Recommendation #1: Contact the local electrical utility to assist or provide guidance whenever work is performed in the vicinity of overhead power lines.**

Discussion: Whenever work involving large pieces of conductive materials, scaffolds, ladders, long-handled tools, or boomed vehicles is done near energized overhead power lines, the local electrical utility company should be notified. Utility companies can de-energize power lines, insulate lines with insulating blankets or hoses, or temporarily remove power lines during the duration of work. Electrical utility companies can provide assistance and guidance for safe work practices near overhead power lines. Through the joint cooperation of businesses and their local electrical utilities, actions can be taken to reduce or eliminate the risk of electrocution due to accidental contact with overhead power lines.

**Recommendation #2: Provide extendable aerial platforms instead of fixed scaffolding whenever possible.**

Discussion: Extendable aerial platforms can provide workers with safe work platforms up to heights of more than 100 feet. In many situations, these devices can be used in place of traditional rigid or fixed scaffolding. When properly used, they can eliminate or reduce some of the risks associated with scaffolds and working at elevations. Extendable aerial platforms can be quickly and easily lowered to their fully retracted position before being moved to alternate locations at a work site. In this case, an extendable aerial platform could have been completely lowered before being moved and the potential for contact with the overhead power line would have been totally eliminated. This recommendation to use an extendable aerial platform whenever possible does not preclude the need to de-energize or insulate overhead power lines as described in the above Recommendation 1.
