DATE: August 31, 1995

FROM: Minnesota Fatality Assessment and Control Evaluation (MN FACE) Program,
Minnesota Department of Health

SUBJECT: MN FACE Investigation 95MN03301
Business Manager Electrocuted While Removing Flagpole Located Near
7,200 Volt Overhead Power Line

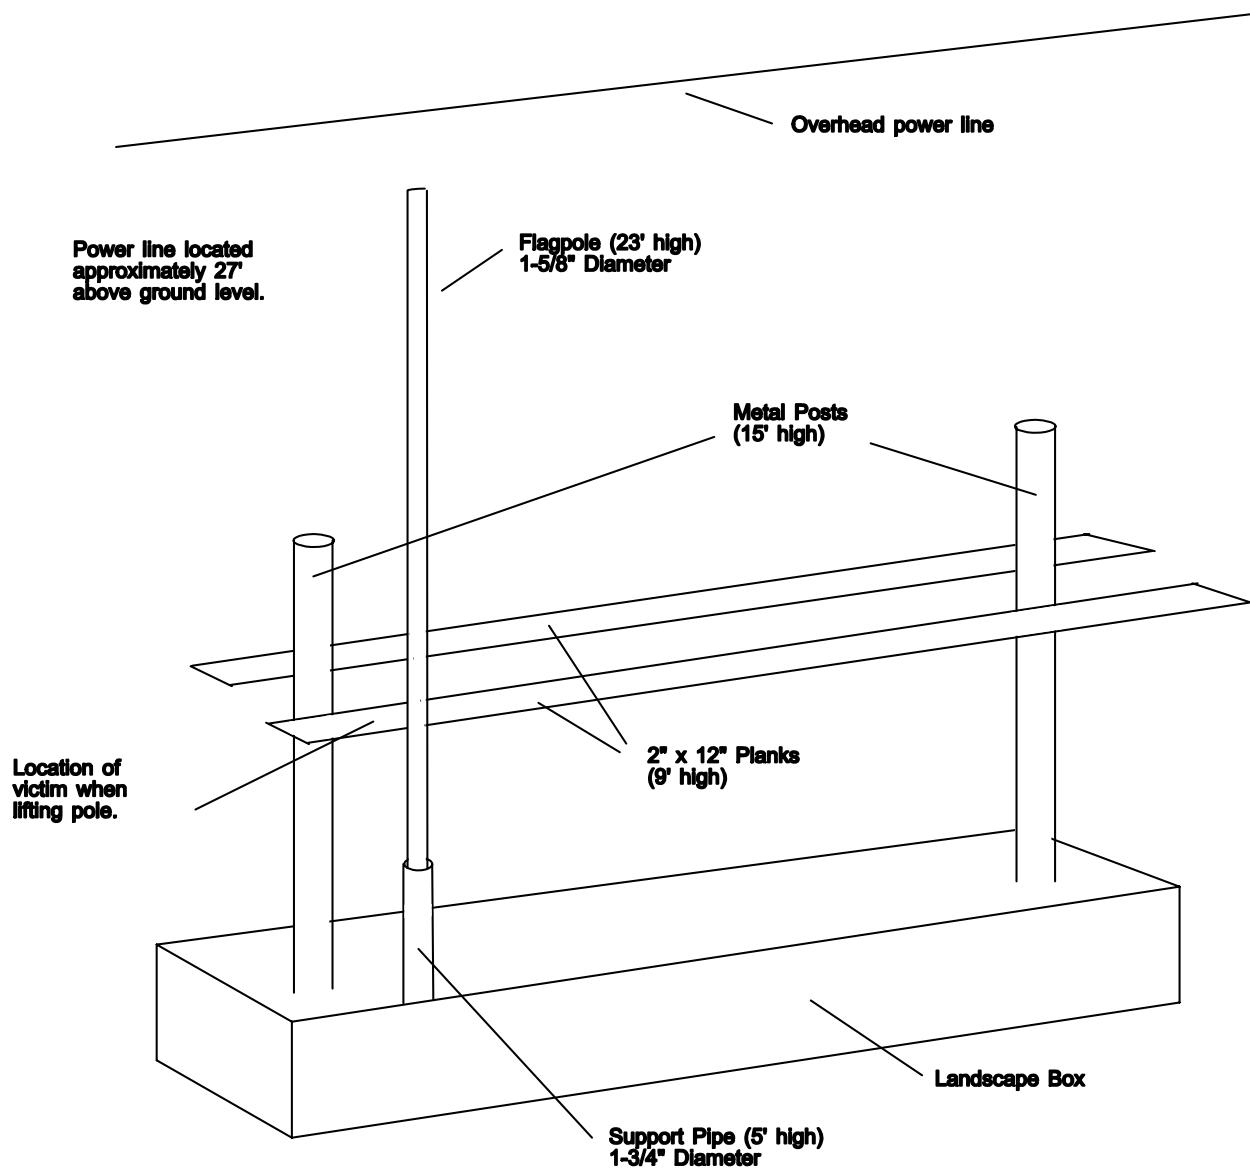
At approximately 9:00 a.m. on the day of the incident, the victim and a coworker attempted to remove a metal flagpole from in front of a business establishment. Removal of the flagpole was not a usual job task performed by the victim or by any of the other employees. It was a one time task for which there were no specific employee safety training needs or requirements. The flagpole was a galvanized steel pipe that was 24 feet-6 inches long and 1-5/8 inches in diameter. The flagpole was inserted inside a vertical support pipe that was 5 feet long and had an inside diameter of 1-3/4 inches. The support pipe was secured inside a rock-filled landscape box that was approximately two feet high. The flagpole extended into the ground approximately one foot below grade level. The box also contained two upright metal posts, each 15 feet long that supported two horizontal 2 inch x 12 inch wood planks. The planks were approximately nine feet above the ground (See Figure 1).

A 7,200 volt power line was located directly above the landscape box and flagpole. The power line was approximately 27 feet high. Two other power lines also ran parallel to this line; one at approximately the same height and the other five feet above the two lower lines. Environmental conditions at the time of the incident were sunny with a temperature of approximately 70 degrees fahrenheit and a relative humidity of approximately 90 percent.

The victim stood on the wood plank adjacent to the flagpole while a coworker remained on the ground. The victim began to lift the flagpole vertically to raise it out of the support pipe. As he raised the pole, the top of the pole neared the power line and an electrical arc occurred between the power line and the pole. A path to ground was completed through the victim as a result of his contact with the flagpole and he was electrocuted. It wasn't known whether the pole came in direct contact with the overhead power line. The victim released the pole and fell from the wood

Figure 1. Flagpole and landscape box. Not to Scale

Recommendation #1: Contact the local electrical utility to assist or provide guidance whenever

work is performed in the vicinity of overhead power lines.

Recommendation #2: Ensure employees follow safe work practices whenever working near overhead power lines or with materials which may contact overhead power lines.
