DATE: October 16, 1995

FROM: Minnesota Fatality Assessment and Control Evaluation (MN FACE) Program,
Minnesota Department of Health

SUBJECT: MN FACE Investigation 95MN02701
Teacher/Handy-man Dies After Falling From Second-Story Roof of House

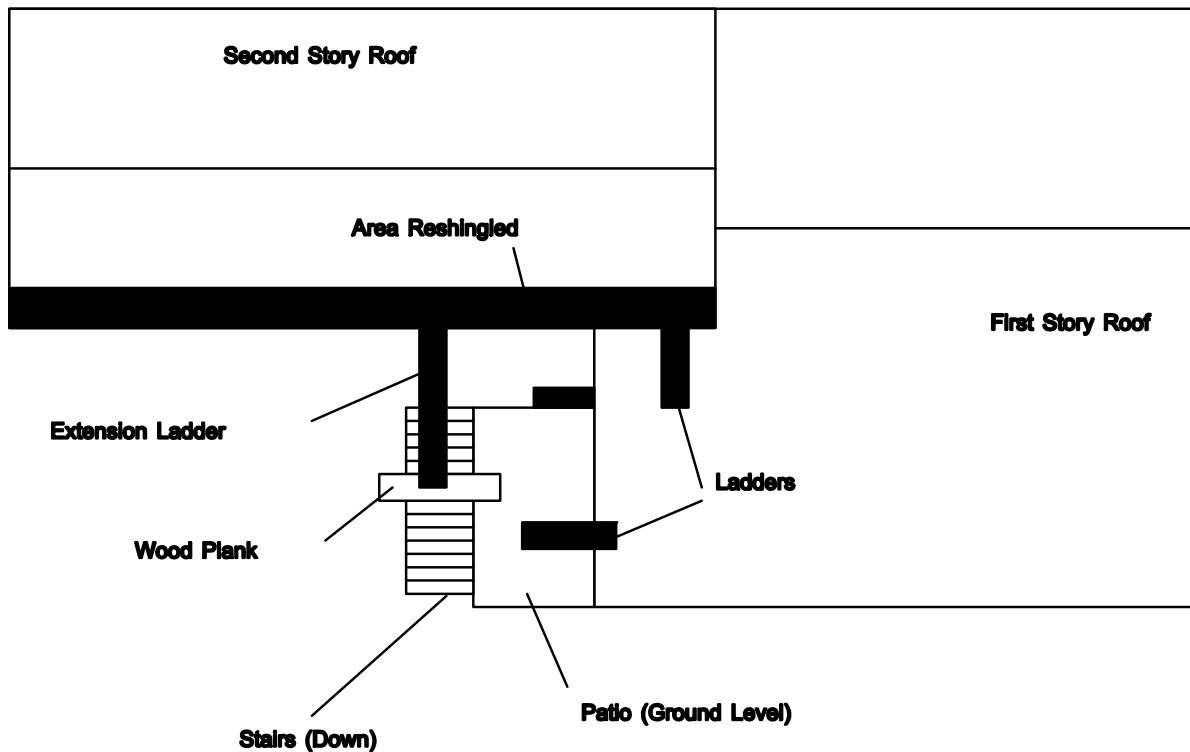
**Figure 1. House Roof Work Site
Not To Scale**

The second story roof of the house had a 6-12 pitch¹ or slope. The victim had removed the old shingles and roofing materials from the roof on the day prior to the incident. The edge of the second story roof was approximately 16 feet above the ground. Two ladders provided access to the second story roof where the victim worked at the time of the incident. One ladder provided access from an adjacent one-story roof which was accessed by a third ladder from a ground level patio (See Figure 1). An extension ladder provided direct access to the second story roof from ground level. The base of the extension ladder rested on a wood plank which extended across a stone stairway (leading down from the patio/ground level to a lower yard level). Due to the uneven terrain near the house, the wood plank was supported on one end by the patio and on the other end by a five-gallon plastic pail.

shingles, he fell from the roof of the house. The homeowner arrived home at approximately 5:00 pm and found the victim laying on the stone stairway. He was laying on his right side with his head on the third step, from the top, of the stone stairway. The distance from the roof edge (rain gutter) to the victim's head was approximately 17 feet. The extension ladder was leaning against the house but tilted to the left, when observed while standing at the base of the ladder and facing the house. The top of the ladder was resting against the edge of a second story window and the feet of the ladder were partially resting on the victim. The wood plank which supported the ladder was found at the victim's feet on the stone steps. The homeowner immediately called emergency medical personnel who arrived at the scene shortly after being called. They examined the victim and pronounced him dead at the scene.

The autopsy report indicated that the victim had massive skull fractures and that both wrists were broken. From this information, it was concluded that the victim probably did not fall from the extension ladder but instead fell from the second story roof of the house.

Recommendation #1: Whenever work is performed at an elevation where the potential for a fall exists, fall protection equipment should be used.

Recommendation #2: A catch platform should be properly installed and used whenever possible to provide a safe work platform.
