DATE: May 31, 1995

FROM: Minnesota Fatality Assessment and Control Evaluation (MN FACE)
Program
Minnesota Department of Health

SUBJECT: MN FACE Investigation 95MN01101
Carpenter Dies From Injuries Sustained After Falling 14 Feet When
Scaffold Collapsed

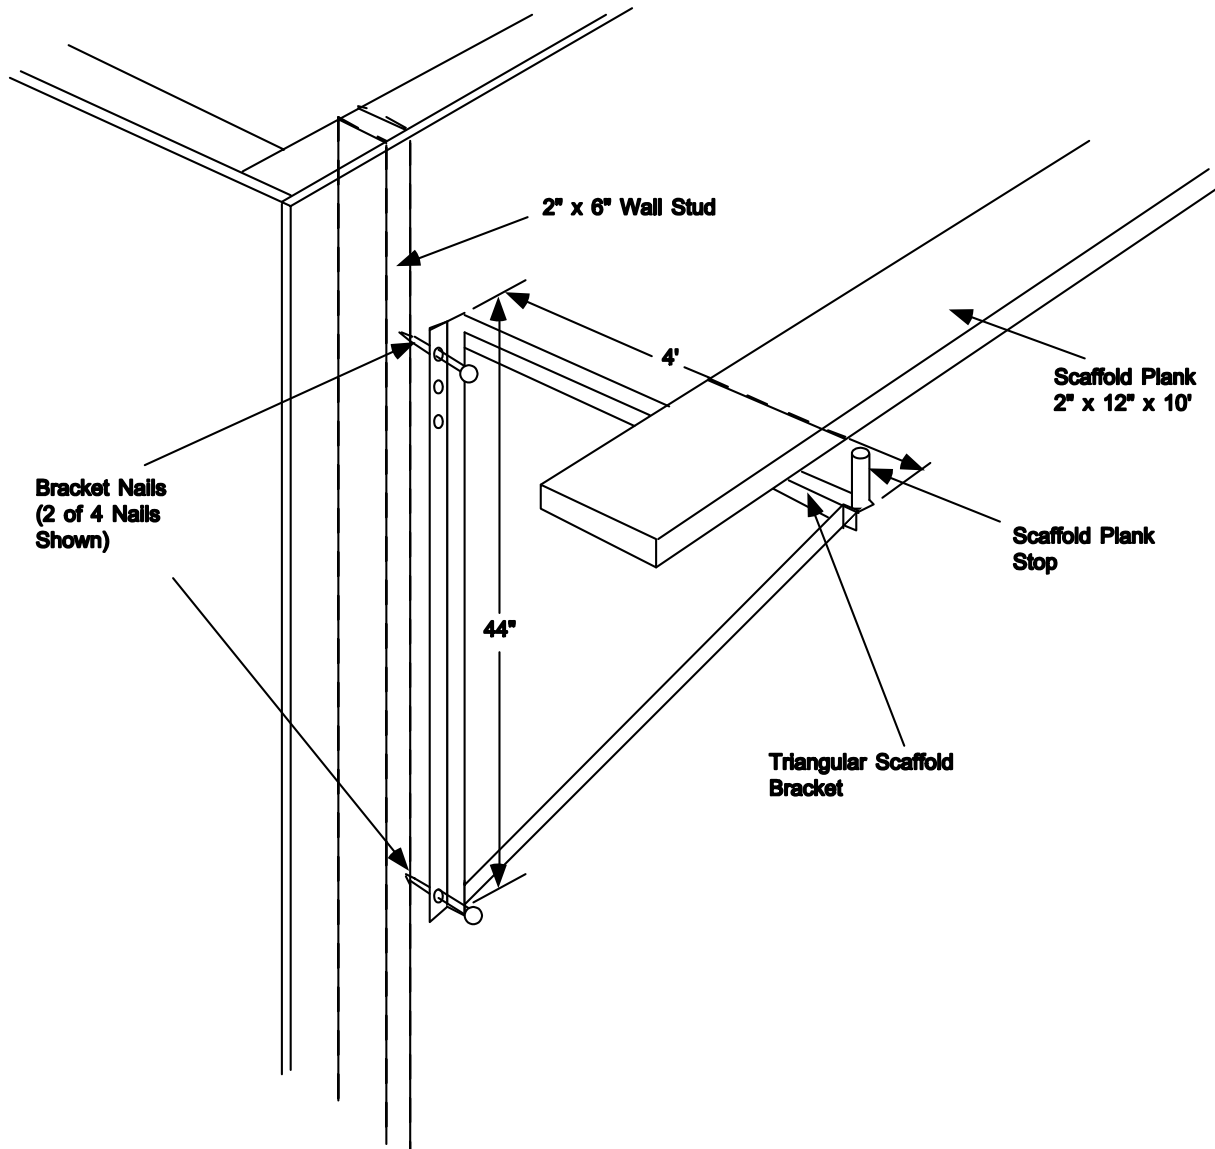
The victim was working on constructing the roof of a 20- by 24-foot room that was being added to an existing home. The room was being built directly above an existing garage that had a flat roof. The sides of the garage were approximately 8 feet high and the walls of the new addition were also approximately 8 feet high. After the walls of the room were framed and put in place, steel triangular scaffold brackets (see Figure 1) were fastened with nails to the exterior side of

the room walls. The brackets consisted of three pieces of 1.5 inch angle iron welded together to form a right triangle. The horizontal arm of the brackets was 4 feet long and the vertical arm was 44 inches long. The brackets were spaced 8 feet apart and were secured to the wall with three nails near the top and one nail near the bottom of the bracket's vertical arm. The brackets were secured by driving the nails into the wall studs of the room. The scaffold brackets were positioned such that the top (or horizontal arm) of the brackets was approximately 3 feet below the top sill plate of the room walls.

Figure 1. Scaffold Bracket Nailed To Corner Of Room
Not To Scale

Discussion: Triangular scaffold brackets are often secured with four large general construction nails. General construction nails have a smooth shaft and can be more easily pulled out of wood than nails with a rough or ribbed shaft such as a ring shank nail. The weight of workers and tools on scaffold brackets exert a large amount of force on the nails which secure the brackets in place. During use, as workers climb onto and off of the scaffold platform, the bracket nails are repeatedly subjected to forces which act to pull the nails from the wood.

Recommendation #1: Employers should ensure that triangular scaffold brackets are securely fastened with bolts.

Alternative methods of attaching scaffold brackets, including the use of bolts, are recommended in OSHA Standard 29 CFR 1926.451 (m)(2)(i). Employers should ensure that scaffold brackets are secured with at least one 5/8-inch bolt to significantly reduce the likelihood of the brackets pulling free and causing the scaffold to collapse. If a single bolt is used, it should be placed in the upper most hole of the vertical arm of triangular scaffold brackets. If the brackets involved in this incident had been secured with at least one bolt instead of with only nails, this fatality might have been prevented.
