DATE: May 31, 1995

FROM: Minnesota Fatality Assessment and Control Evaluation (MN FACE)
Program
Minnesota Department of Health

SUBJECT: MN FACE Investigation 95MN00801
Truck Driver Dies From Injuries Sustained After Falling From A
Truckload of Sheetrock

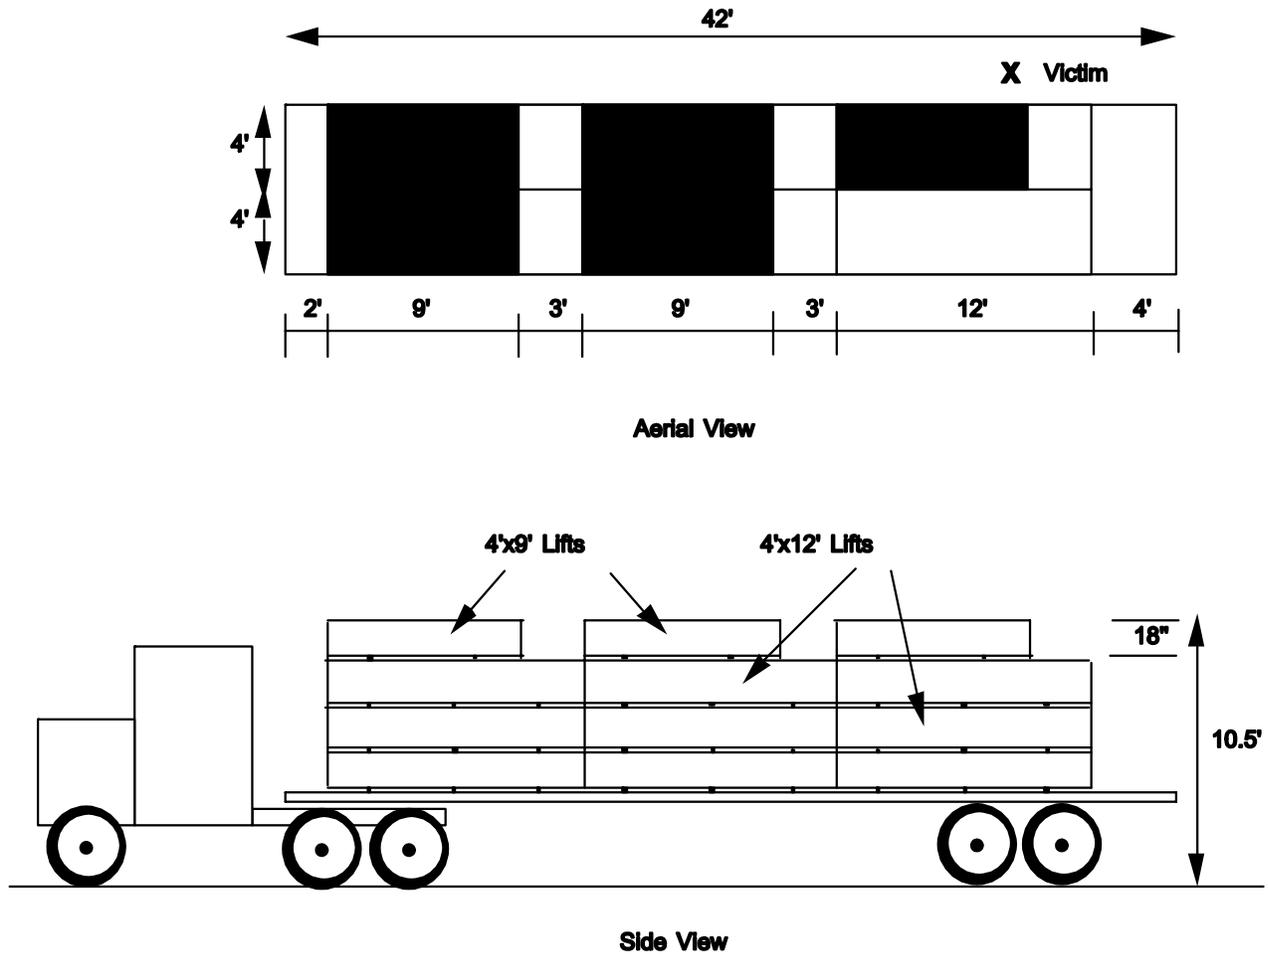
**Figure 1. Semi-truck and load
Not To Scale**

The victim delivered a semi-truck load of sheetrock to a retail lumber company. The flatbed trailer was approximately 8 feet wide and 42 feet long. The truck load consisted of 23 "lifts" or individual stacks of sheetrock and was configured as shown in Figure 1. Eighteen lifts contained 4 feet by 12 feet pieces of sheetrock and five lifts contained 4 feet by 9 feet pieces of sheetrock. Each "lift" was approximately 18 inches thick. Wood spacers, 2 inches by 3 inches by 8 feet, were placed between the lifts and between the flatbed trailer and the first layer of lifts loaded onto the trailer. The wood spacers provided a space for the forks of the forklift during loading and unloading of the sheetrock.

The four feet by 12 feet lifts were loaded on the flatbed in three layers with each layer containing six lifts. Each layer was configured in two parallel rows with a 4 foot edge of the two forward most lifts approximately 2 feet from the front edge of the trailer. The 4 feet by 12 feet lifts were loaded on the trailer without any space between the ends of the lifts. A portion of the back end of the flatbed trailer approximately 4 feet wide by 8 feet long was not covered by the lifts of sheetrock. The five 4 feet by 9 feet lifts were loaded on top of the third layer of 4 feet by 12 feet lifts. One lift of 4 feet by 9 feet sheets was loaded directly above five of the 4 feet by 12 feet lifts with the 4 foot front edge of a small lift aligned with the 4 foot front edge of a large lift. This resulted in a space 3 feet wide by 18 inches deep by 8 feet long behind the first two small lifts and a space 3 feet wide by 18 inches deep by 4 feet long behind the second two small lifts. The load was covered with a large tarpaulin that was securely tied to the perimeter of the flatbed trailer.

lumber company employees arrived for work. He parked the truck in the lumber company's gravel parking lot, directly in front of a locked yard gate. He untied the tarpaulin and partially uncovered the load. He may have climbed on top of the load since the tarpaulin had been pulled back from the left front corner of the load toward the right rear corner. Apparently while he removed the tarpaulin, he fell to the gravel parking lot. He was discovered by an employee of the lumber company shortly after the employee arrived for work and heard the victim's call for

help. The victim was found on the ground along the right side of the trailer (when facing the front of the truck) near the location of the rear axles. The victim's location along the side of the trailer indicated that he probably fell from the top of the load versus the empty trailer space at either the front or the back of the trailer.

Recommendation #1: Employers should ensure that flatbed semi-trailer load covers are removed from the ground.

Discussion: Generally, when material is transported on flatbed semi-trailers, it is protected from moisture with a tarpaulin or similar type of flexible protective cover. These covers are tied to the flatbed trailer at various locations around the perimeter of the trailer. The placement of the 4 feet by 9 feet by 18 inch lifts of sheetrock created gaps in the top of the load that were 3 feet wide by approximately 20 inches deep. These gaps were hidden by the tarpaulin and probably were not noticeable to an individual walking on the top of the load. Whenever a driver climbs onto a flatbed trailer or the material being transported on the trailer, the potential for a fall and for a serious injury exists. If a driver climbs on top of a load similar to the load in this incident, he will be exposed to a potential fall of approximately 10 feet or more. If after untying the tarpaulin, the driver had remained on the ground and pulled the tarpaulin off to either side of the trailer or to the back of the trailer, he would not have been exposed to a fall, and this fatality probably would have been prevented.
