DATE: June 9, 1995

FROM: Minnesota Fatality Assessment and Control Evaluation (MN FACE) Program,
Minnesota Department of Health

SUBJECT: MN FACE Investigation 95MN00701
Farm Equipment Mechanic Dies from Injuries Sustained After Tractor
Overturned

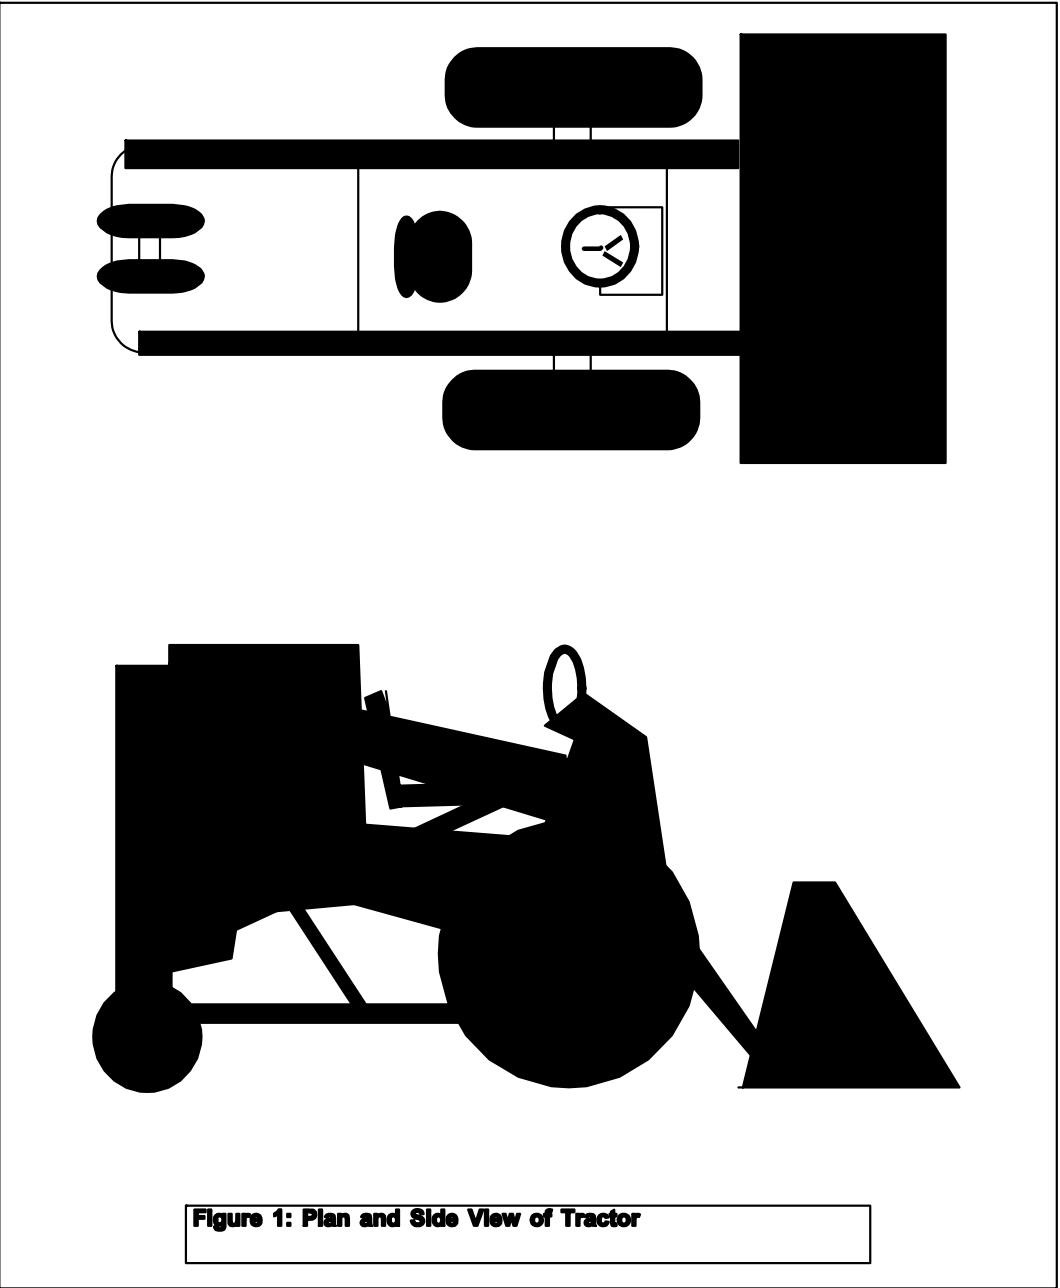
The incident occurred while the victim was delivering a tractor which had been repaired at the farm implement dealership. The tractor was a Honeybee Model 140 (a converted McCormick Farmall "C," Model 140, manufactured in the 1950's) which had been retrofitted with a front-end loader. The tractor had four wheels set in a triangular configuration. The drive axle was located at the front of the tractor with two large wheels set on either side of the tractor body. The steering axle was located at the rear of the tractor with two small wheels set together and directly under the body of the tractor. The wheelbase of the tractor (axle to axle) was 5.5 feet and the width and height were both 4.5 feet. The operator position was forward of the tractor engine and access to it was restricted by the loader arms which attached to the rear of the tractor. The tractor was not equipped with a roll-over protective structure, an operator restraint system, or a general purpose cab.

At the time of the incident (approximately 8:45 am), the victim was driving over an ice-covered portion of the road. For an unknown reason, the rear wheels of the tractor slid off of the road and into the right-hand ditch which caused the entire tractor to be pulled towards the ditch. The tractor began to overturn on its right side as it entered the ditch, throwing the victim out of the operator's position and forward into the ditch. The tractor continued to overturn and came to rest in the ditch pinning the victim underneath.

Recommendation #1: All tractors should be equipped with a rollover protective structure and a seat belt.

Recommendation #2: Farm equipment should be driven at reduced speeds when traveling on potentially hazardous roads and roads of changing or varying condition. Operators should be cautioned of this when operating uncommon equipment or equipment unfamiliar to them.
