DATE: June 9, 1995

FROM: Minnesota Fatality Assessment and Control Evaluation (MN FACE) Program,
Minnesota Department of Health

SUBJECT: MN FACE Investigation 95MN00501
Sawmill Foreman Dies of Injuries After Legs were Severed by a Saw Blade

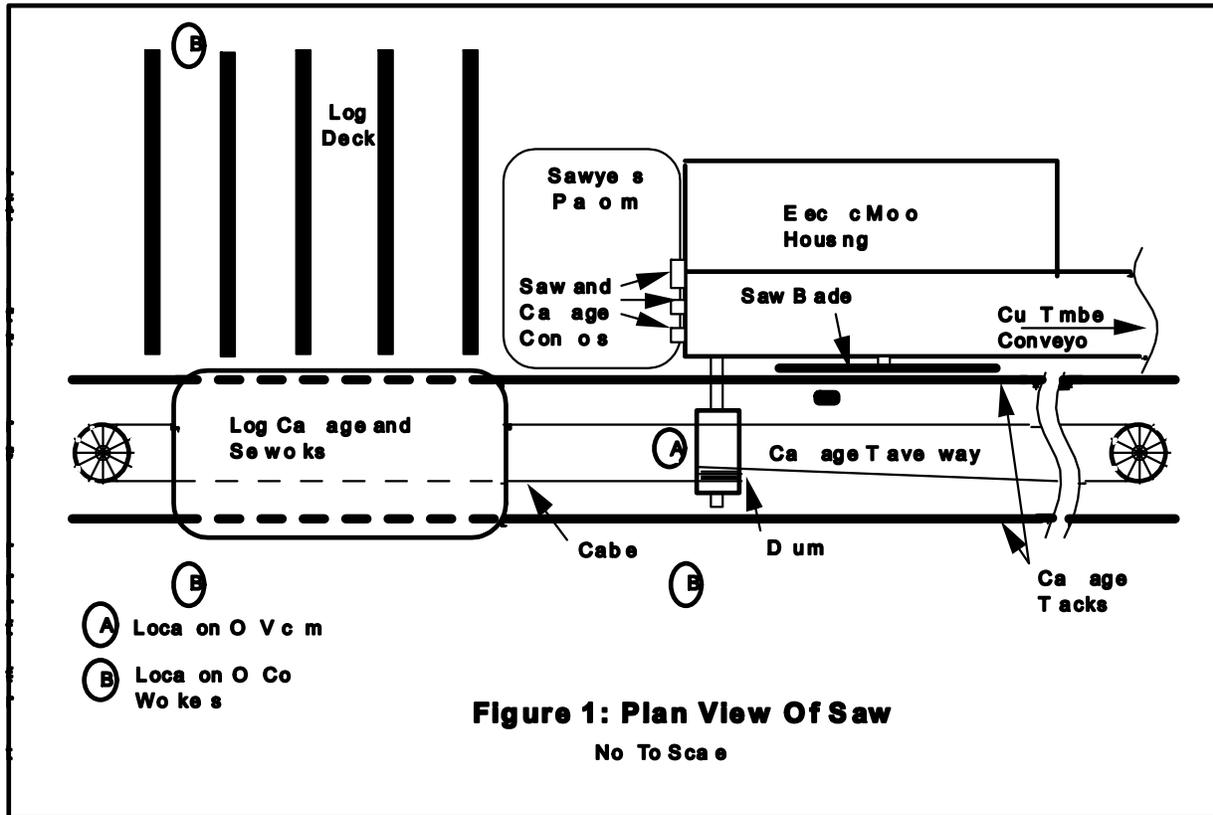
The timber saw consisted of a four-foot diameter saw blade and a metal carriage used to hold and transport logs during the sawing operation (see Figure 1). The carriage moved along the carriage track-way parallel to the saw blade on two tracks. The carriage is propelled by a continuous cable system driven by a horizontal rotating drum located between and below the tracks and slightly forward of the saw blade. A wire cable wrapped around the drum, traveled around pulleys located at either end of the carriage runway, and connected to both ends of the carriage. Rotation of the drum clockwise or counter-clockwise moved the carriage forward or backward along the carriage track-way. The drum was grooved to inhibit the cable from 'traveling' horizontally on the drum. Both the saw blade and the drum were powered by one electric motor. The saw blade was directly linked to the motor and rotated when the motor was activated while rotation of the drum was controlled by a clutch which allowed the sawyer to control the speed and direction of drum rotation. Saw controls were located at the sawyer's platform located forward of the saw and adjacent to the cable runway.

On the day of the incident, the cable had 'traveled' off of the drum and required maintenance to re-install the cable. At this time the carriage was located five to six feet ahead of the saw blade. The victim and co-workers de-energized the saw and locked-out the main electrical power switch located approximately 50 feet from the sawyer's platform. The Company lock-out procedure required each individual in the vicinity of the saw to place a lock on the power switch; however, only one lock was used by the workers

Recommendation #1: Prevent the carriage cable from traveling off of the drum.

- Retrofit existing drums and redesign new drums to include raised edges on both ends of the drum to physically restrict the cable from lateral travel.
- Verify proper alignment of the cable on a routine basis. The drum and pulleys should be aligned to prevent the cable from traveling toward either edge of the drum.
- Install a spring on the pulleys or on the cable where it attaches to the carriage to maintain cable tension during carriage operation.
