Highway Technician Dies After Falling 55 Feet From Bridge Scaffold

Minnesota FACE Investigation 94MN06401

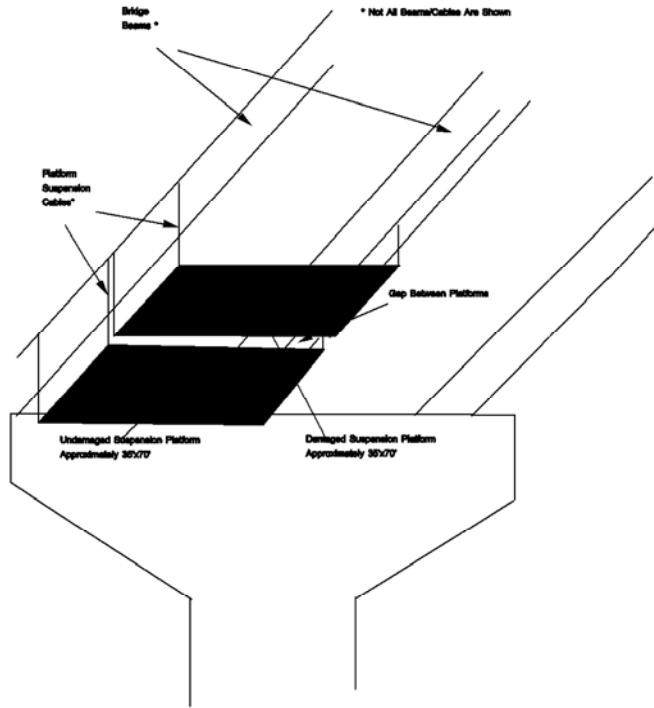
Figure 1. Suspension Platforms Below Bridge – Not to Scale

A steel platform scaffold was suspended directly below the most recently painted section of the bridge (see Figure 1). The scaffold was approximately 35 feet wide by 70 feet long and was suspended by chains and cables from the bridge. The scaffold surface was approximately 53 inches below the bottom of the beams that supported the bridge deck. It was installed by contract workers who were sandblasting and painting the bridge. The contractor's employees left the scaffold in place until their work was approved by the highway technician.

A second platform scaffold was suspended next to the scaffold that the workers used earlier on the morning of the incident. Although the suspension mechanism for the second platform had been damaged, the platform remained suspended beneath the bridge deck. The two suspended platforms were at the same distance beneath the bridge but were separated by a narrow gap. The gap was approximately 14 inches wide at one end and 43 inches wide at the other end. The scaffold with the damaged suspension system was "off limits" to all workers at the site. However, there were no barriers in place to prevent workers from stepping across the gap between the platforms. It is not known whether the victim was aware that one of the scaffolds was unsafe for use. In addition, guard rails had been removed from three sides of the scaffold that was safe for use by the workers.

The victim's mill thickness gauge was found on the scaffold platform that was unsafe for use. The battery cover was missing from the gauge which suggested that the gauge struck either the platform or another surface with enough force to knock the cover off the gauge. This may have occurred as a result of the victim tripping on equipment on the safe scaffold platform. It also may have resulted from the victim tripping and falling while attempting to step across the gap between the two scaffold platforms.

Recommendation #1: Employers should ensure that appropriate fall protection equipment is available and correctly used when employees are working from elevations where the potential for a fall exists.

form of fall protection (e.g., safety nets as specified in OSHA Standard 29 CFR 1926.105) should be used. If the victim had been using adequate fall protection equipment (i.e., lifeline, safety belt, and lanyard) or if safety nets had been installed beneath the platforms, this fatality might have been prevented.
