Construction Worker Dies After Falling From a Wind Turbine Tower

Minnesota FACE Investigation 94MN01301

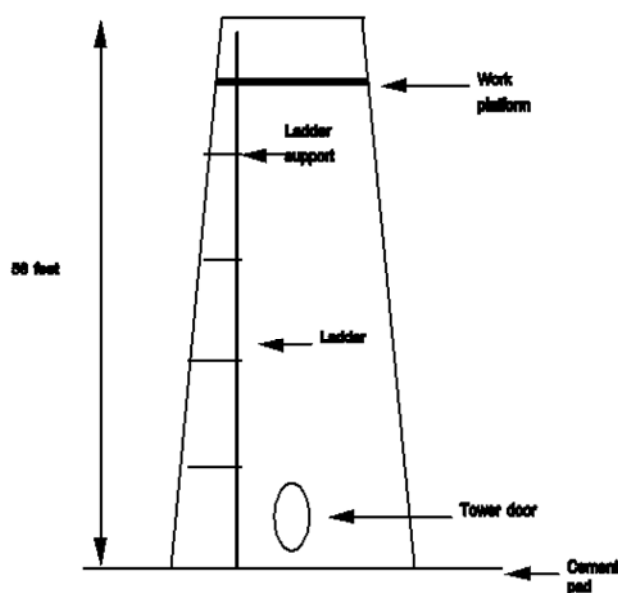
A 29-year-old male rigger (victim) died from injuries incurred after falling from a ladder inside a wind turbine tower under construction. He and two coworkers (Coworker 1 and Coworker 2) were bolting two tower sections together when the incident occurred. All were equipped with hard hats and safety belts with lanyards. The 120-foot tall tubular, tapered tower consisted of a bottom and top section, 56 and 64 feet tall, respectively. The bottom section, already bolted to a base concrete pad, was 11 feet in diameter. It tapered to 9 feet at the top, where the two sections were connected using 36 bolts. A door at the base of the bottom section allowed access to the inside of the tubular structure. Inside, a pre-installed metal ladder, secured with heavy steel supports at 12-inch intervals, ran along one side of the section. Workers climbed the ladder with the wall at their backs and the steel supports at their sides. During construction, fall protection for riggers consisted of a safety belt and two lanyards equipped with clips to tie/clip off to the ladder rungs as they ascended or descended it. A cable climbing kit for self-retracting lifelines had not yet been installed behind the ladder as permanent fall protection. The ladder led to a pre-installed work platform at about 50 feet, where workers stood while bolting the tower sections together. See Figure 1. The platform's ladder opening, about 3-foot square, could be covered with a hinged metal cover after the platform was gained.

Figure 1.; Interior of bottom section of tower. Not to scale.

Except for ice on the bolt flange, which was removed, the tower's top section appeared clear. The top section was lifted into position, and the workers on the platform began bolting it into place. Four bolts were connected when the workers noticed more ice in the top section. They decided there was insufficient accumulation to warrant its removal; Coworker 1 climbed up its pre-installed ladder to dislodge it instead. A large chunk of ice fell to the platform and struck Coworker 2 on the head, knocking his hard hat off. Coworker 2 complained of feeling dizzy and the victim, also on the platform, notified crew on the ground that he and injured Coworker 2 were coming down; Coworker 2 descended the ladder first. Apparently, neither worker clipped off to ladder rungs during their descent. More large pieces of ice, estimated to be up to 1 foot square and 6 inches thick, suddenly let loose from the sides of the top section and fell through the platform's ladder

opening onto the men on the ladder. The victim, above Coworker 2 on the ladder at between 20-40 feet, was struck by the ice and knocked from the ladder. As he fell, his head struck a steel ladder support and he sustained instant, fatal, head injuries.

Recommendation #1: Ensure workers use fall protection, even in emergency situations, when ascending/descending fixed ladders.

Recommendation #2: Cap wind turbine tower sections exposed to inclement weather to avoid ice build-up inside.
