DATE: April 22, 1994

FROM: Minnesota Fatality Assessment and Control Evaluation (MN FACE)
Program
Minnesota Department of Health

SUBJECT: MN FACE Investigation 93MN07901
Construction Laborer Electrocuted After Accessing Primary Side
of Transformer Box

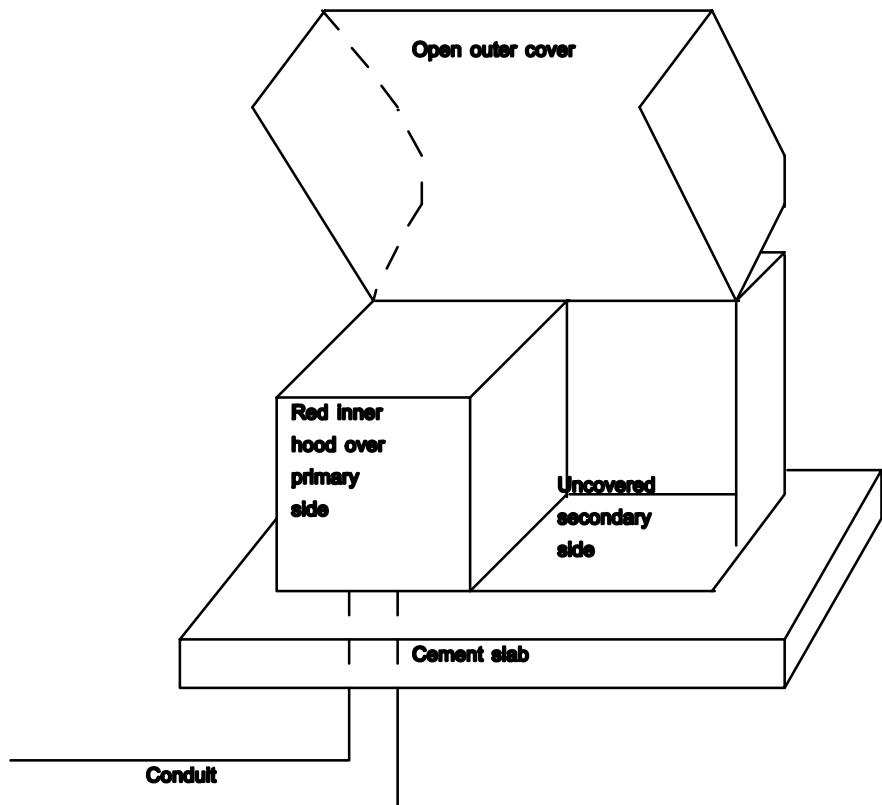
The 22-year-old transformer box, about 3-feet square, sat on top of an 8- to 10-inch thick cement slab. The slab was open directly beneath the box for

running underground cables into it. A locked outer metal box covered both the transformer's primary (8000-volt) side and its secondary (120-240-volt) side. Its primary side was, in addition, double covered with an unlocked inner fiberglass hood. The inner hood was red and had a yellow warning label attached which read "Warning-high voltage-operate hood with hot stick." The inner hood completely enclosed the primary side of the box but did not extend over the box's secondary side. See Figure 1.

Figure 1. Transformer box - not to scale.

90-degree elbow piece beneath and up to the bottom of the box as specified by the utility company, it entered the box and got hung up on a ground wire. The victim, at the box, and his coworker, in the trench, could not dislodge the conduit. The victim lifted the inner hood and reached inside to move the wire or conduit. He was kneeling on the ground, supporting himself on the box's outer cover with his left hand as he reached inside the inner hood with his right hand. As he withdrew his hand, he made direct contact with the angle bar connecting the 8000-volt primary conductor to the transformer, completed a path to ground, and was electrocuted. An exit wound was later found on his left hand.

Recommendation #1: Ensure that energized components inside transformer boxes are inaccessible to unqualified employees. This recommendation is in accordance with CFR 1926.403(j)(2)(i).

Discussion: The victim of this incident was not qualified to access energized components inside the transformer box. Under these or similar conditions, employers should ensure that energized components are strictly inaccessible to unqualified workers and/or enforce rules prohibiting access without the presence of a qualified person.
