DATE: January 6, 1994

FROM: Minnesota Fatality Assessment and Control Evaluation (MN FACE) Program
Minnesota Department of Health

SUBJECT: MN FACE Investigation 93MN06201
Heavy Construction Equipment Mechanic Dies From Electrocution

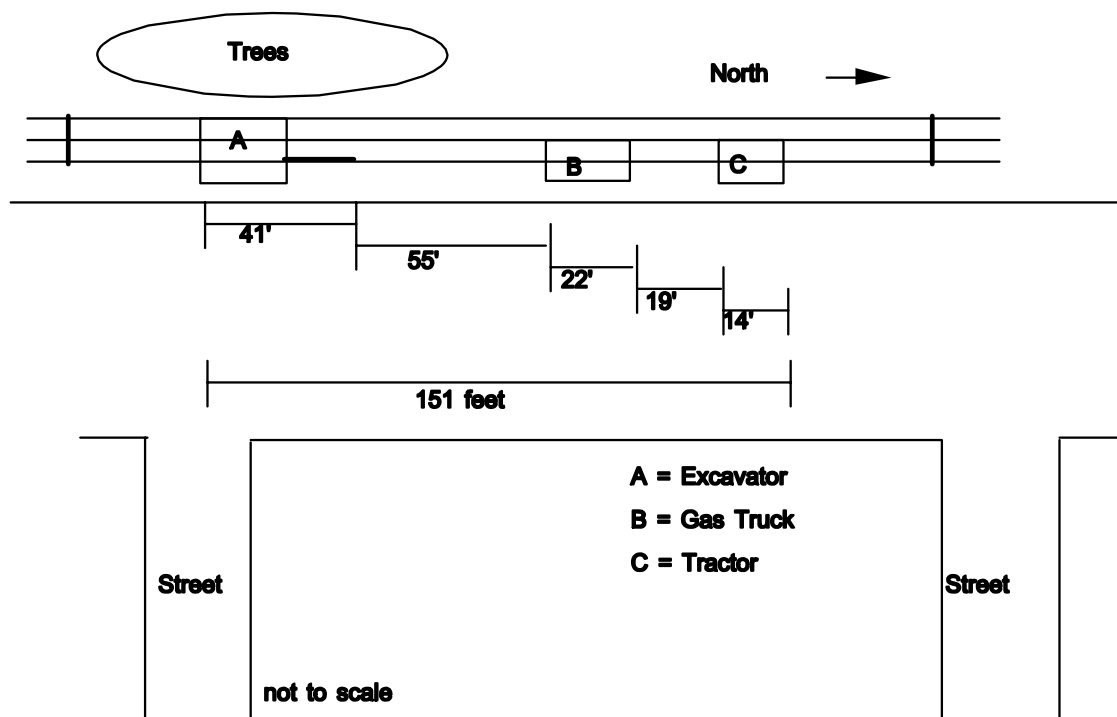
FIGURE 1.

An excavator had been parked at the site earlier that day by a sewer and street-work contractor who anticipated beginning work the next day. It was parked approximately 150 feet south of the tractor. The excavator had a 26' 3" boom and 7'10" stick; the bucket had not yet arrived at the site. According to manufacturer's data, when fully extended without the bucket, the boom and stick could reach an approximate height of 32 feet. A 1500-gallon diesel fuel tank truck was parked between the tractor and excavator. All three pieces of equipment were parked beneath a 30-foot high, three-phase, 8000V power line that ran parallel to the residential roadway. The excavator's tracks were parallel to the overhead lines and its boom initially faced to the south. See Figure 1.

Two mechanics employed by the sewer and street-work contractor had been assigned to remove and repair a drive sprocket on one of the excavator's tracks. The mechanics intended to use the excavator's boom to raise the track by pushing down against the ground with the tip of the boom. This would relieve the track of the machine's weight and allow the sprocket to be removed. To perform the lift, the excavator had to be "walked" (moved) a short distance north and the boom swung from south to north. The mechanics decided to swing the boom around to the west because of the residential road and a light pole to the east of the machine. To swing to the west, it was necessary to raise the excavator boom to clear a grove of trees adjacent to the excavator. While one mechanic acted as an observer, the other raised the boom above the trees and swung it westward. As the boom was being swung, its tip contacted the 8000V field phase of the overhead power line and severed it. The phase fell across the tank truck and the tractor, knocking the victim from it. He fell from the tractor with the energized line across him, completing a path to ground.

Recommendation #1: Identify and evaluate workplace hazards, including job hazard analysis as an ongoing part of each construction phase.

Discussion: Job sites should be evaluated prior to the start of any project involving the use of construction machinery to identify the safest areas for the storage of materials, the placement of machinery, and the type and size of machinery to be used. One of the excavator mechanics told MN FACE investigators that swinging the boom around was necessary because of the location of the sprocket requiring repair. In this instance, it may have been possible to park the excavator away from site obstacles in such a way that operation of the boom under the power line was not necessary to perform the repair job on it. Additionally,

Recommendation #2: Maintain safe minimum working clearances from energized overhead power lines when operating a boomed vehicle.

Discussion: OSHA regulation 29 CFR 1926.600(a)(6) requires that boomed earth-moving vehicles comply with the requirements of 29 CFR 1926.550(a)(15) when working or being moved in the vicinity of power lines. This standard specifies that the minimum clearance between electric lines rated 50kV or below and any part of the boomed vehicle shall be 10 feet, unless the electrical lines have been "deenergized and visibly grounded" at the point of work. A 10-foot clearance would ensure that the vehicle would not contact and cut the overhead line, as in this incident, or become energized because of the contact. When a 10-foot clearance is difficult to maintain by visual means, a designated person can observe clearance between the lines and the equipment and give timely warning of imminent contact to the operator, or the local utility company should be contacted to deenergize the power line before work starts.
