The National Institute for Occupational Safety and Health (NIOSH)

Worker Dies After Being Run Over by a Digger Derrick Truck

Minnesota FACE Investigation 93MN008

September 2, 1993

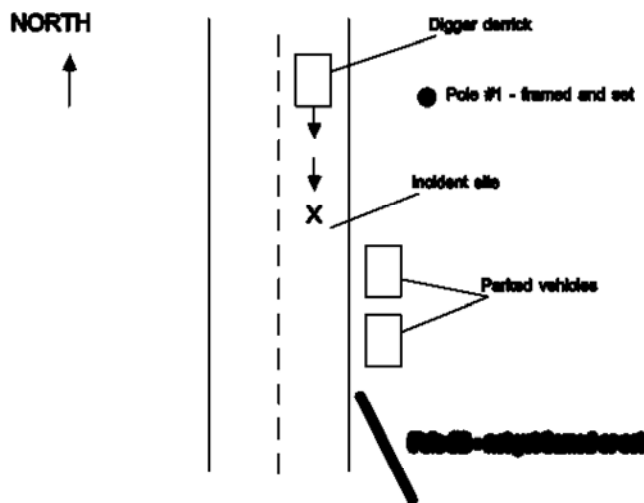
Figure 1. Overview of job site.

The incident occurred on a two-lane, north-south bound road. The workers were framing and/or setting poles on the east side of the road. See Figure 1 for an overview of the work site. The crew, forgetting to don their high-visibility vests, began work after lunch by setting the already framed Pole #1 with the digger derrick. They had initially by-passed Pole #2 because they did not have all of the necessary equipment for framing and setting it at the time they began work. Two company vehicles were parked on the shoulder of the road about mid-way between the poles in the north-bound lane. Seal coating, a soft tar substance, had been used to repair cracks at several locations on the roadway.

After finishing with back-filling around the newly set Pole #1, the crew members walked south in the north bound lane to Pole #2. They were about 30 feet in front of the digger derrick, which was proceeding in reverse to the same pole. The truck was moving about 2 miles per hour. It was customary for workers to direct a backing truck and any oncoming traffic in this manner.

Approximately mid-way to Pole #2, with his coworkers a bit ahead of him, the victim knelt with his back to the truck to apparently inscribe a word or initials into some soft seal coating with a plumb bob he was carrying. The truck driver, not seeing the victim in his blind spot, continued backing. The victim was hit and run over by both sets of tandem dual rear tires on the passenger side of the truck before it could be stopped. Coworkers discovered two capital letters in seal coating where the victim was run over after the incident.

Recommendation #1: Consider equipping vehicles with additional mirrors to help eliminate the blind spot behind vehicles or utilize infrared or ultrasonic devices to detect the presence of objects behind vehicles.

Discussion: The truck involved in this incident was equipped with rear view mirrors on each side of the cab. Even if he had been wearing a high-visibility vest, the victim behind the truck was not visible to the driver. Additional mirrors could be mounted on the left rear corner of vehicles to provide the driver with a view across the rear of the vehicle while backing up. Additionally, devices are available which are capable of sensing objects through ultrasonic or infrared signals within the vehicle's path. These devices, though not commonly used on construction vehicles, have been used successfully on other utility vehicles and may increase safety for pedestrians exposed to the hazards of backing vehicles.

Recommendation #2: Consider equipping vehicles with audible back-up alarms.

Discussion: Evidently the victim did not realize how close the backing truck was and/or how quickly it would reach him. Traffic on the county highway where the incident occurred was very light, and no other construction equipment was in operation. Audible back-up alarms, especially in circumstances like those that existed, may be useful in warning workers of approaching backing vehicles. An alarm on a backing vehicle, becoming louder as it gets closer, may increase worker awareness of their position in relation to it.

Recommendation #3: Consider implementing a safety policy which assigns one person per site the responsibility for directing vehicles and specifies site locations for non-directing pedestrian personnel. This recommendation is in accordance with 29 CFR 1926.601(b)(4)(ii).

Discussion: Under light traffic conditions like those that existed at the incident site, one person could be assigned responsibility for directing backing trucks and oncoming traffic. Since it is likely that oncoming drivers can more readily see and avoid workers than the drivers who are backing trucks, it is especially important that the person not turn his or her back to them. A company policy assigning responsibility for directing traffic to one individual on a work site and specifying appropriate work practices may be helpful in exposing fewer workers to hazards of backing vehicles. In addition, safe locations for non-directing site workers during vehicle back-up (i.e., in the view of the truck driver) could be part of such a policy.
