DATE: September 24, 1992

FROM: Fatal Accident Circumstances and Epidemiology (FACE) Project
Minnesota Department of Health (MN FACE)

SUBJECT: MN FACE Investigation MN9214
Highway Construction Flagman Dies after Being Struck by a Pickup Truck

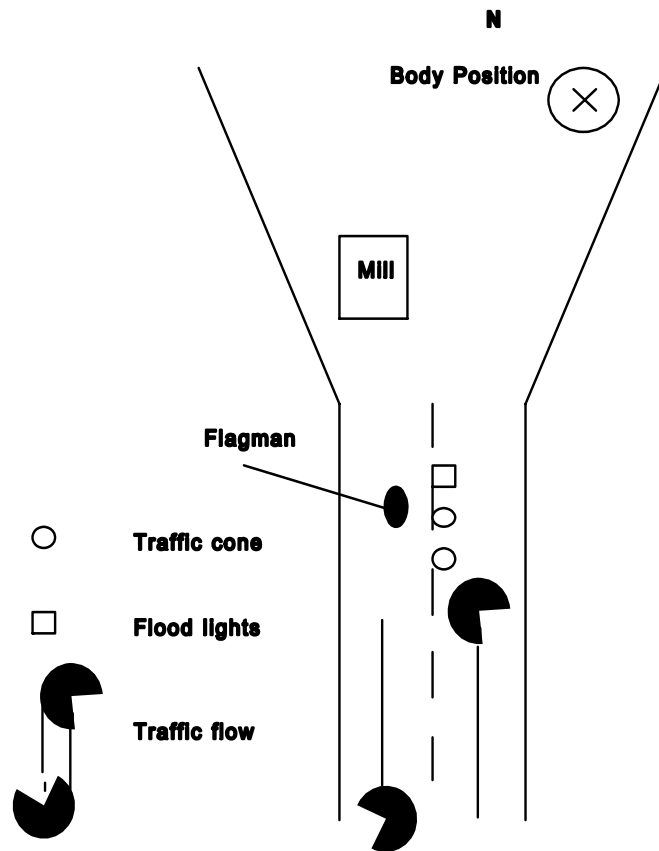
FIGURE 1.

The victim was positioned just at the north end of the bridge, approximately 75 feet in front of the mill machine. He stood just west of the center line in the southbound lane with the mill machine at his back, facing on coming, northbound traffic. He was responsible for stopping and directing this northbound traffic, part of the process of coordinating traffic around the mill machine and work area. See Figure 1.

A pickup truck traveling north at approximately 55-60 mph approached the bridge. It advanced across the bridge in the wrong (southbound) lane, directly towards the flagman who was standing in that lane. The truck struck the flagman, managed to maneuver into the correct (northbound) lane before striking the mill machine and other workers, and carried the victim approximately 200 feet before coming to rest in the road at the north end of the bridge. There was no indication of the truck slowing or stopping before impact.

Recommendation 1: Reduce posted speed limits through highway construction and work zones, especially during night hours.

Recommendation 2: To ensure traffic slows before entering highway work zones, law enforcement vehicles and/or personnel should be posted in a visible location well in advance of highway construction zones.
