LEO 2014-01

January 21, 2016

## Sergeant Struck by a Motor Vehicle on Interstate Highway— New Mexico

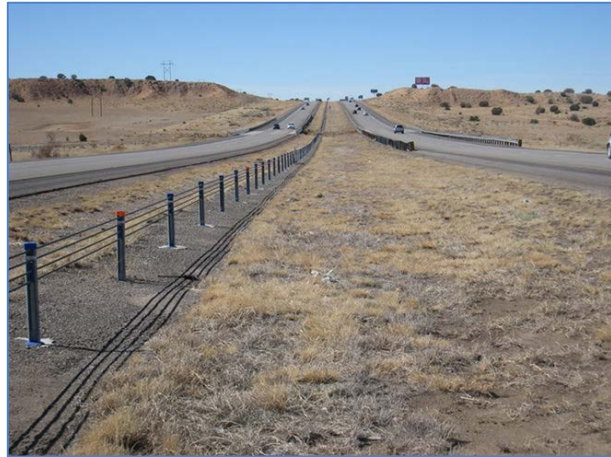
The highway approaching the crash site in the northbound lanes is a gentle decline approximately 0.5 miles in length, following an incline and crest; the road surface levels out at the bridge and then begins a gentle incline toward the next crest. The speed limit in the area is 70 miles per hour (see Image 1).

**Image 1. Incident site looking south; note gentle down-slope to north end of bridge.  
(NIOSH photograph)**

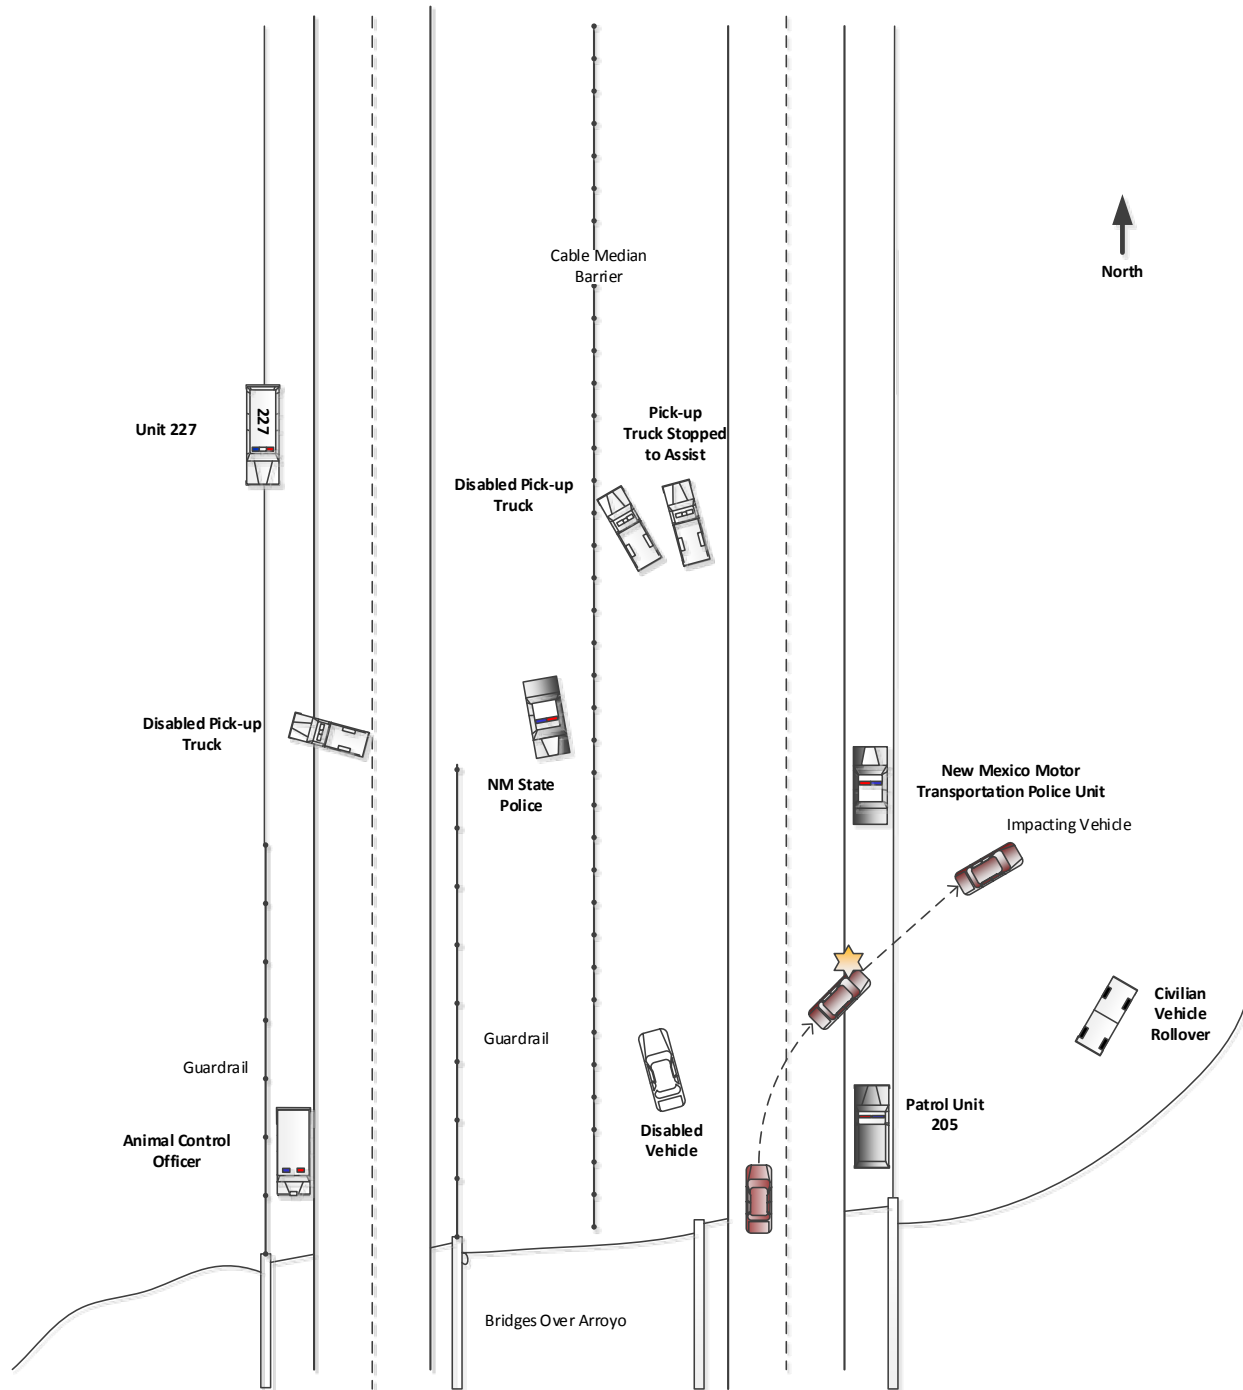
Diagram Not to scale

At the time the sergeant parked on the northbound shoulder, five civilian vehicles were in the immediate vicinity of mile marker 254.5 (see Diagram):

1. Unit 227 was located on the southbound shoulder.
2. South of Unit 227, a disabled pickup truck was situated in the right-hand southbound lane, perpendicular to the direction of traffic, obstructing the lane and shoulder.
3. The animal control officer's unit was in place on the southbound shoulder with emergency lights activated just south of the disabled truck.

4. The state police officer's unit was located next to the cable barrier on the southbound side.
5. A disabled pickup truck faced north in the northbound median, up against the cable barrier, near the state police unit.
6. A pickup truck with emergency flashers activated was parked near the disabled pickup truck that was against the cable barrier.
7. A disabled vehicle faced north in the northbound median a few yards north of the bridge.
8. A vehicle that had rolled over lay in the rough area off the northbound shoulder, about 200 yards north of the bridge. A roll-back tow-truck was parked abreast of it on the same shoulder. Note, the roll-back truck left the scene at 1020, prior to the incident and is not shown in the diagram.

**Diagram Locations of vehicles at the time the sergeant was struck**

As shown on the diagram, law enforcement vehicles with lights activated were located along the right hand shoulder of the northbound lanes and a disabled vehicle was located off the left hand shoulder. A law enforcement vehicle with lights activated was also located in the east bound side of the median and disabled vehicles were located on the left hand shoulder, northbound. The location of these vehicles, both left and right of the travel lanes may have made it difficult for the motorist to know which lane to use to provide safe clearance for the responders. Additional traffic control devices such as flares, warning lights or cones located along the right hand shoulder further in advance of the law enforcement vehicles may have prompted the motorist to slow down and move left sooner, allowing him to traverse the area without losing control. Additional emergency vehicles or portable message boards located near the top of the grade may also have served this purpose. Computerized emergency lighting devices are currently available for emergency response and law enforcement vehicles. These lighting devices may be programmed to display lights sequencing left-to-right or right-to-left, warning motorists to move left or right of the emergency vehicles.

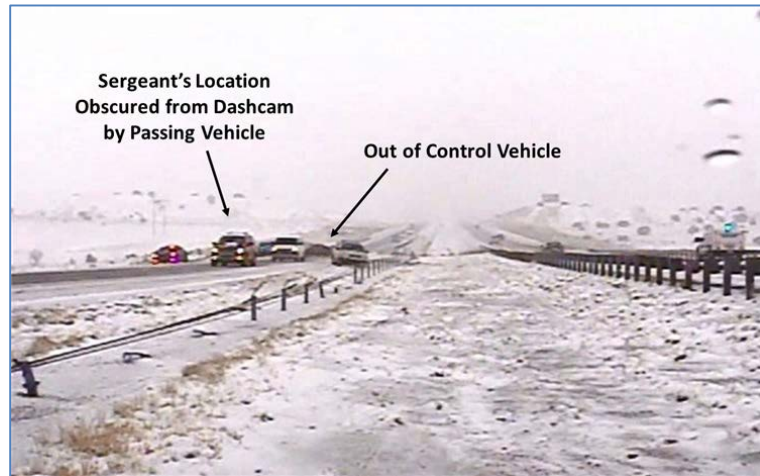
At 1021, the sergeant crossed the northbound lanes to confer with the MTD officer in his unit on the shoulder. He then started southward along the shoulder, facing traffic, toward his own unit (see Image 2).

At 1022, a car veered from the northbound lanes onto the shoulder, spinning 180 degrees, and striking the sergeant with its left front fender as he walked along the shoulder. The animal control officer witnessed the incident from his unit on the southbound shoulder of the highway; he saw the sergeant struck by the car, tossed several feet in the air, and land on the shoulder. The animal control officer immediately called the county dispatcher and said, “Code 82, officer down.” He requested EMS then exited his unit and crossed to the southbound lanes to help the sergeant (see Diagram).

**Image 2. The dashcam video of the vehicle approaching the scene prior to striking the sergeant. (dashcam courtesy of sheriff's department)**

Investigators also noted that just prior to the incident, the striking vehicle had been traveling closely behind two other vehicles which were in the left hand travel lane. The striking vehicle appeared to have been in the right hand travel lane before the motorist lost control. This is corroborated by the motorist's statement to police investigators.

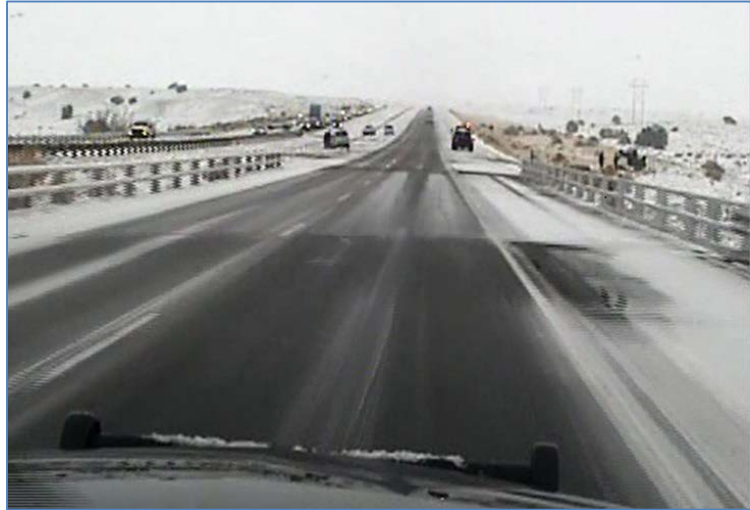
Discussion: During this incident, law enforcement officers responding to the scene were clothed in dark-colored uniforms. Further, as evidenced by the dashcam footage from the MTD unit as it approached the scene northbound, the area near the northbound bridge exit was highly congested (see Image 3). A disabled vehicle was located in the northbound median; a disabled pickup and the pickup of an assisting civilian were also located in the northbound median beyond the first disabled vehicle. To the right was a roll-back tow truck. Note that at the time the striking vehicle was crossing the bridge, the roll-back tow truck had left the scene and the motor transit unit with lights flashing had stopped just short of where the roll-back tow truck had been (see Diagram). Also, as the motorist was crossing the bridge, the sergeant's unit, also with lights flashing, was located on the shoulder near the bridge exit and the sergeant was walking the shoulder toward his vehicle. Finally, the vehicle rollover was located near the edge of the arroyo, off the right shoulder. Three other law enforcement vehicles, all with lights flashing, were located in the southbound median and along the southbound shoulder. The presence of all these vehicles may have distracted the motorist and hampered his ability to see darkly clothed officers on foot in time to safely react to their presence. The use of high-visibility, retro-reflective vests may have permitted the motorist to see the sergeant sooner, allowing more time to react appropriately by

**Image 3. Dashcam view of scene prior to incident from northbound MTD unit minutes prior to the incident. Note Number of disabled and responding vehicles. (dashcam courtesy of sheriff department)**

***Recommendation #4: Law enforcement agencies should ensure that officers wear suitable high-visibility, retro-reflective vests when operating at highway/roadway incidents.***
