## *Hispanic Lumberyard Worker Dies When Struck By a Forklift – North Carolina*

### SUMMARY

### Fatality Assessment and Control Evaluation (FACE) Program

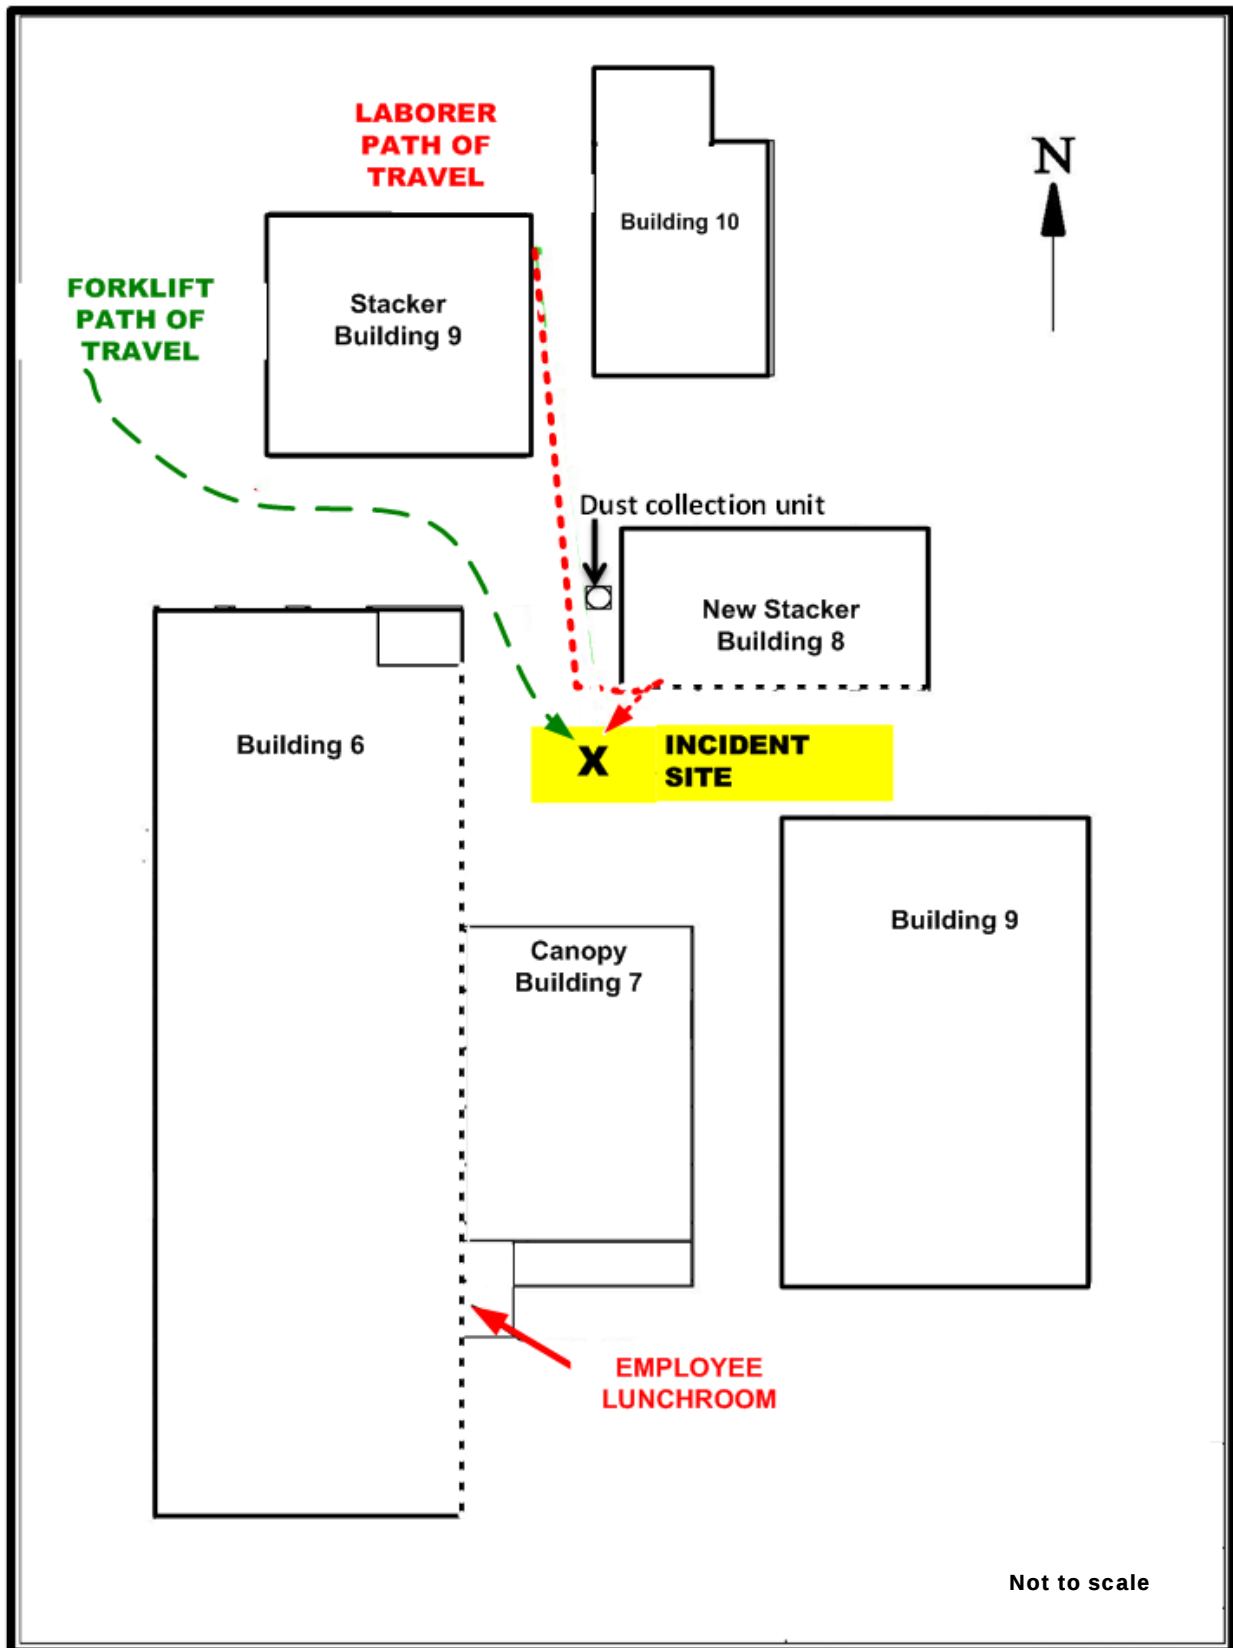
Diagram. Aerial depiction of forklift and Laborer's travel path.

The incident occurred in an open area between buildings that was approximately 35 feet across with a concrete surface (Diagram). There was an area of concrete deterioration toward the west side of the forklift travel lane. The lumberyard laborer was walking from B9 to B8, a distance of between 600 to 900 feet. He had about 200 feet to go to reach his destination, the lunchroom.

On March 30, 2012, at approximately 7:00 a.m. the lumberyard laborer began his workday at the lumberyard where he was employed through a staffing agency as a temporary lumberyard laborer. He had been assigned to two separate work areas that morning, first to B8 and later to B9 (Diagram). His duties were to place spacers between stacks of lumber to facilitate the drying process. At approximately 11:45 a.m., he stopped work to eat lunch. The employer had provided a lunch/break area for workers located in B7. It is believed that the laborer's path of travel to get to the lunch area would have taken him from B9 to B8 and then to B7 (Diagram).

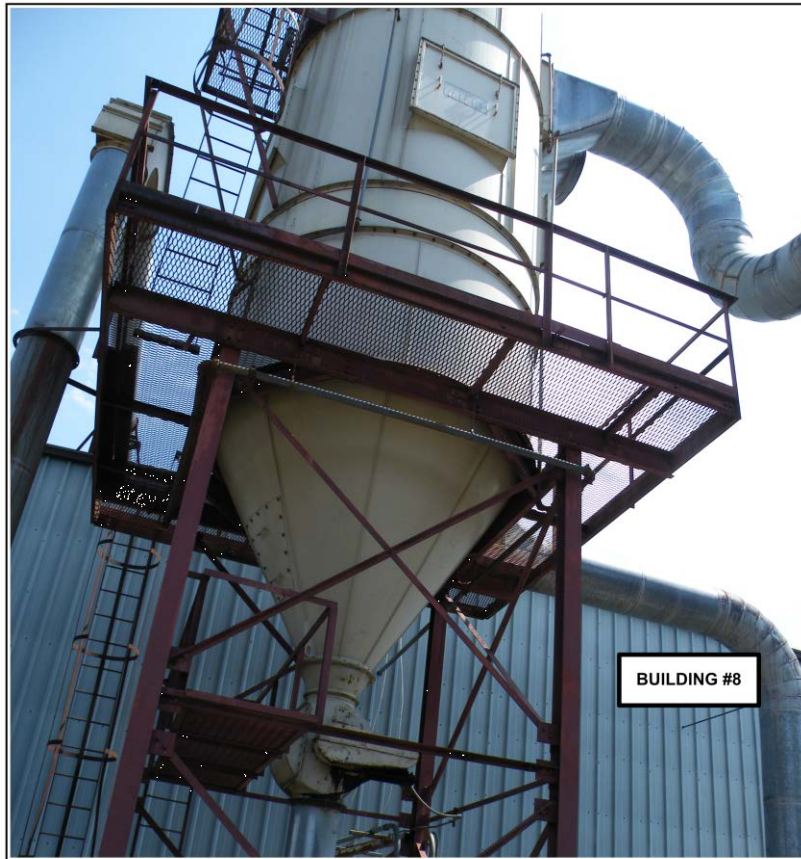
A dust collection unit was located approximately 15 feet from where the laborer was struck (Photo 1). The unit was activated only when needed and was in operation when the incident occurred. According to NCDOL/OSH, the noise level readings taken while the system was operating registered between 85.1 and 86.9 decibels adjusted (dBA). These levels are in compliance with Occupational Safety and Health Administration (OSHA) regulations; however depending on proximity to the dust collection unit, the noise may have been loud enough to interfere with a pedestrian's ability to hear an approaching forklift. Forklifts have an average decibel level of 89.4dBA<sup>1</sup>.

**Photo 1. Dust collection unit. (Photo courtesy of NCDOL/OSH)**

Near the area where the laborer was struck, the concrete road surface had begun to deteriorate along the west side of the forklift travel lane. It was common for operators to steer to the left to avoid the uneven road surface when they were transporting lumber from B9 to B8, which was the forklift operator's intended path of travel. This maneuver would have placed the forklift close to the dust collection unit. Therefore, the routes that the laborer and the forklift operator took would have placed both of them in proximity to the dust collection unit at the same time (Diagram). It is possible that the forklift operator could not see the laborer due the height of the load of lumber (Photo 4.) The laborer may not have seen the forklift because he was facing the opposite direction heading to B7, and may not have heard it due to the noise from the dust collection system.

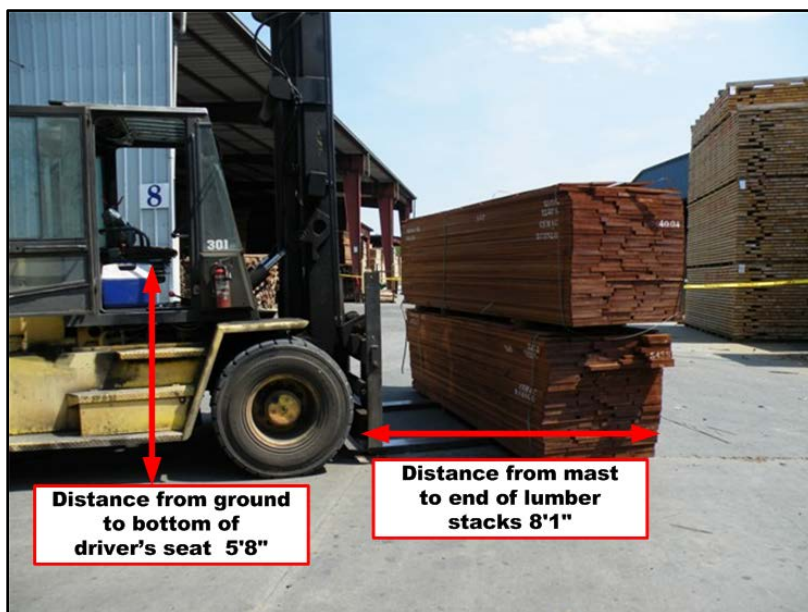
The laborer was struck by a 33,000 pound capacity forklift which was manufactured in 1990 with one forward-facing driver's seat. The cab was enclosed with glass doors on each side of the driver's seat and equipped with an operational horn, back-up alarm, and flashing light affixed to the top rear of the cab enclosure. The distance from the ground to the bottom of the driver's seat was 5 feet 8 inches and the distance from the mast to the end of the stacks of wood measured 8 feet 1 inch (Photo 2).

Photo 2. Photo showing a side view of the forklift and load of lumber.  
(Photo courtesy of NCDOL)

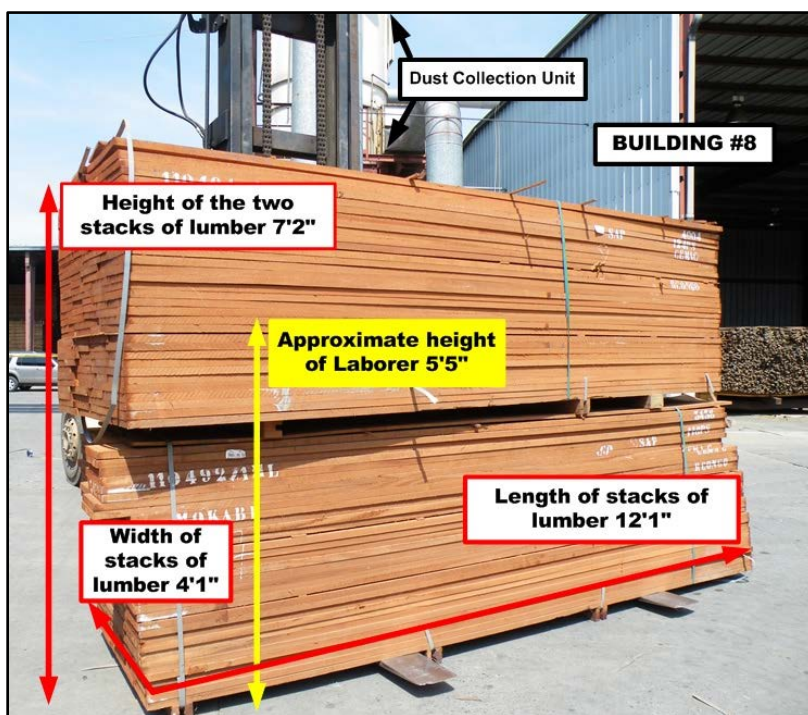
Photo 3. Area where incident occurred and pertinent measurements.  
(Photo courtesy of NCDOL/OSH)

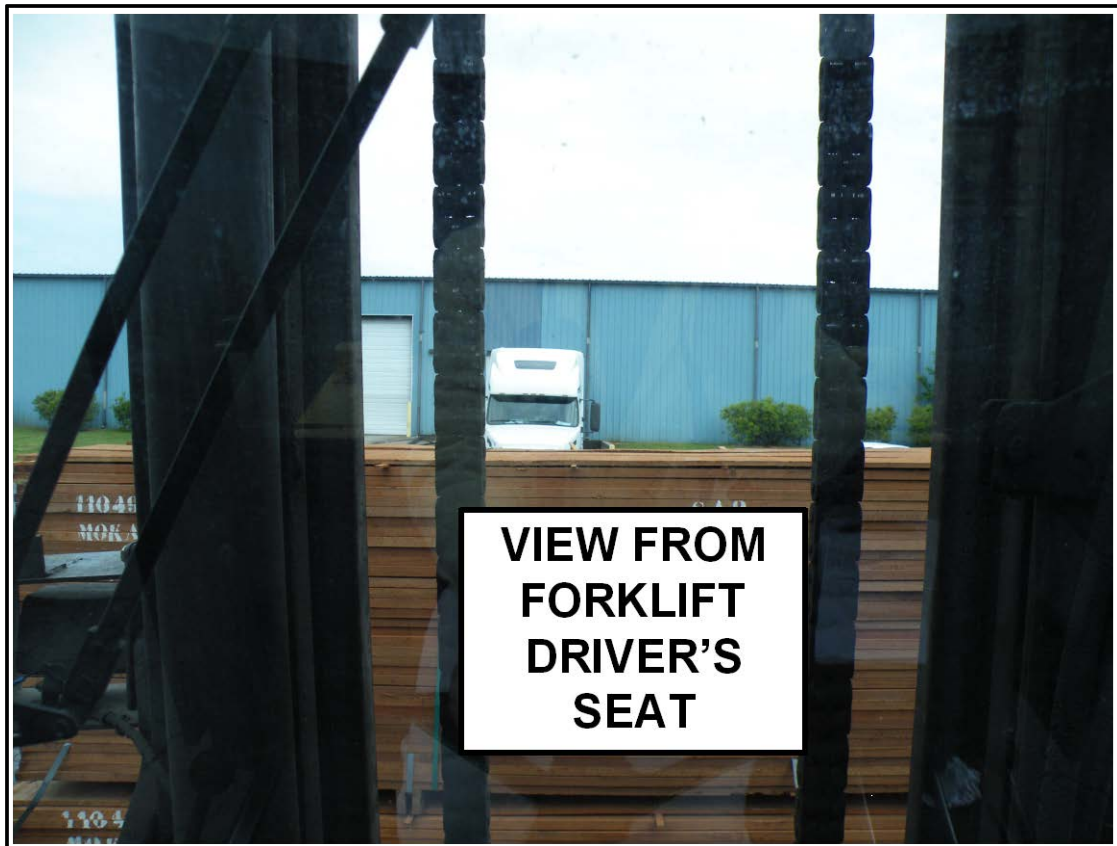
**Photo 4. Photo taken from the forklift driver's seat showing obstructed forward facing view. (Photo courtesy of NCDOL/OSH)**

- Do not move the forklift if you do not have a clear view of travel. OSHA forklift regulations state that “The operator is required to look toward and keep a clear view of the travel path [29 CFR 1910.178(n)(6)],”
- Slow down, stop and sound horn at intersections, corners, and wherever your vision is obstructed,
- When provided, use flashing warning lights or backup alarms when traveling in reverse,
- Use a spotter for blind spots,
- Always look in the direction of travel,
- Start, stop, travel, steer and brake smoothly,
- Signal to pedestrians to stand clear,
- Do not allow anyone to stand or pass under the load or lifting mechanism.<sup>4</sup>
