FACE Report Number 2009-02

August 19, 2011

Hispanic Worker Dies When a Sixty-Foot Tree Falls Onto the Hydraulic Excavator He Was Operating to Clear Land – Tennessee

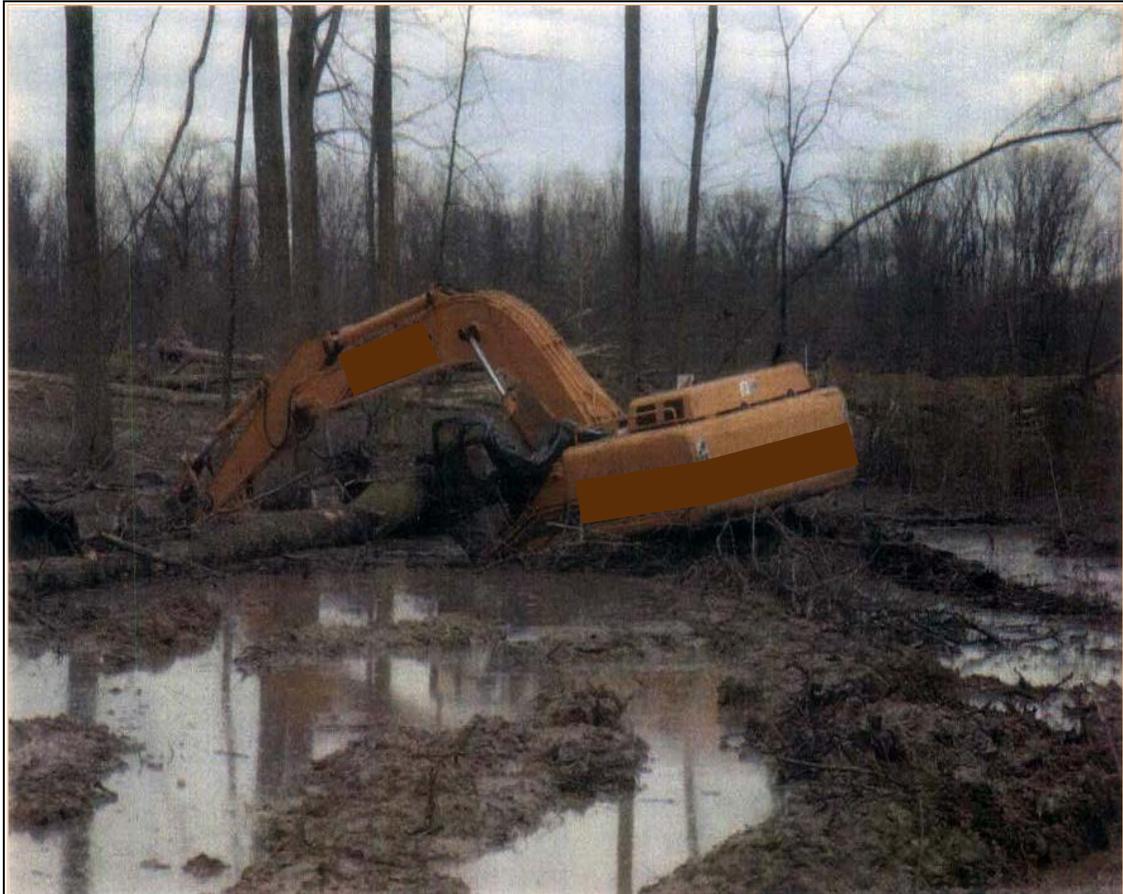
The ground at the scene where the incident occurred was partially covered by standing water (Photos 1 and 2). The swampy and marsh-like environment was incorporated into the design of the golf course to preserve the wetland appearance. The depth of the standing water is not known, but review of the photos of the hydraulic excavator following the incident (Photo 1) show a portion of the upper structure and the operator cab (Diagram) to be partially submerged in the mud due to the weight of the tree causing the hydraulic excavator to tilt to one side.

In this incident, as evidenced by the photographs taken shortly after the fatality, the area in which the victim was working consisted of mud and ponding water (Photos 1 and 2). Prior to commencing work, a thorough evaluation of the ground conditions may have indicated that the area was not conducive to heavy equipment stability and it would be unsafe to conduct tree-felling activities until conditions improved.

Photo 1. Photo of the incident scene showing location of the hydraulic excavator following the incident. *(Photo courtesy of TOSHA)*

Companies involved in tree-felling operations should develop a "felling plan" in accordance with the OSHA regulation 1910.266(h)(2)(ii). Developing a felling plan and training equipment operators on the plan, would have provided the operator with the understanding of the hazards created in the felling process. It is possible that the victim misread the tree's lean and the wind direction, which were both elements that contributed to the fatality. Additionally, the operator had the tree on the cab side of the boom and stick which may have increased the severity of the consequences of losing control of the tree. Making the first dig in the intended direction of the fall and the subsequent dig with the boom and stick between the tree and the cab may have prevented the tree from falling on the cab.

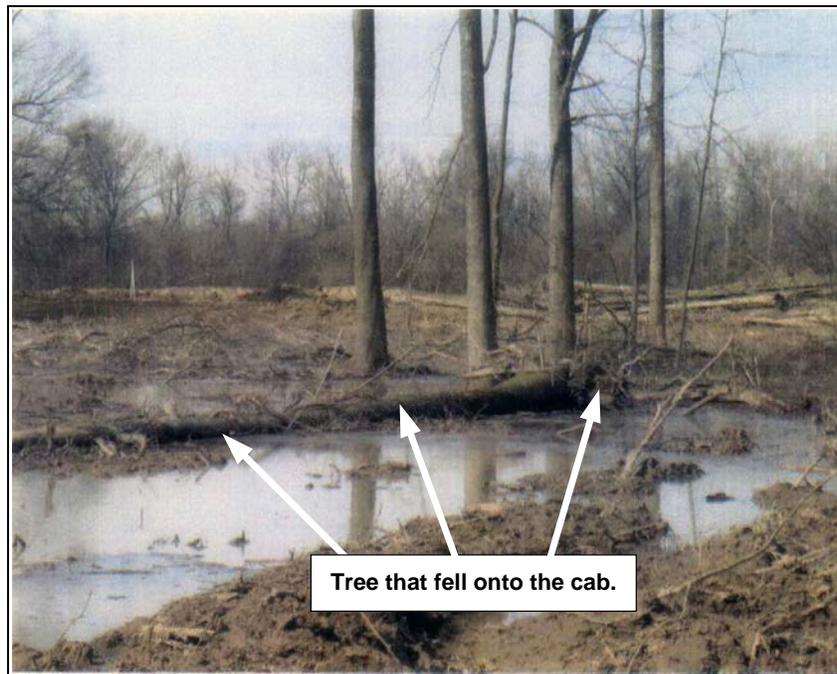
Photo 2. Photo of the incident scene showing the tree that fell onto the cab roof of the hydraulic excavator. *(Photo courtesy of TOSHA)*

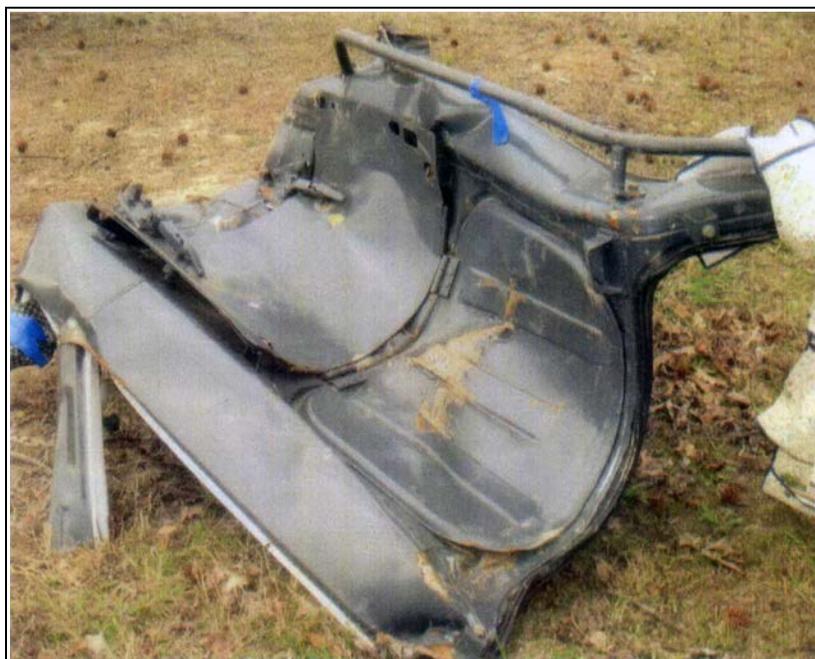
The victim was operating a 1996 hydraulic excavator at the time of the incident. The cab was enclosed with safety glass on four sides. The roof of the cab was steel with a hatch that opened but was closed at the time of the incident. According to the TOSHA investigator, the canopy roof was constructed of two-ply steel, each measuring 3/32" (total 3/16") which met the OSHA requirement of 1/8". However, the weight of the tree produced a large indentation in the roof of the cab (Photo 3).

of two-ply steel, each measuring 3/32" (total 3/16") which met the OSHA requirement of 1/8". However, the weight of the tree produced a large indentation in the roof of the cab (Photo 3). Had the canopy been reinforced with FOPS, it is logical that the intrusion of the tree into the cab would have been less severe; thereby maintaining the integrity of the operator compartment and increasing the probability that the operator could have survived the incident. Although there is no regulation that prohibits using hydraulic excavators to fell trees, and it is not an uncommon practice, it is recommended that employers use excavators equipped with FOPS that meet current applicable consensus standards for operator protection, or a forestry machine specifically designed for the type of tree removal to be performed. Presently owned excavators that will be used to fell trees can be retrofitted with appropriate guarding packages that are available separately.

Photo 3. Photo of the cab roof showing the indentation made by the tree. *(Photo courtesy of TOSHA)*

Recommendation #3: Employers should ensure that the equipment being used on the job provides the highest level of physical protection for the workers and is the most appropriate for the work being done.
