Cement Truck Driver Dies after being Backed Over by a Skid-Steer Loader – South Carolina

Fatality Assessment and Control Evaluation (FACE) Program

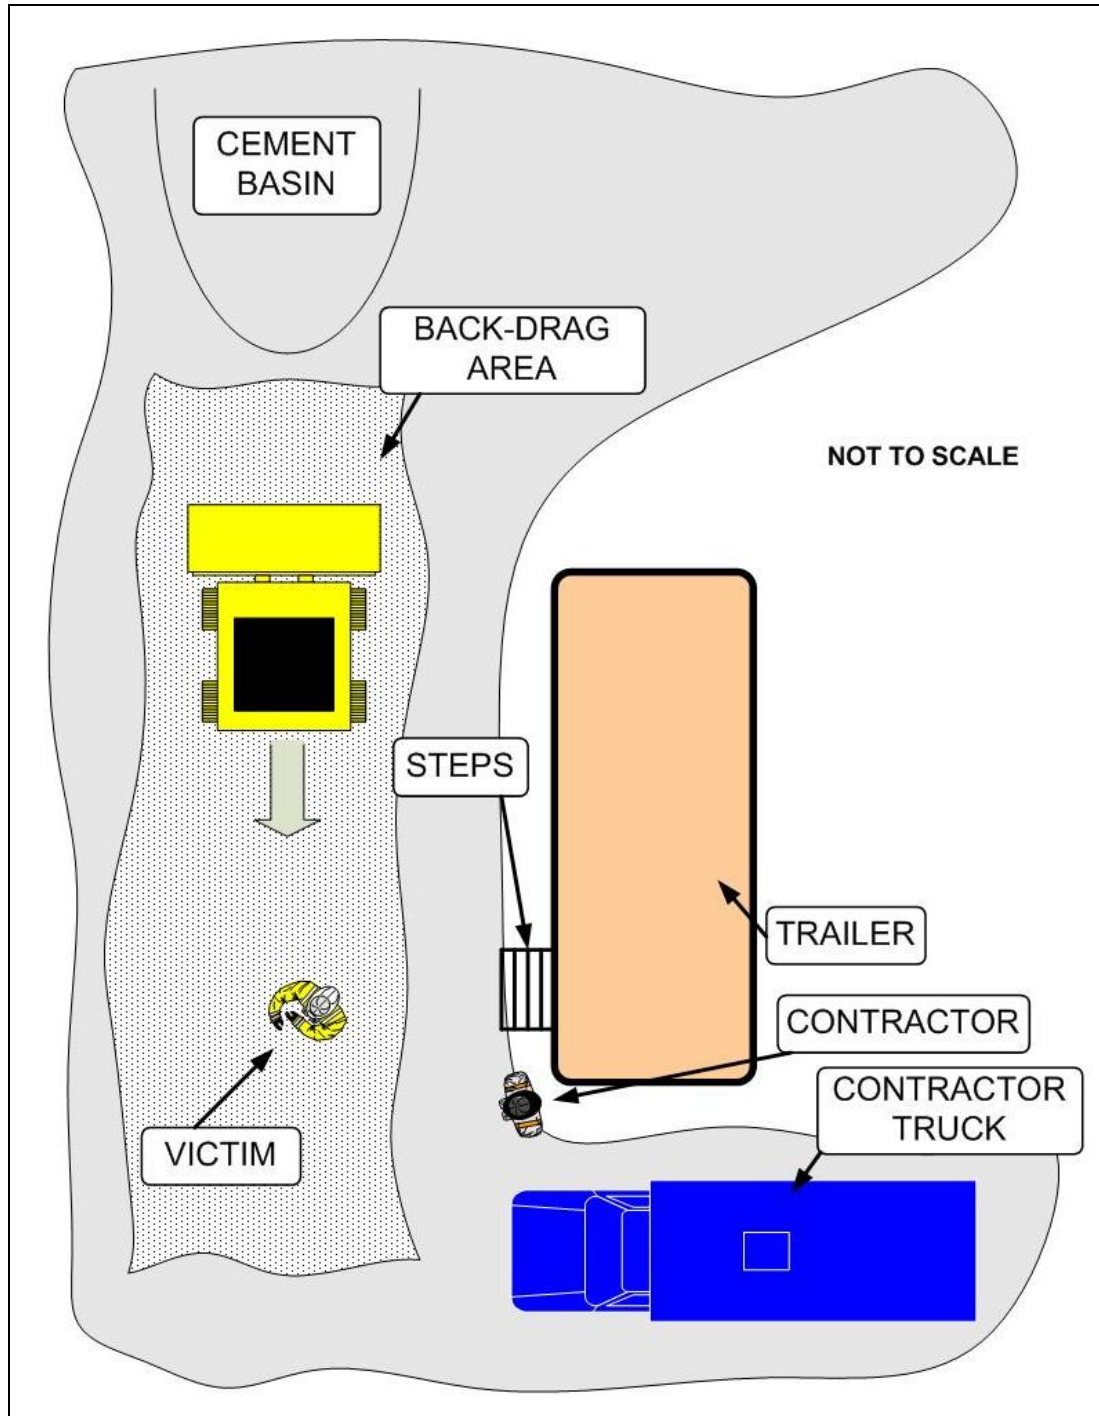
Diagram 1. Overhead View of Incident Site

The incident site was a commercial construction site where ready-mixed concrete and other concrete products were prepared and tested. Located on site was a worksite trailer where basic office work and radio dispatching occurred. There was a set of wooden stairs leading out of the worksite trailer onto an unpaved sidewalk which directed foot traffic away from the front of the trailer. Located directly in front of the worksite trailer was a 20 feet wide by 20 feet long section of gravel which was used to test patches of concrete prior to use (Diagram 1).

The fatality occurred just outside of the worksite trailer, on the gravel section used to test concrete, as the victim stepped into the path of the skid-steer loader as it was traveling in reverse (Diagram 1). The day of the incident, it was overcast and rainy.

Recommendation #1: Employers should install permanent barriers separating commonly used walkways from that of areas where heavy equipment is being operated.

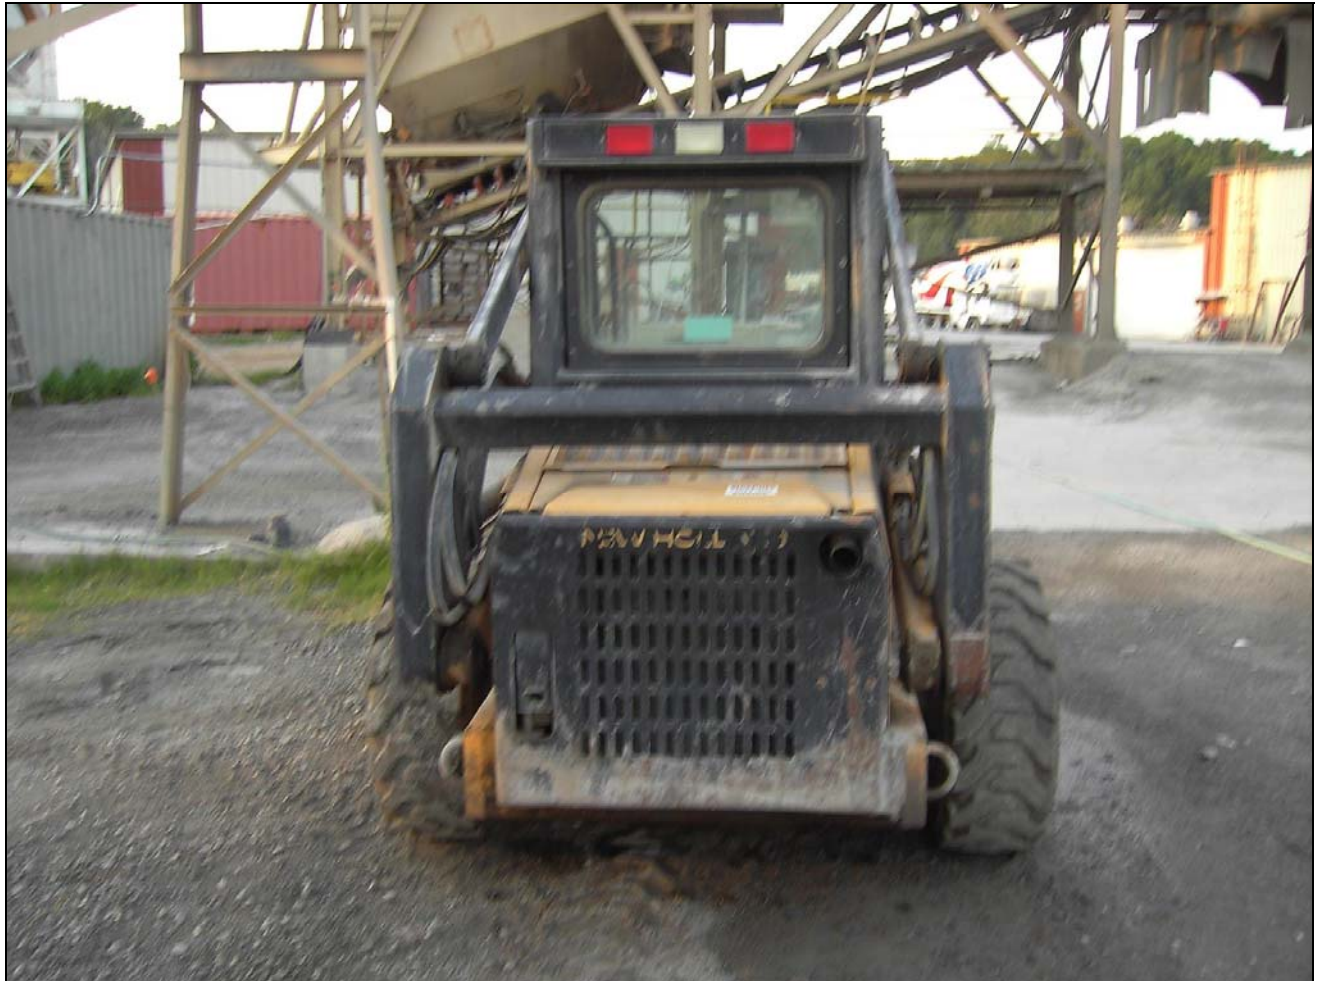
Photograph 1. This photograph illustrates the rear of the skid steer loader

The skid steer loader involved in this incident was purchased used approximately 6-8 years prior to the incident, and was used regularly. Safety equipment such as extended mirrors or backup alarms were not required because the machine had a large rear plexi-glass window (Photo 1). The compliance officer asked the employer to operate the machine and the employer reported the machine to be in good operating condition. Since the time of the workplace fatality, the skid-steer loader has been equipped with an audible backup alarm.

Discussion: The company installed an audible back-up alarm on the skid steer loader following this incident. Employers should consider installing after market electronic signaling devices or sensors on heavy mobile equipment, such as skid-steer loaders, to help monitor the presence of workers-on-foot within blind areas. Current research is investigating navigation and warning aids for mobile equipment in the mining and construction industry, and such collision warning systems could be used on heavy mobile equipment.^{5,6,7} Although such machines are frequently equipped with a large plexi-glass window, this requires diligence on the part of the operator to use proper backing procedures. In this case, the operator reported using the plexi-glass window and did not see the victim.

Recommendation #4: Employers should consider installing backup alarms and electronic sensors to warn heavy equipment operators of workers-on-foot in the immediate work area
