Fatality Assessment and Control Evaluation Program

**FACE Report Number 2005-08**

## ***Highway Construction Supervisor Dies After Being Backed Over By a Water Truck-South Carolina***

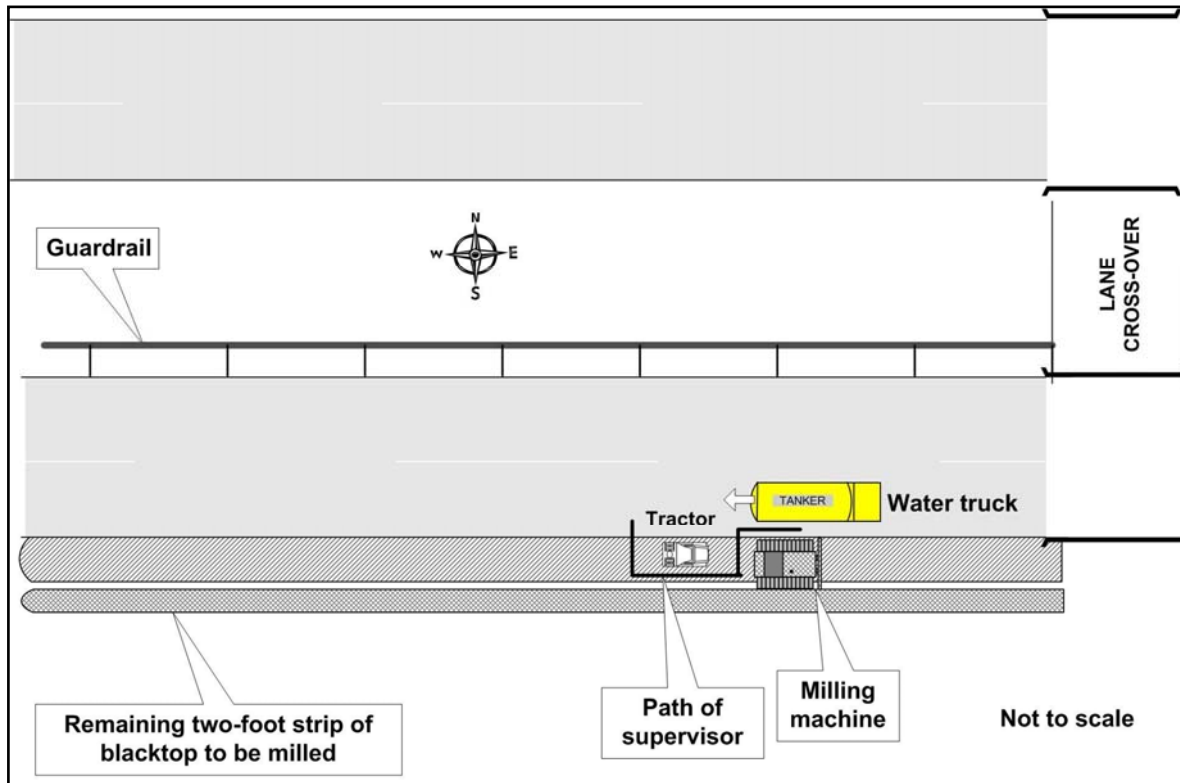
Diagram. Incident Scene

After the dump truck pulled out to transport the blacktop to the batch plant, the broom tractor pulled behind the milling machine. The water truck pulled into a location adjacent to the milling machine (Diagram). The supervisor hopped onto the passenger-side running board of the water truck to further discuss with the driver what they would do next. It could not be determined if the supervisor discussed with the water truck driver whether to back his truck to the starting point or to use a lane crossover in the highway less than a quarter mile down the highway, east of the machinery. The supervisor then hopped down from the running board and walked around the tractor into the path of the backing water truck (Diagram). It is unknown why the supervisor traveled the path he did. The supervisor was backed over by the two rear axles of the water truck. The broom tractor operator saw what happened and jumped onto the running board to tell the driver to stop. The supervisor was pulled out from underneath the water truck and 911 was called from a cell phone. He was breathing and vital signs could be detected. When 911 arrived approximately 15 minutes later, they transported the supervisor to the hospital where he was pronounced dead by the attending physician.
