Fatality Assessment and Control Evaluation Program

FACE Report Number 2006-05

## ***Equipment Operator Dies From Burns After a Hydraulic Line Burst on a Bulldozer and Sprayed Hydraulic Fluid Across the Exhaust Manifold – Tennessee***

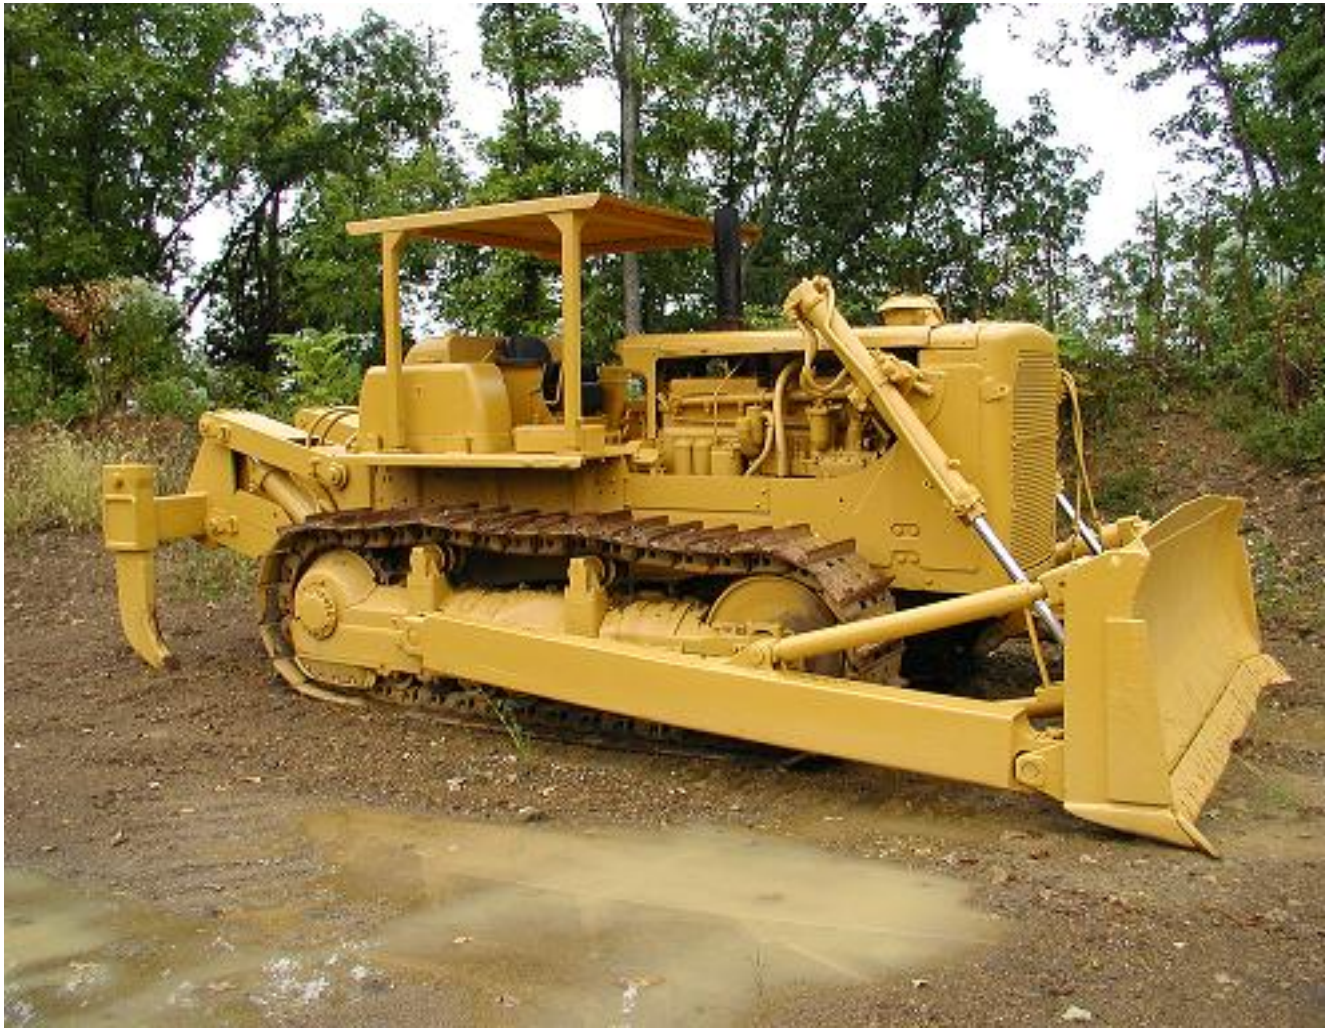
**Equipment:** The bulldozer involved in this incident was purchased new in 1966. The bulldozer was used to push and carry dirt and shale at the fill-dirt site. The bulldozer was equipped with a universal blade on the front (Photo 1).

During operation of the bulldozer, a fire ignited between the engine compartment and the cab. According to TOSHA, the fuel source was identified as the bulldozer's hydraulic system oil. The hose assembly span was approximately ten inches from the engine compartment to the lift cylinder tube assembly. This hose failed and subsequently the hydraulic oil was forced out across the exhaust manifold.

**Photo 1. Photo of bulldozer after being refurbished and receiving the necessary service modification.**

Following this incident, the bulldozer was sent to the local equipment manufacturer to be refurbished and to receive the necessary service modification.

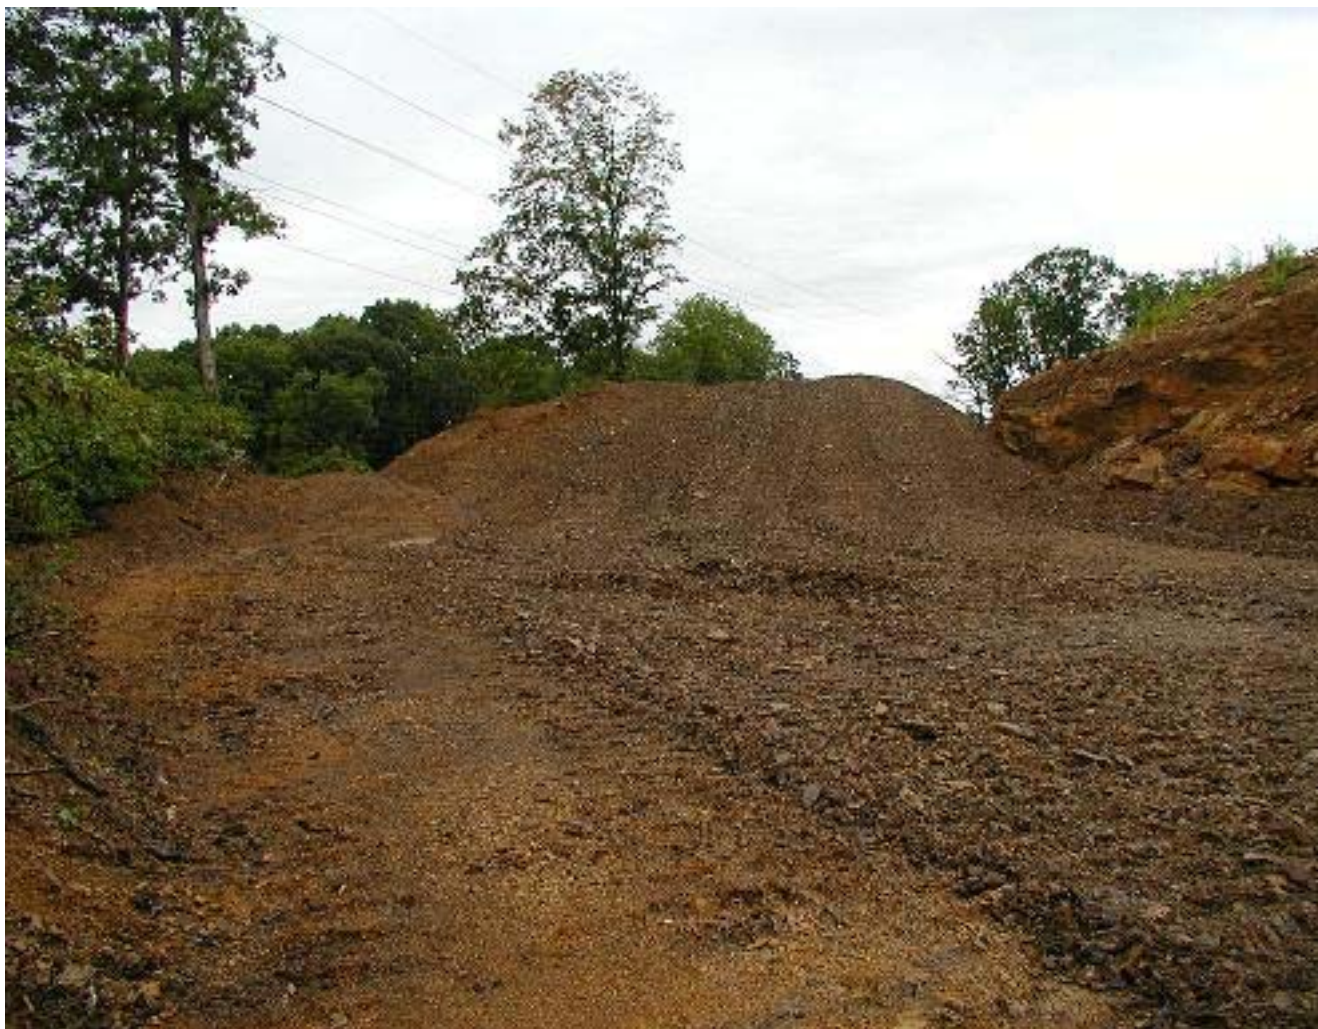
**Photo 2. Photo of the incident site.**
