FACE Report Number 2007-03

June 29, 2007

Company Owner Dies From Fall After Upper Boom Failure On Aerial Lift - Ohio**SUMMARY**

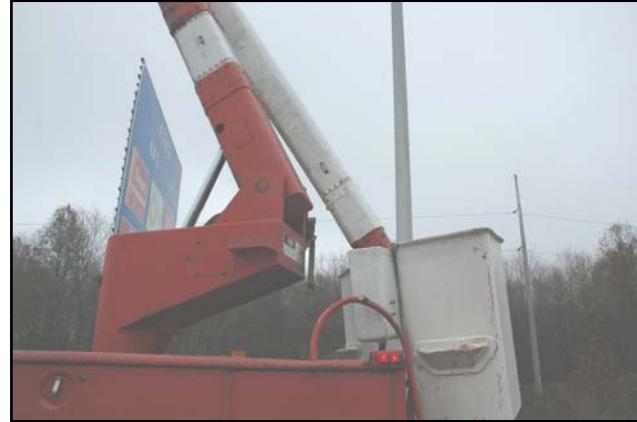
On November 8, 2006, a 45 year-old owner of an electrical contracting company (the victim) died after falling approximately 9 feet to the road surface after the articulating boom of the aerial lift truck he was working from collapsed (photo 1). The victim, working at a height of approximately 35 feet, was changing light bulbs on overhead streetlights along a state highway. After replacing a bulb, the victim began lowering the boom. The upper boom actuating chain connecting the upper and lower boom sections broke and the upper section fell, striking the truck bed and ejecting the victim from the bucket. The victim struck his head and neck on the truck bed before landing on the road surface. A co-worker (the victim's son), who witnessed the collapse from the ground, determined that the victim was unresponsive and began resuscitation efforts. A passing motorist called emergency medical service (EMS) personnel. The victim was transported to a local emergency department where he was pronounced dead.

Photo 1: Aerial lift boom after incident. Note that the lower boom section remains elevated while the bucket-end of upper section is in a lowered position (photo courtesy of OSHA).

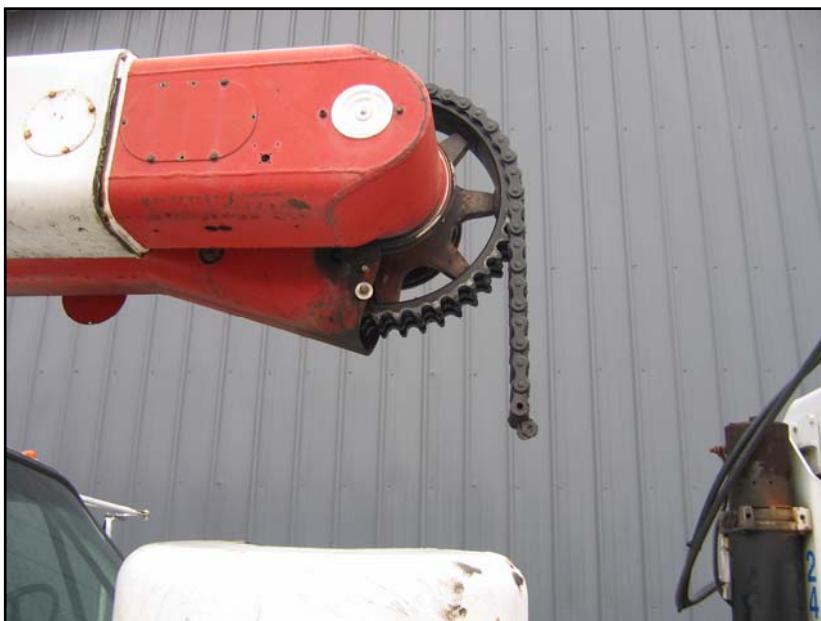
Photo 2: Broken boom actuating chain
(photo courtesy of OSHA).

The victim had just finished changing out a light bulb and started to lower the boom when the boom actuating chain connecting the upper and lower boom sections broke (photo 2) and the upper boom and bucket fell onto the truck.

Company records documented periodic maintenance on the engine and chassis components of the truck, but no records were available to support an ongoing maintenance program for the articulating boom. Post incident inspection of the articulating boom revealed that the boom actuating chain had separated resulting in the catastrophic collapse of the upper boom.

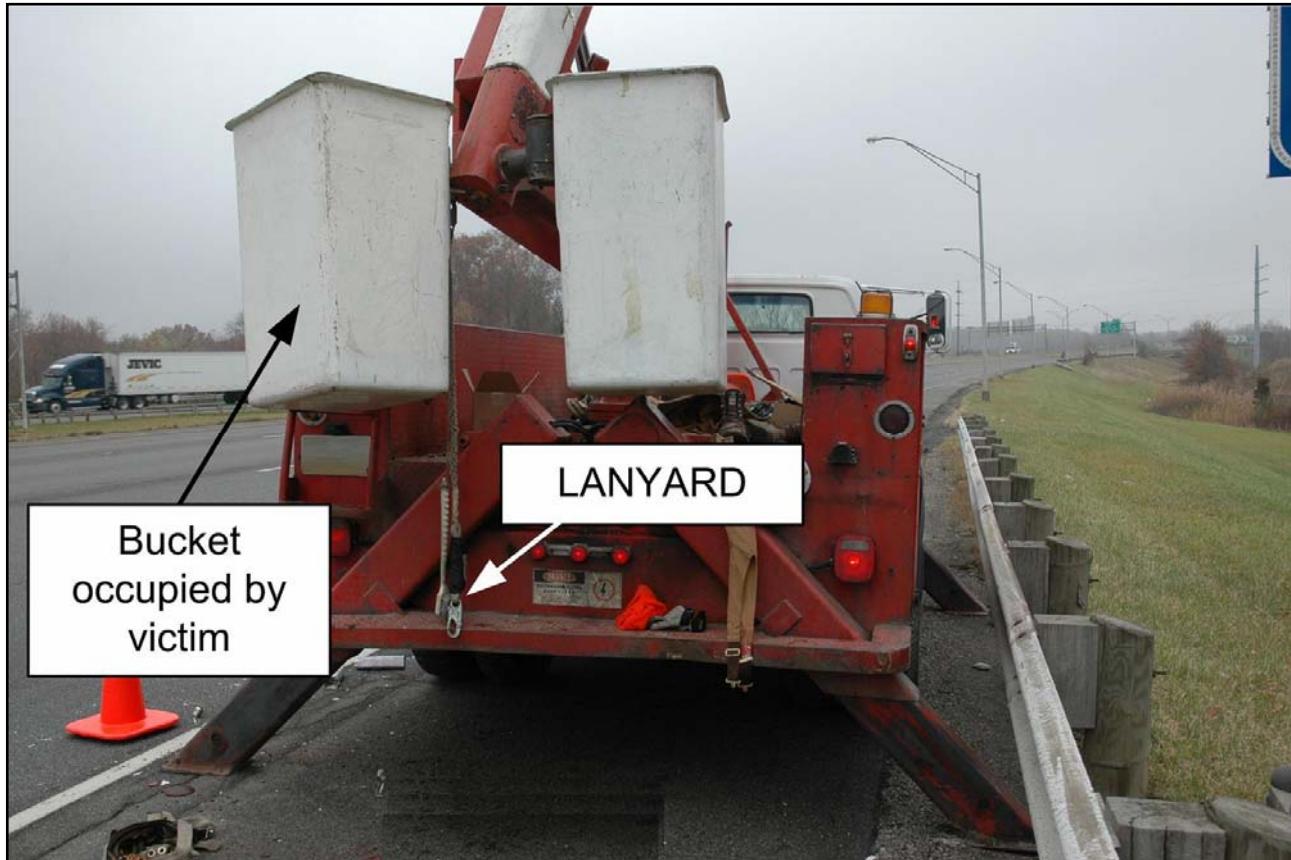
bed (photo 3). The boom fell slightly off center from the saddle that secured the boom during travel. The bucket in which the victim was standing struck the back left (driver's) side of the truck, striking the ladder that provided access to the truck bed. The impact broke the metal mounting bracket that attached the bucket to the boom tip causing the bucket to rotate away from the boom. The victim was thrown from the bucket, striking the back of his head and neck on the truck before coming to rest on the road surface. The six-foot lanyard did not prevent the victim from striking the truck as the distance from the lanyard's anchorage point to truck bed was less than six feet (photo 3). A co-worker (the victim's son), who witnessed the collapse from the ground, determined that the victim was unresponsive and began resuscitation efforts. A passing motorist witnessed the boom collapse and phoned 911 at 11:03 a.m. EMS personnel arrived at 11:07 a.m. and the victim was transported by ambulance to a local emergency department where he was pronounced dead.

Photo 3. Photo of upper boom showing dual buckets and lanyard (photo courtesy of OSHA).

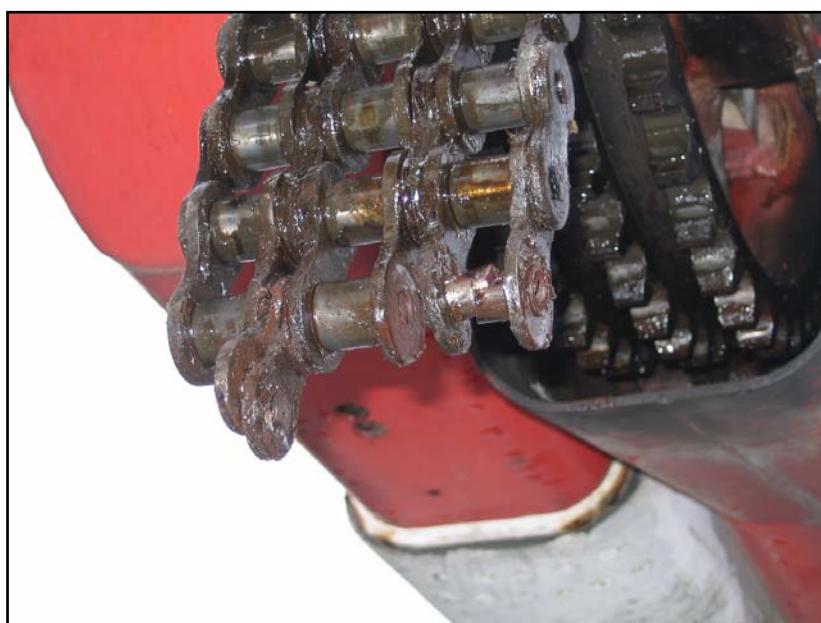
roller chains, to include the upper boom actuating chain, be lubricated at 30 day intervals using recommended penetrating oils.² A warning was contained in the manual which stated: "Lack of lubrication, by causing galling and corrosion of the chain pins, can cause breakage of the pins, with resulting free fall of the upper boom, or tipping of the buckets." FACE investigators were not able to examine the aerial lift or broken chain. However, close examination of photos of the broken chain links and roller pins revealed a dull reddish brown discoloration near the fracture area indicating a lack of lubrication and corrosion (photo 4).

**Photo 4: Broken section of boom actuating chain
(photo courtesy of OSHA).**

Recommendation #2: *Employers should strictly adhere to the manufacturers' recommendations for maintenance and lubrication of aerial lift operating mechanisms.*

Recommendation #3: Employers should ensure that qualified repair personnel conduct regular maintenance and inspections of aerial lifts.
