FACE Report Number 2007-01

May 31, 2007

***Hispanic Laborer Dies after Falling through a Second Story Floor Opening in a Single Family Home under Construction --North Carolina*****SUMMARY**

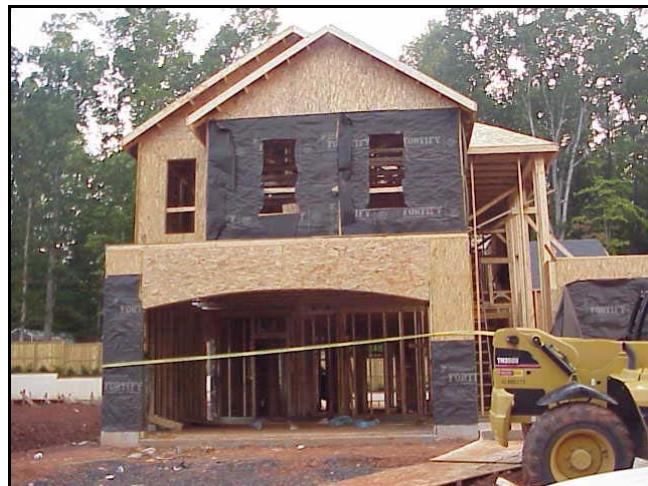
Photo 1: This photograph illustrates the two-story home that workers were framing when the incident occurred

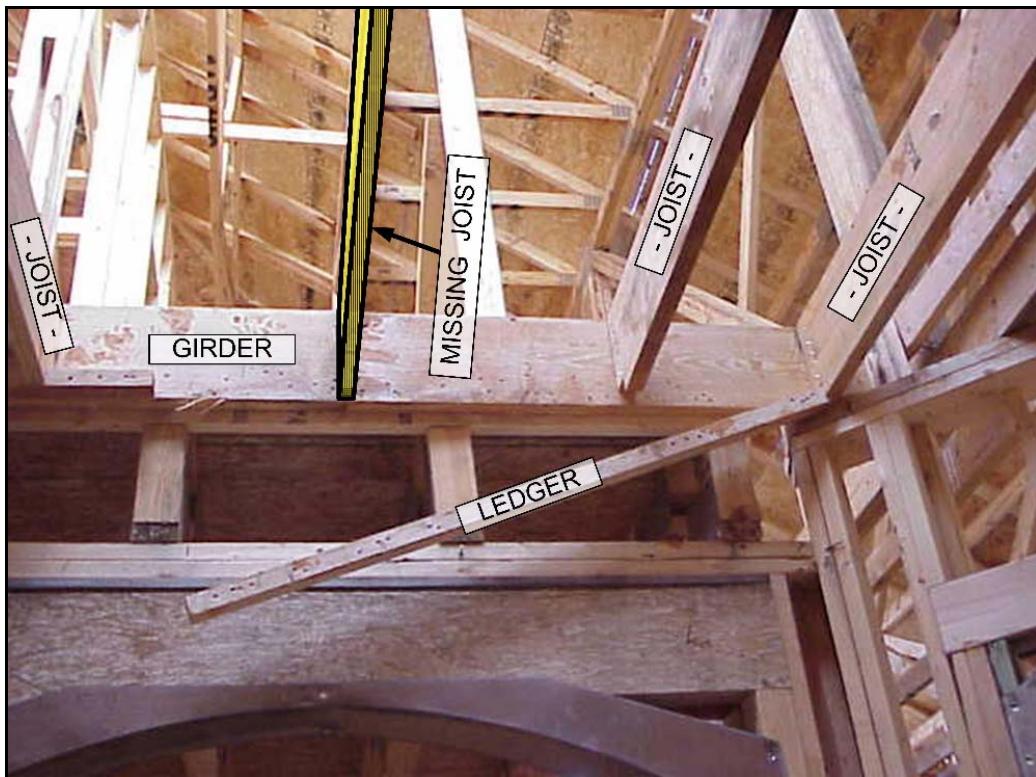
The NCDOL/OSH compliance officer assigned to the case inspected the site the day following the incident and took photographs. He reported that it appeared that when the victim, who was not protected against falling, fell through the joist openings, his body struck one of the joists

causing it to fall with him. He also reported that the ledger used to support the joist and the joist nailing appeared to be substandard; the ledger (Photo 2) had separated from the floor framing (girder) to which it was nailed, eliminating the support to the joist that failed. The NCDOL/OSH compliance officer inspected the ledger and the joists and noted that they were fastened with 8d versus 16d nails. 8d nails are 2 1/2 inches long versus 3 1/2 inches long for the 16d nails. The joist appeared to be adequately nailed at one end but at the other end, the nails just barely exited the joist and provided little support (Photo 3). The NCDOL/OSH compliance officer reported that although the nonstandard joist and ledger nailing could have contributed to the incident, the primary cause of the incident was walking onto unsecured plywood used to deck floor openings in the walk-in closet without wearing any fall protection.

Photo 2: This photo illustrates where the ledger separated from the girder to which it was nailed and illustrates the location where the worker fell through. Note the missing joist. (Photo courtesy of NCDOL/OSH).

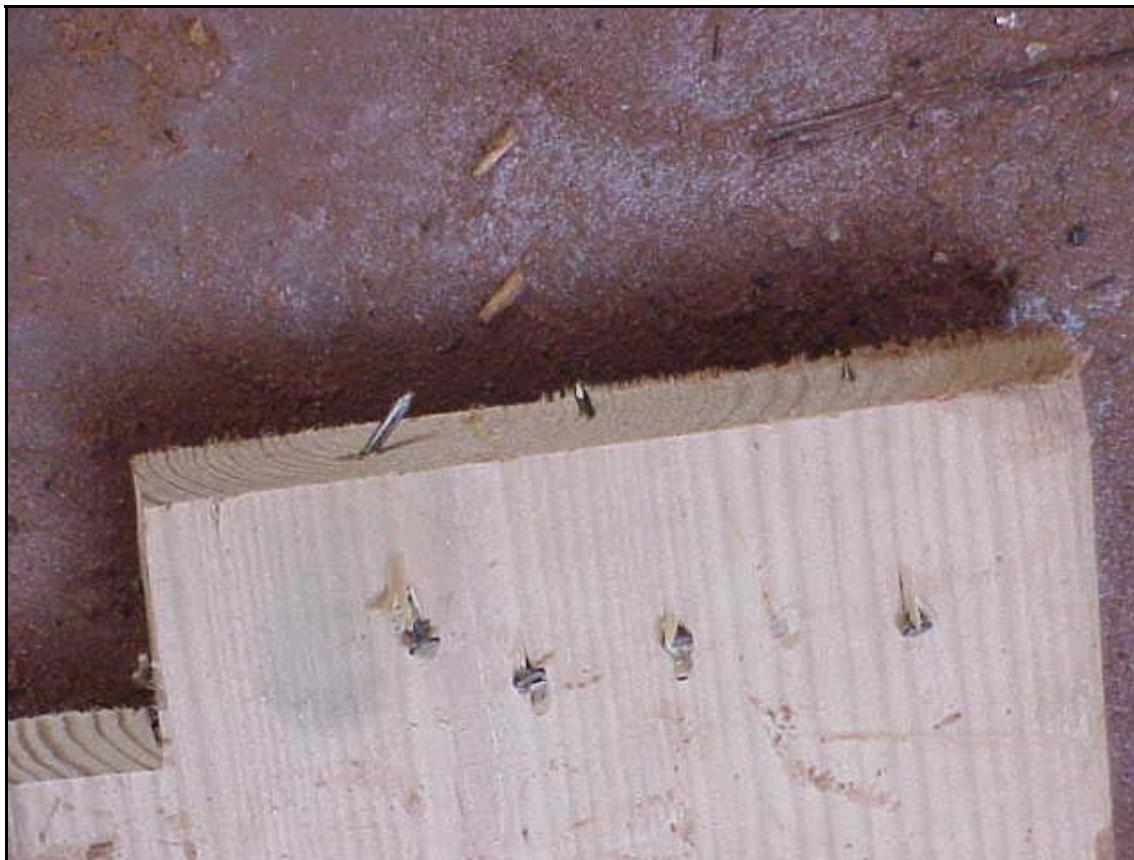
Photo 3: This photo illustrates the 8d nail placement on one end of the joist that failed (Photo courtesy of NCDOL/OSH).

During the FACE investigation, the DSR investigator, NCDOL/OSH compliance officer, general contractor's safety officer, victim's employer and the victim's supervisor, viewed photographs of the incident that had been taken after the victim's fall. The floor joists under the walk-in closet in the attic space were placed 24-inches on center and had been notched at one end and placed over a 2-inch by 1 1/2 inch ledger that had been nailed in place using 8d nails. These 8d nails are used on the roof sheathing where the plywood is 1/4 inch to 1/2 inch thick. According to the general contractor's safety officer, the victim's employer and his supervisor, workers had run out of 16d nails at the site on the day of the incident and used the 8d nails instead because they were available. The general contractor's safety officer reported that the 8d nails were too short for floor decking but were on-site for roof sheathing. The DSR investigator noted that the 8d nails, in addition to being too short for the job, were nailed at an angle and not evenly placed, making them even less likely to hold. Both sizes of nails fit the pneumatic nail guns used at the site.

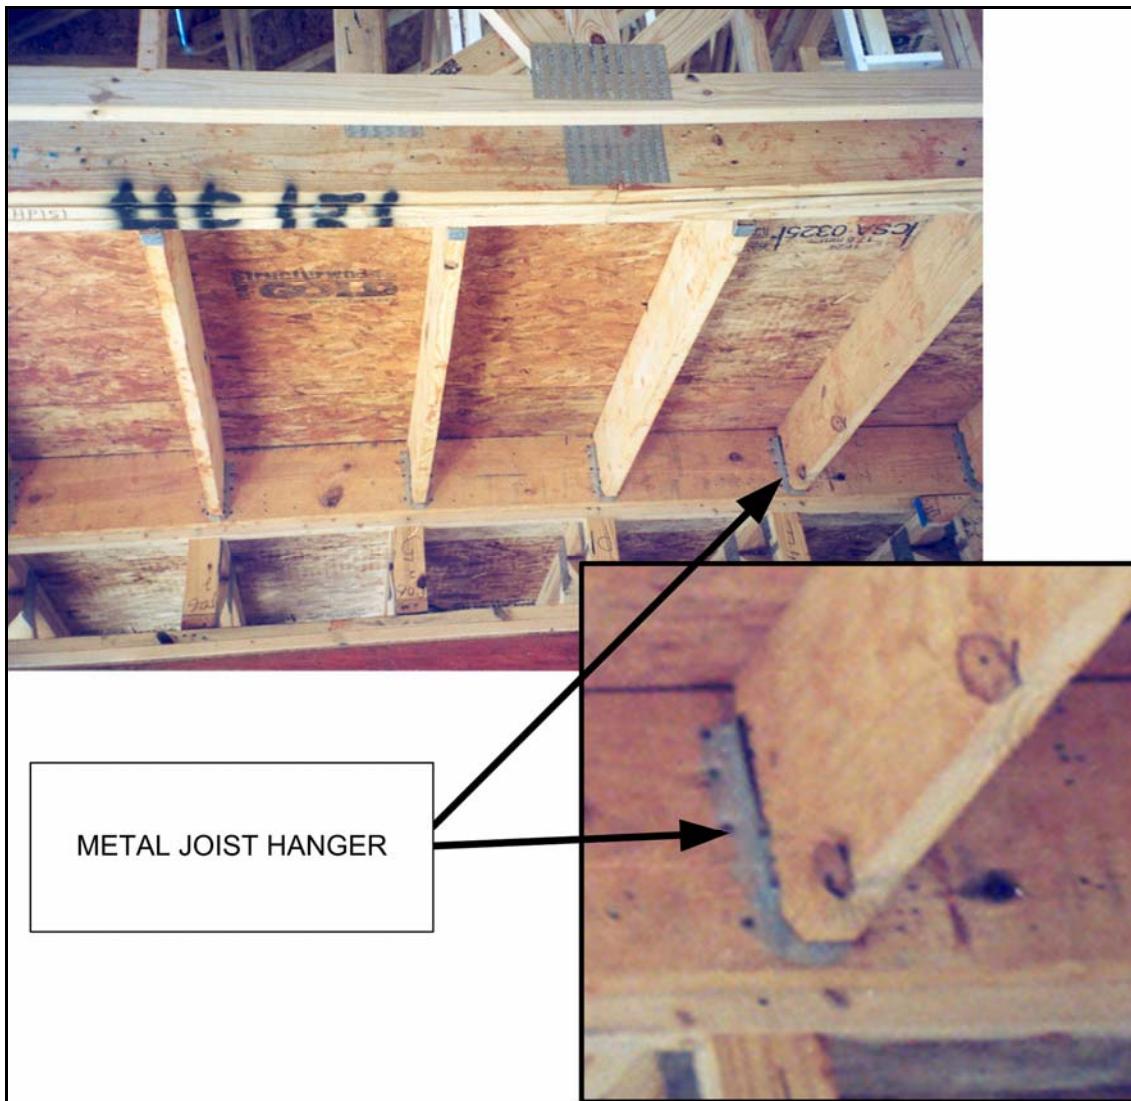
Photo 4: This photo illustrates the use of metal joist hangers (see arrow) and was taken by the DSR investigator on another house under construction at the site.

Following the incident, the general contractor chose to require the use of metal joist hangers (Photo 4) instead of wooden ledgers for hanging floor joists. The general contractor determined that although joist hangers are more expensive, they are more efficient and require less skill to install, and can be nailed in place using either 8d or 16d nails.
