## ***Laborer Dies When a Water Truck Drifts Downhill and Pins Him Against a Retaining Wall – Tennessee***

### **SUMMARY**

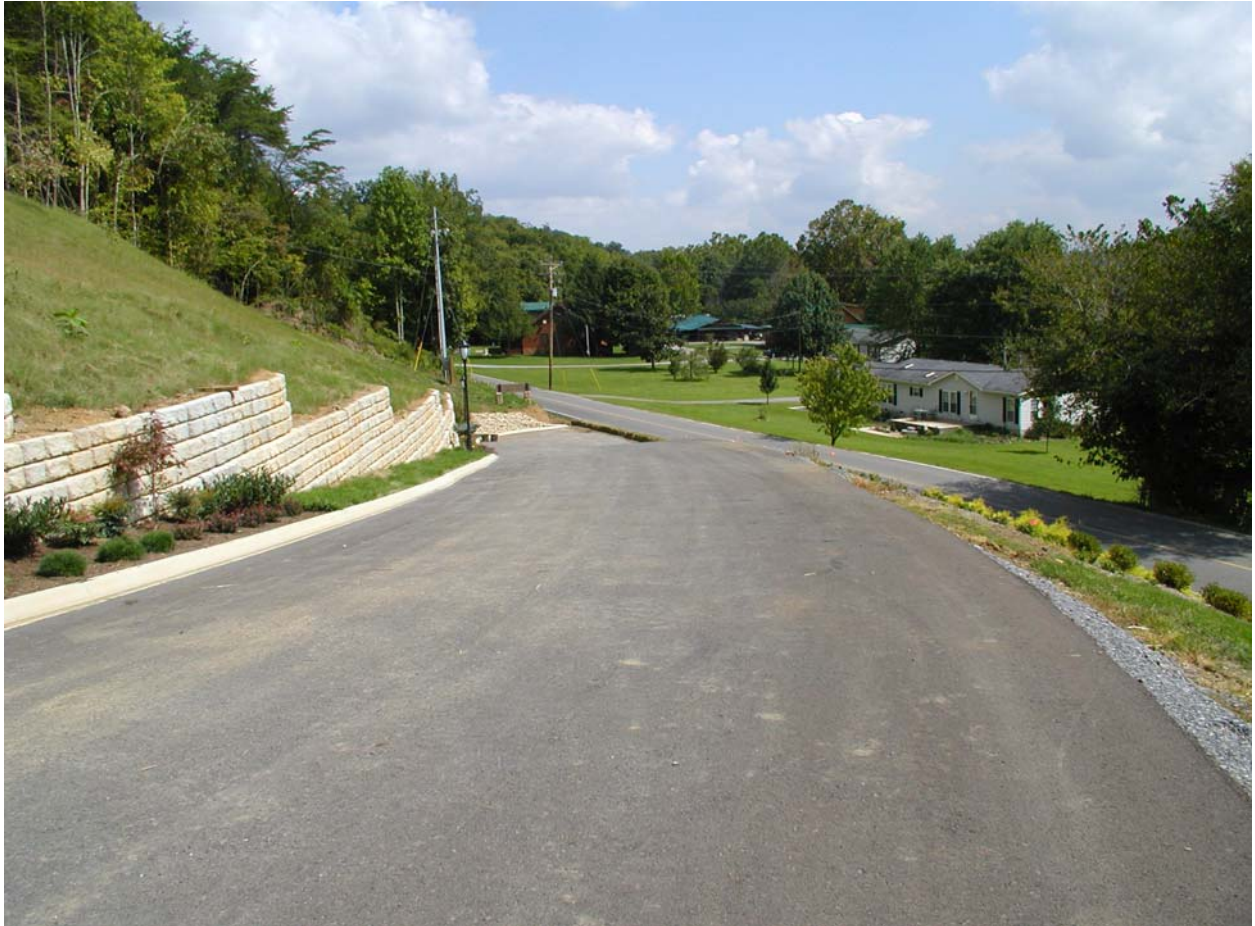
The incident occurred at a residential construction site. Work began on the 400-acre site in February 2006. The residential construction site was owned by a family member of the employer. The incident occurred at the entrance of the site where the victim was cleaning a retaining wall (Photo 1). The masonry retaining wall was multi-level, varied in height and was approximately 300 feet in length. The entrance road located beside the retaining wall where the truck was parked had a 12-percent down grade and at the time of the incident the road was compressed dirt and gravel.

**Photo 1. Photo of the Entrance Road and Retaining Wall 3 Months After the Incident.**

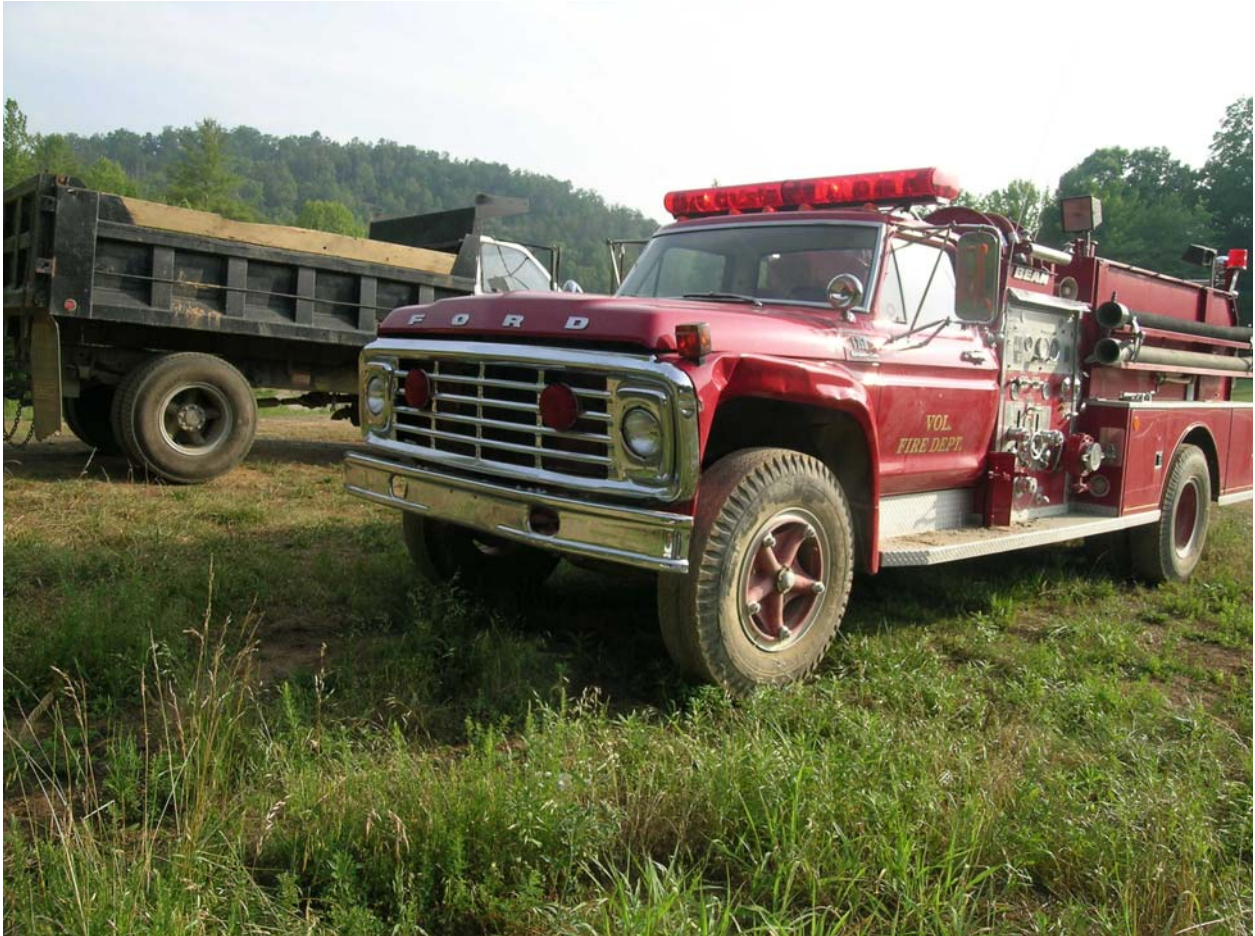
The water truck involved in this incident was a 1975, used fire engine pumper, with a 5-speed manual transmission, that had been previously owned by a volunteer fire department. (Photo 2). The truck was purchased to be used as a water truck on the construction site by the owner of the residential construction site in March 2006.

Following this incident, the TOSHA compliance officer attempted to check the parking brake on the truck, however she was unable to do this due to the ignition of the truck being inoperable. The NIOSH investigator was unable to view the water truck due to weather issues and the truck's unsafe location. According to a written statement provided by the chief of the volunteer fire department, the truck was in service until the date of purchase and there was no indication of any service issues. According to the employer, prior to this incident the truck has been used at other areas on the residential construction site on two separate occasions without incident.

**Photo 2. Photo of the Water Truck. [Photograph courtesy of the TOSHA].**

Companies should require that chocks be used as a standard operational procedure when parking any construction motor vehicle, especially on an incline. To prevent downhill movement of the water truck in this incident, wheel chocks should have been placed squarely against and installed on tires downhill from the truck's center of gravity (i.e. on the front axle tires) and placed squarely against the tires.

According to the victim's employer, wheel chocks were purchased following this incident and are now kept on the water truck at all times. Additionally, workers were notified that they are now required to use the wheel chocks anytime the water truck is parked.
