FACE Report Number 2005-09

February 12, 2007

Operator Dies From Crushing Injuries After Being Pinned Between a Track Drill Control Console and Exterior Wall of Courthouse – Tennessee

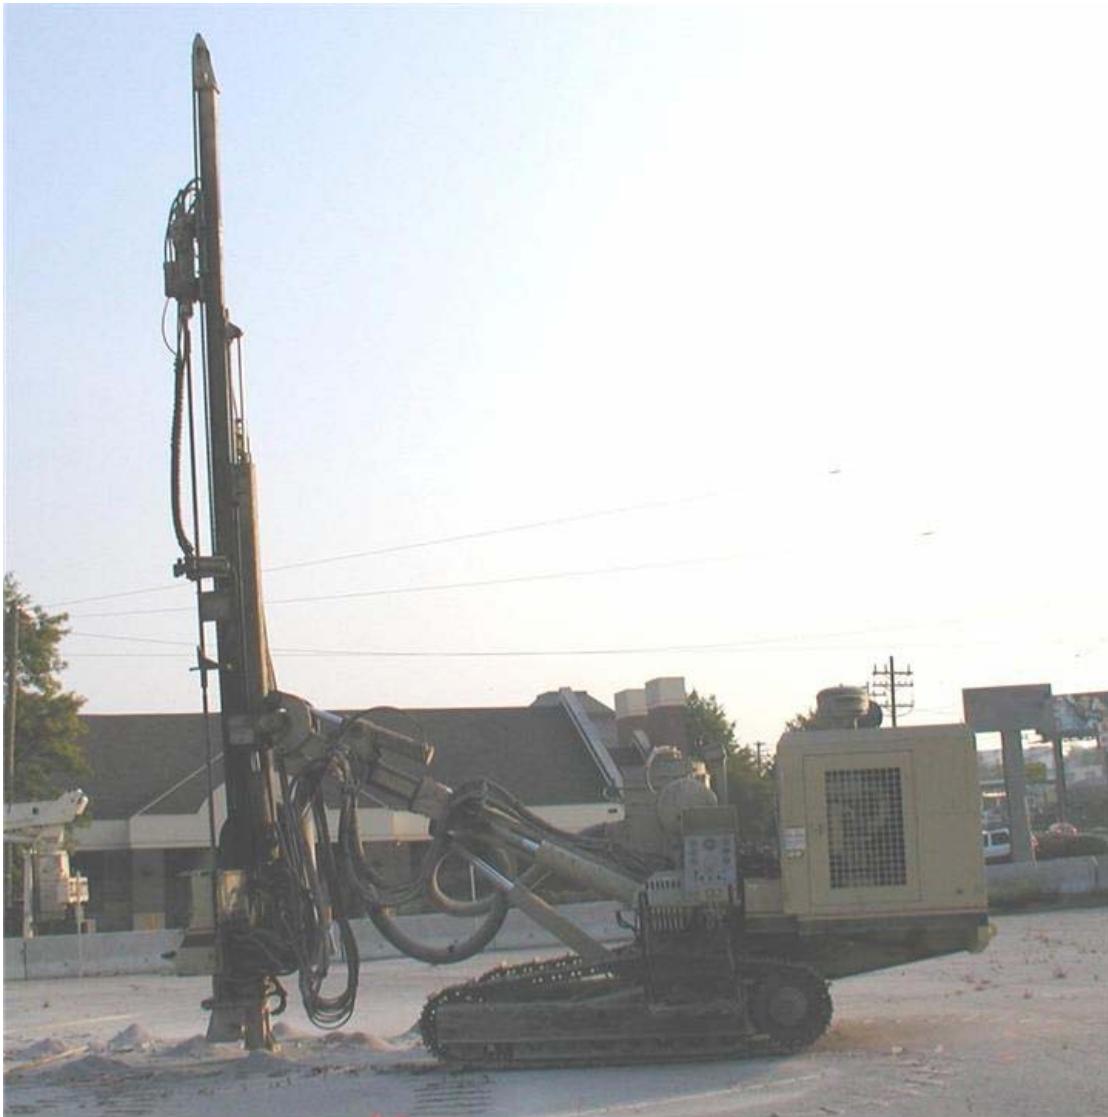
Photo 1. Photo of track drill.

Equipment: The track drill involved in this incident was a hydraulic track-mounted, self contained deck-engine-powered percussive drill, designed for construction and quarry applications (Photo 1). The track drill used a diesel engine coupled directly to a hydraulic pump, and an excavator type undercarriage. Two consoles operated the track driller; a main control console and a drill control console. The main control console was located on the side of the drill's frame, was used to tram the drill into position, and contained all necessary start-up switches and engine monitoring gauges (Photo 2). The main control console also included a hydraulic valve bank that could be used for boom and drill guide positioning. The drill control console was mounted on, and moved with the drill boom guide, allowing optimal operator visibility of the hole collar (Photo 3 and Photo 4). The drill boom and guide featured a hydraulically driven drifter and hydraulic drill feed systems. The drill control console contained the feed and rotation controls and gauges, dust collector and water injection controls, automatic rod changer controls, emergency stop button, blow control lever and blow air pressure gauge, dust collector, and the centralizer control. The drill control console could be rotated counter clockwise sideways up to 80 degrees by removing a pin and then selecting one of the three locking slots, which allows the console to be repositioned (Photo 4). All the control levers on the track drill were self-centering.

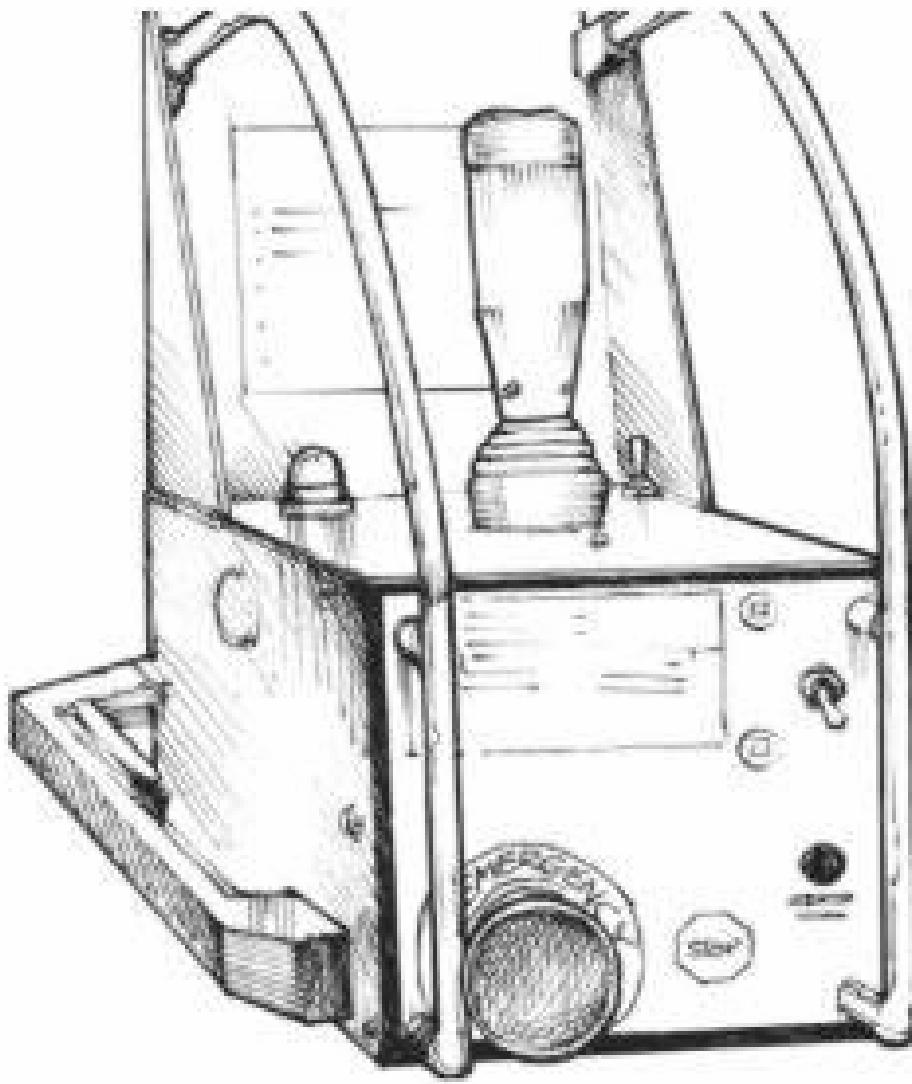
Figure. Example of guarded controls. Courtesy of
Workers' Compensation Board of British Columbia,
Richmond, B.C., Canada. WorkSafeBC.com

Recommendation #3: Equipment designers and manufacturers should consider adding equipment control guards to prevent the inadvertent operation of equipment controls.

Discussion: Control guards are safety features designed to prevent the inadvertent operation of equipment controls, levers, switches, buttons and similar control devices (Figure).³ Smaller controls such as switches and buttons can be covered to prevent accidentally bumping or pressing these controls. Larger controls such as levers may require bars or specially designed guards to limit access to the levers. Alternatively, mechanical stops such as removable pins or blocks can be used to limit movement of the lever until the operator is ready to activate the control(s).

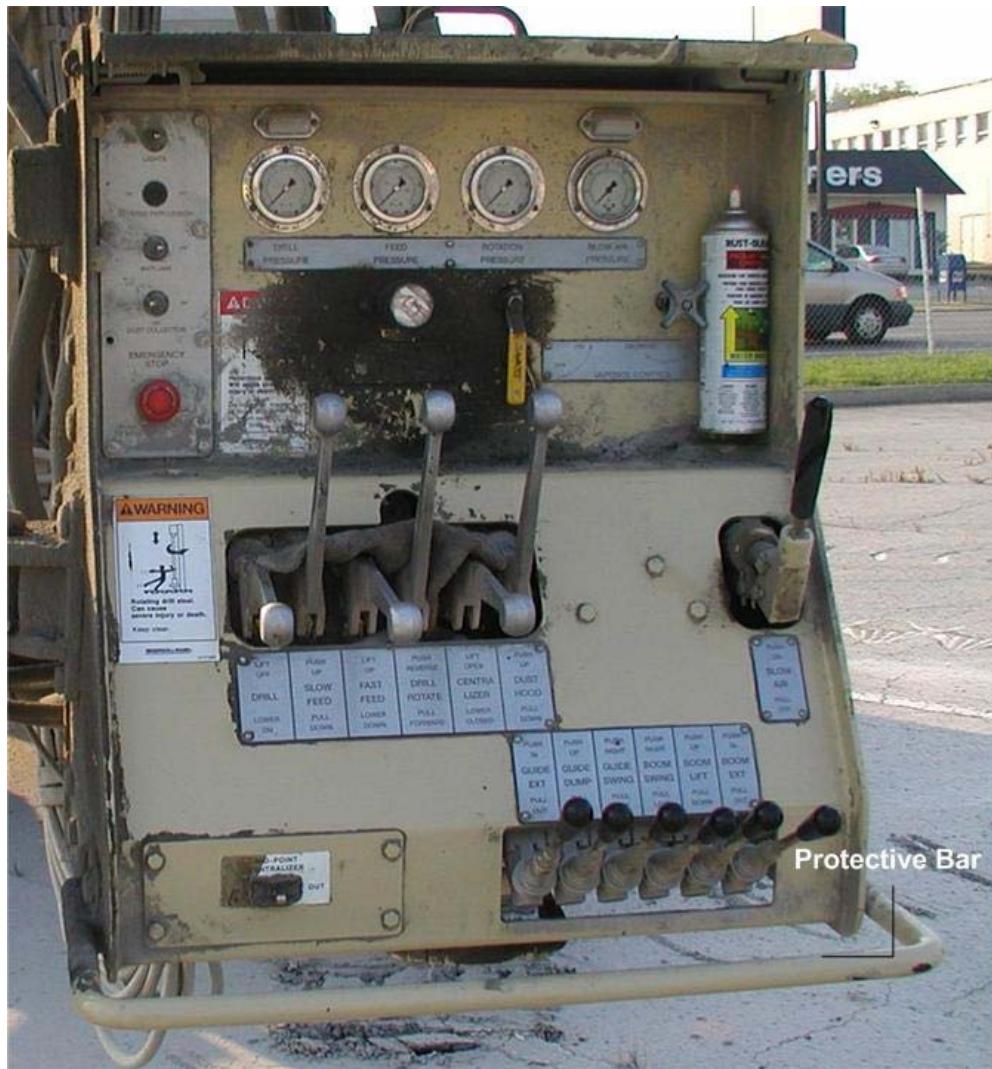
Photo 3. Photo of drill control console.

Discussion: The drill control console featured a protective bar around the lower portion of the control panel intended as a guard to keep the operator from getting too close to the drill guide assembly and also to protect the control panel. There were no interlock devices installed on the protective bar around the lower portion of the drill control panel. An interlock system is especially important in cases where a equipment operator is working in close proximity. In this case, an interlock device mounted on the protective bar and connected to the equipment's operating controls would have automatically shut down the operation when the protective bar received a certain amount of exterior pressure. This bar could be re-designed to include a toggle switch interlocked with the emergency stop switch so that pressing against the bar would de-energize the machine. Such a re-design would produce an easy to activate "panic bar" that could be activated from any direction around the drill control console and may have been able to prevent this fatality (Photo 3).

Recommendation #4: Equipment designers and manufacturers should consider including an interlock device (panic bar) to automatically shut down energy when pressure is applied to the protective bar on the drill control console.

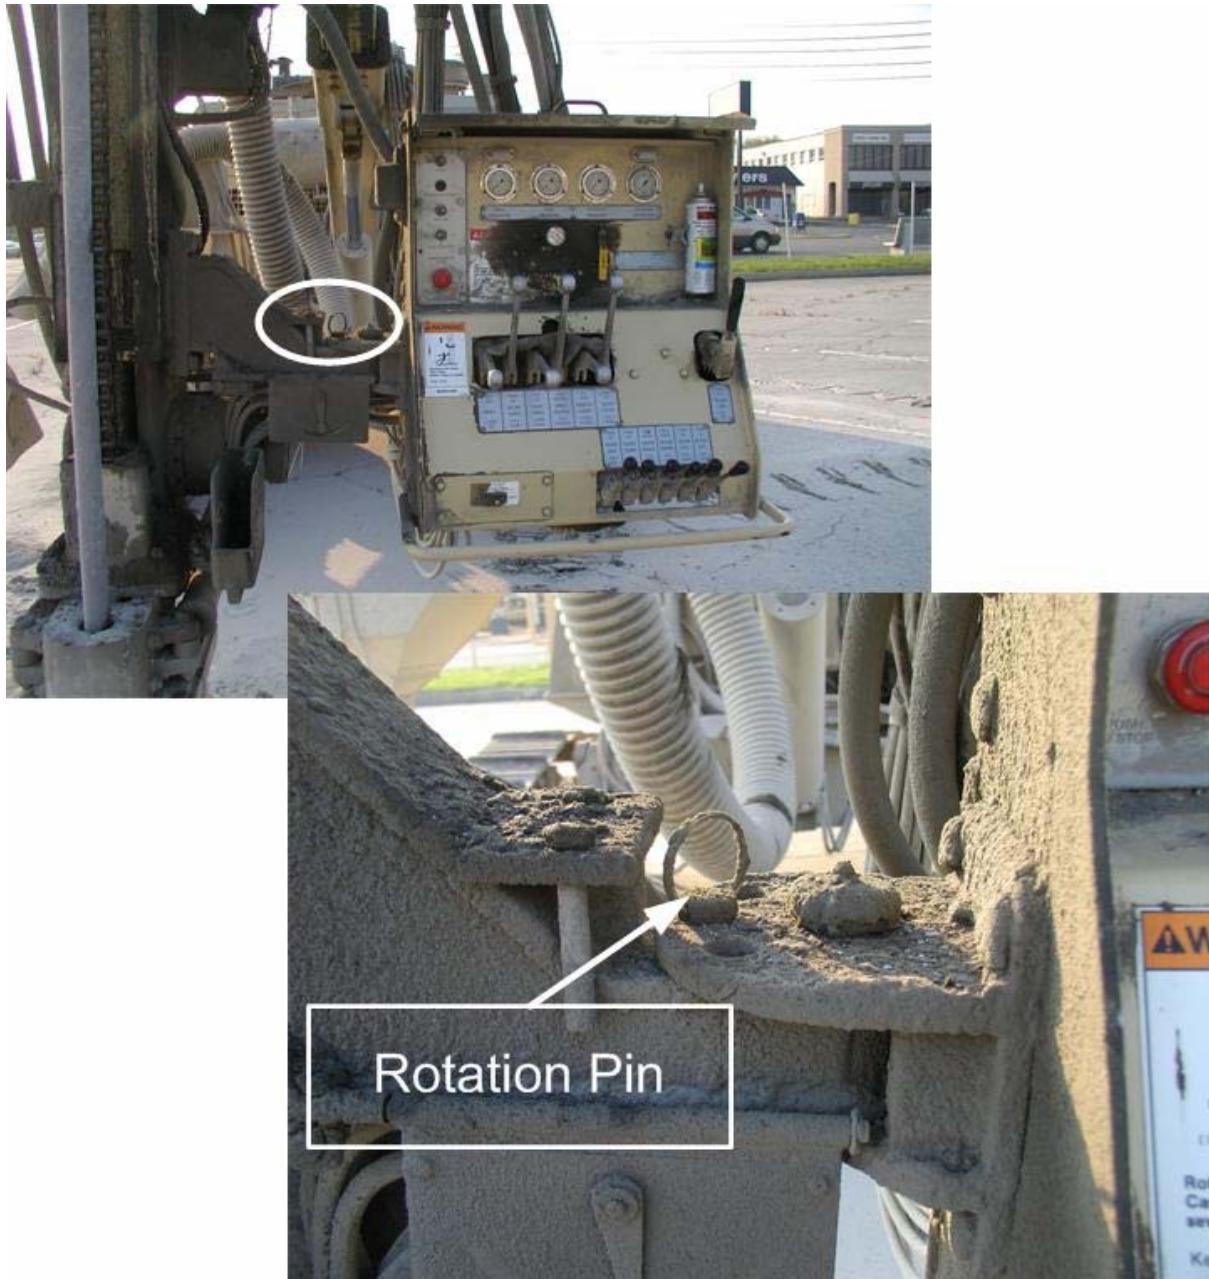
Photo 4. Photo of rotation function of drill control console.

himself between the exterior wall and driller's console while drilling holes in the ground. The drill control console could have been rotated sideways up to 80 degrees, which would have allowed the driller's console to be repositioned, therefore affording the operator more working space.

where the operator should not place hands, arms, etc., but did not warn against the hazard of being caught between the machine and a wall, barrier or other solid object. Also, the drill control console was mounted on a bracket that afforded the ability to rotate the control panel up to 80 degrees horizontally. However, the manufacturer's instruction manual does not make mention of this feature. The victim could have provided himself more room to work in by rotating the control panel to the right (away from the building). The state service support manager representative from the track drill manufacturer stated that the representative demonstrates the drill features for the employees at the time of purchase and during this time normally shows the rotation feature of the drill control console. The utility and importance of this feature plus the appropriate safety warnings in the instruction manual as well as warning labels on the machine should be highlighted to address the hazard of being caught between the machine and another stationary object.

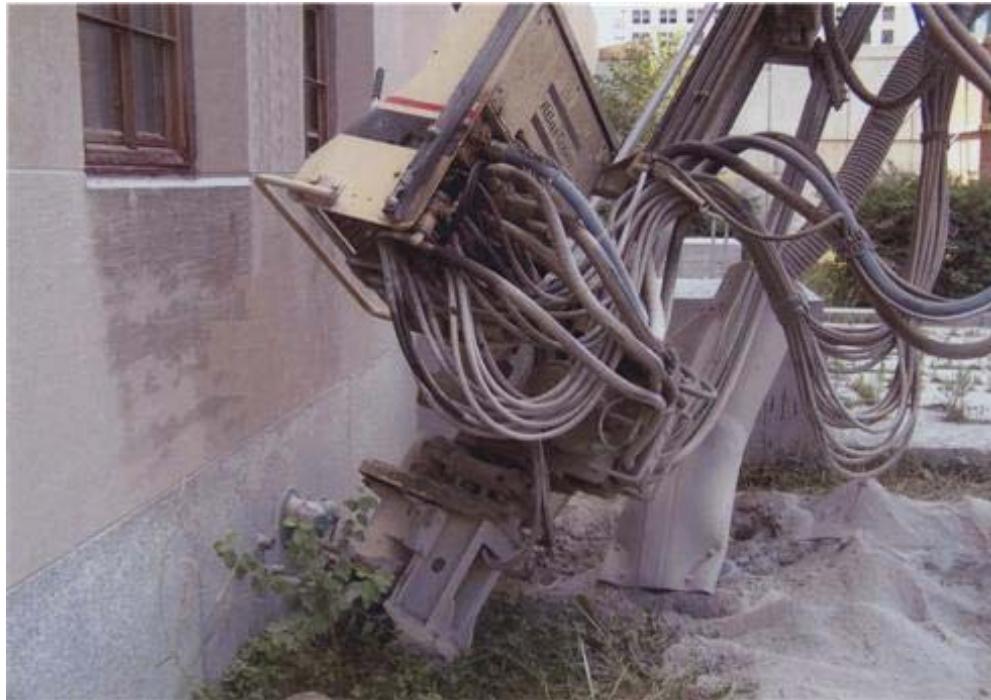
The track drill operator (victim), dump truck operator, two track hoe operators, and three laborers arrived on site at approximately 6:30 a.m. on the day of the incident. There were markings on the ground which indicated that two parallel rows of four holes needed to be drilled. The holes to be drilled were approximately two feet out from the exterior wall of the courthouse. The victim trammed the drill so it faced the courthouse's exterior wall, then positioned himself with his back to the exterior wall and the drill control console in front of him. While sandwiching himself between the exterior wall and drill control console, he operated the boom drill and began drilling holes in the ground. While drilling the fourth hole, it is believed that the victim inadvertently operated the boom extension control in such a way that he pinned himself between the drill control console and the exterior wall (Photo 5).

It is theorized that the victim, while attempting to drill the fifth hole, may have tripped over the wall fire hydrant and inadvertently activated the controls causing the boom to extend and pin him between the control console and the courthouse wall.

Photo 5. Photo of incident scene. Photograph courtesy of TOSHA.

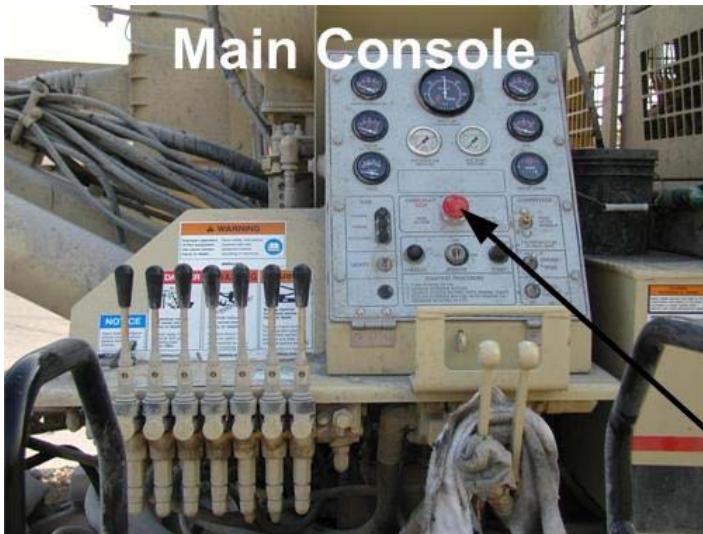
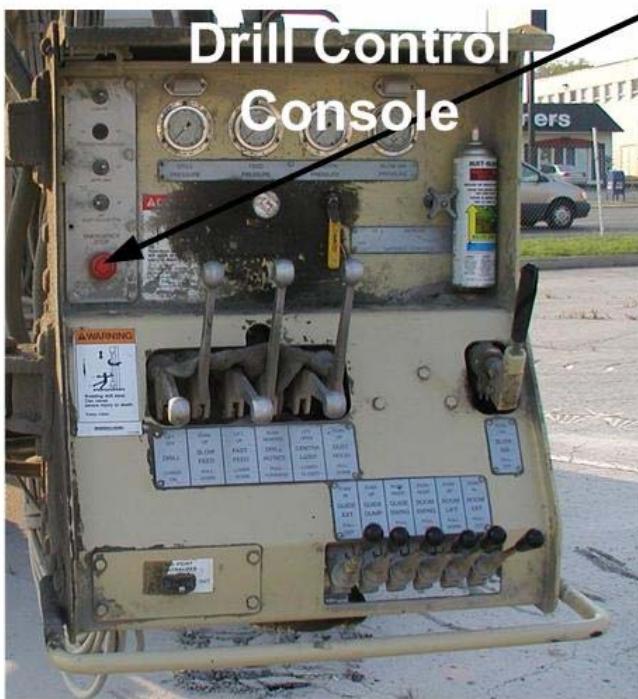
In this incident, the track-mounted rock drill had two separate control panels mounted on the machine. The main control console, mounted to the machine frame over the tracks included a platform for the operator to stand on. This control panel could be used to operate all functions of positioning the rock drill, including tramping the machine and swinging and raising the boom. The drill control console, mounted on the drill mast could only be used to control the drill functions. The main control console, where the tramping function is controlled, contained an emergency stop button located in the center of the control panel and the drill console emergency stop button was located on the far left side of the drill console (Photo 6). Placing the emergency stop buttons in the same vicinity on both consoles will assist operators with always knowing where the button is located if an emergency occurs. Additionally, increasing the size of the emergency stop button would assist in making the button more readily accessible for use in difficult times and conditions.

Emergency
Stop Buttons

Photo 6. Photo of both track drill consoles.

Recommendation #6: Equipment designers and manufacturers should consider standardizing the location of various individual controls within the control panels located on the same or similar machines and increasing the size of the emergency stop buttons.
