Fatality Assessment and Control Evaluation Program

FACE Report Number: 2006-01

Hispanic Carpenter's Helper Dies after Crane Boom Fell on Him during Disassembly - North Carolina

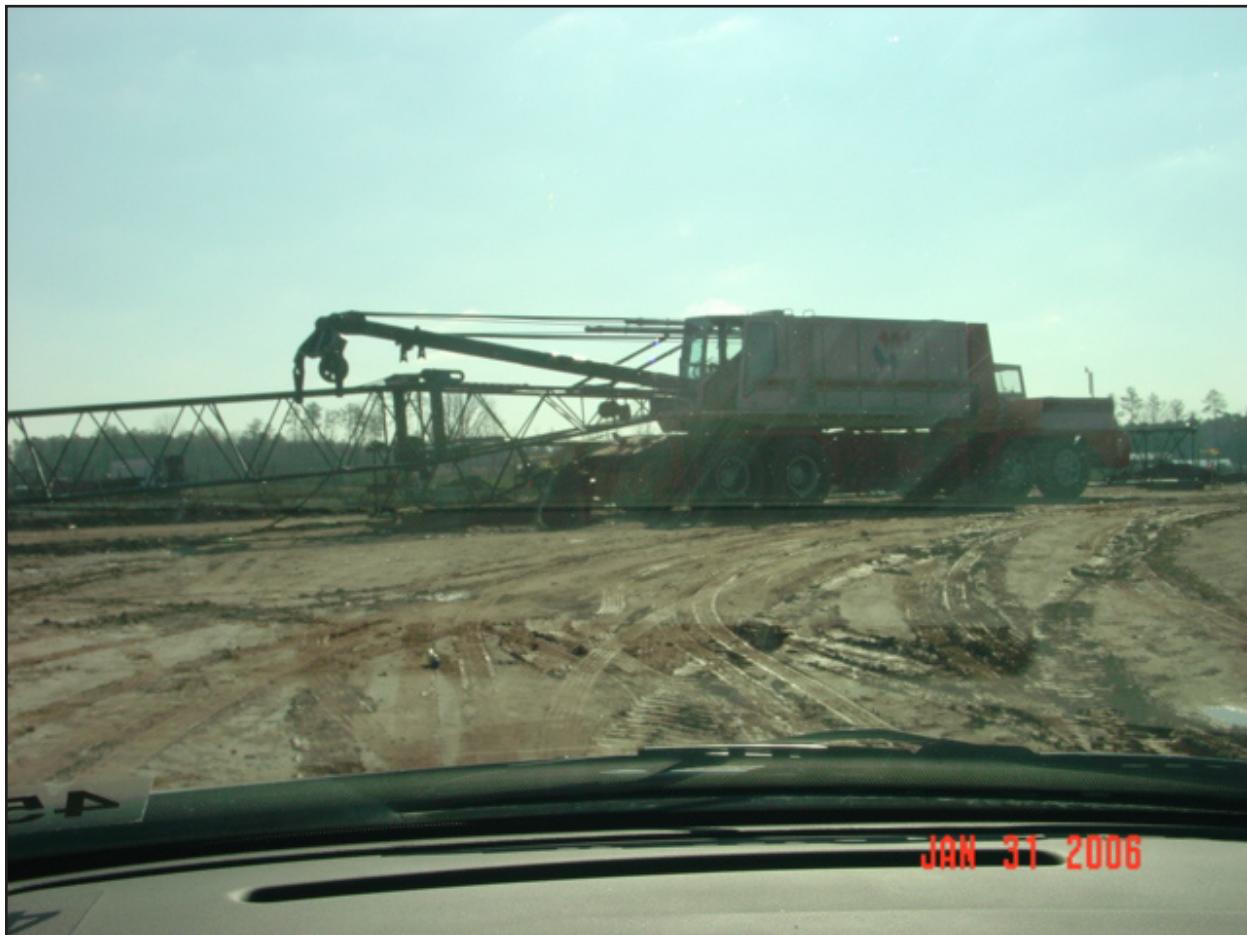
The incident site was a bridge overpass, part of a larger state-funded highway construction project that began August 4, 2005, and was to be completed by July 1, 2007. A truck-mounted crane with an 80-foot lattice boom (Photo1) had been used to set approximately 20 girders which spanned the southbound lanes of the bridge. The next task, unloading and placing concrete decking over the girders, required a longer boom. The company had a 30-foot and a 40- foot lattice boom section lying on the ground next to the truck mounted crane. These sections were to be assembled and then added to the existing 80-foot boom (which was comprised of a 20-foot end boom section, 40-foot center section, and a 20-foot lower boom section). The boom on the truck-mounted crane was to be disassembled between the 40-foot center section and the 20-foot lower boom section. After the 70-foot section was inserted, the overall boom length was to be 150 feet.

Photo 1. This photograph illustrates the truck-mounted lattice boom crane that was involved in the incident [Photograph courtesy of NCOSHA]

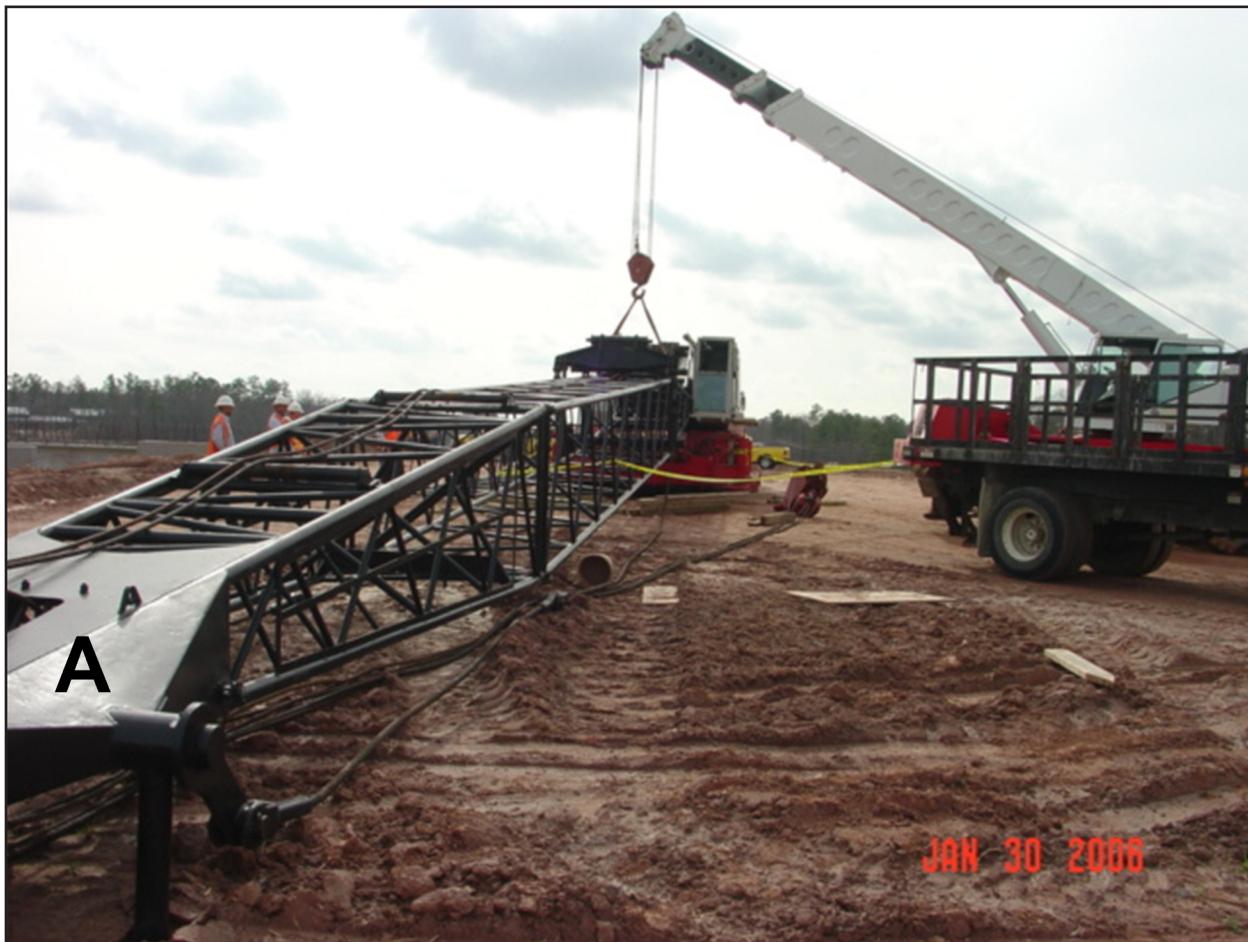
end boom section on the ground (Photo 2-peak is marked A). The live mast was then lowered and the cables and pendants were slackened. The 40-foot center section was about four feet off of the ground. The crane operator asked the victim to help him remove the pins that secured the 40-foot center section to the 20-foot lower boom section. There were four pins securing the center section to the lower boom section, two upper and two lower pins. Each pin was about seven inches long, two inches in diameter, tapered on one end, and secured with a cotter pin. The crane operator went under the boom and knocked out the first lower pin easily. He tried to knock out the second lower pin, but it would not budge. The victim picked up the pin that had landed on the ground on the west side of the lattice boom and indicated with hand motions that he could use it as a punch to drive out the second bottom pin. The crane operator moved from under the boom and reached through the lattice and pounded on the pin held by the victim as the victim, located under the boom, held the first pin against the second bottom pin. The crane operator reported that he told the victim to move as the boom could fall, and the victim moved from the center section to underneath the lower boom section. After the crane operator pounded on the pin about four more times with a sledge hammer, the second bottom pin came out. The boom hinged on the top two pins and the lower boom section fell on the victim's back and pinned him to the ground (Photo 3). It was approximately 8:30 a.m.

Photo 2. This photograph illustrates the peak of the lattice boom (A) after it had been lowered to the ground [Photograph courtesy of NCOSHA].

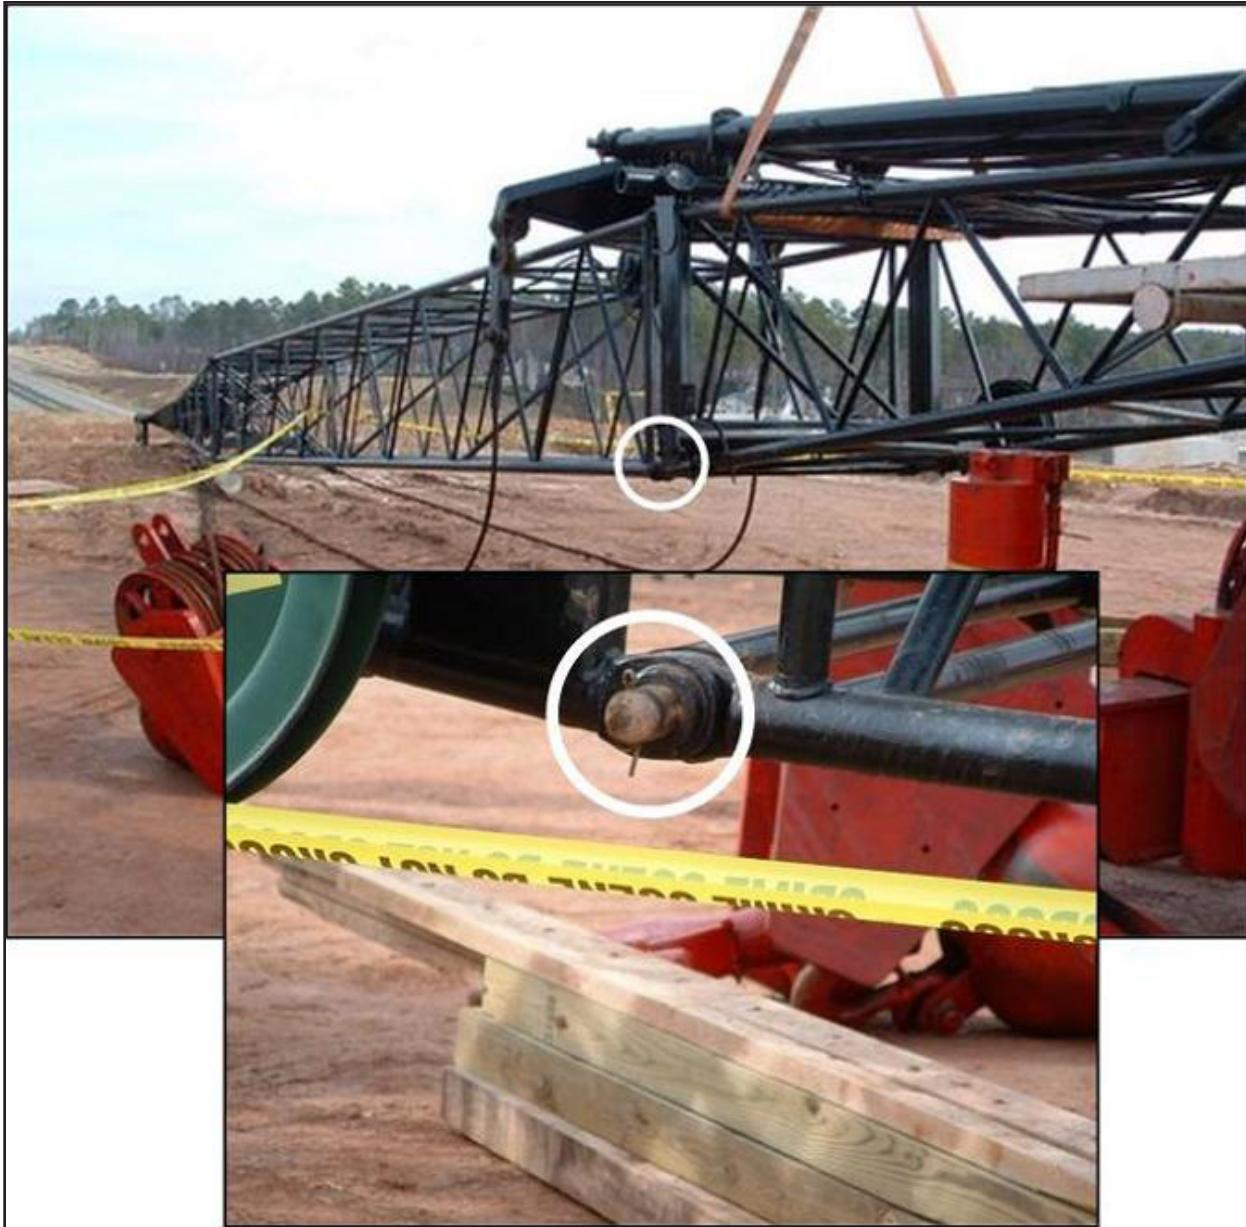
Photo 3. This photograph illustrates a close up of the location where the victim was struck by the boom. The 4x4's shown on the photograph were brought to the site and used to pry the boom up as it was lifted by the second crane. The pin is marked with a circle and was one of two lower pins removed. The two lower pins had been replaced during rescue efforts. An insert shows a larger illustration of the pin. [Photograph courtesy of NCOSHA].

Recommendation #1: *Employers should ensure that manufacturer's safety recommendations for proper blocking and support procedures to prevent movement of the boom sections are implemented when disassembling cranes.*

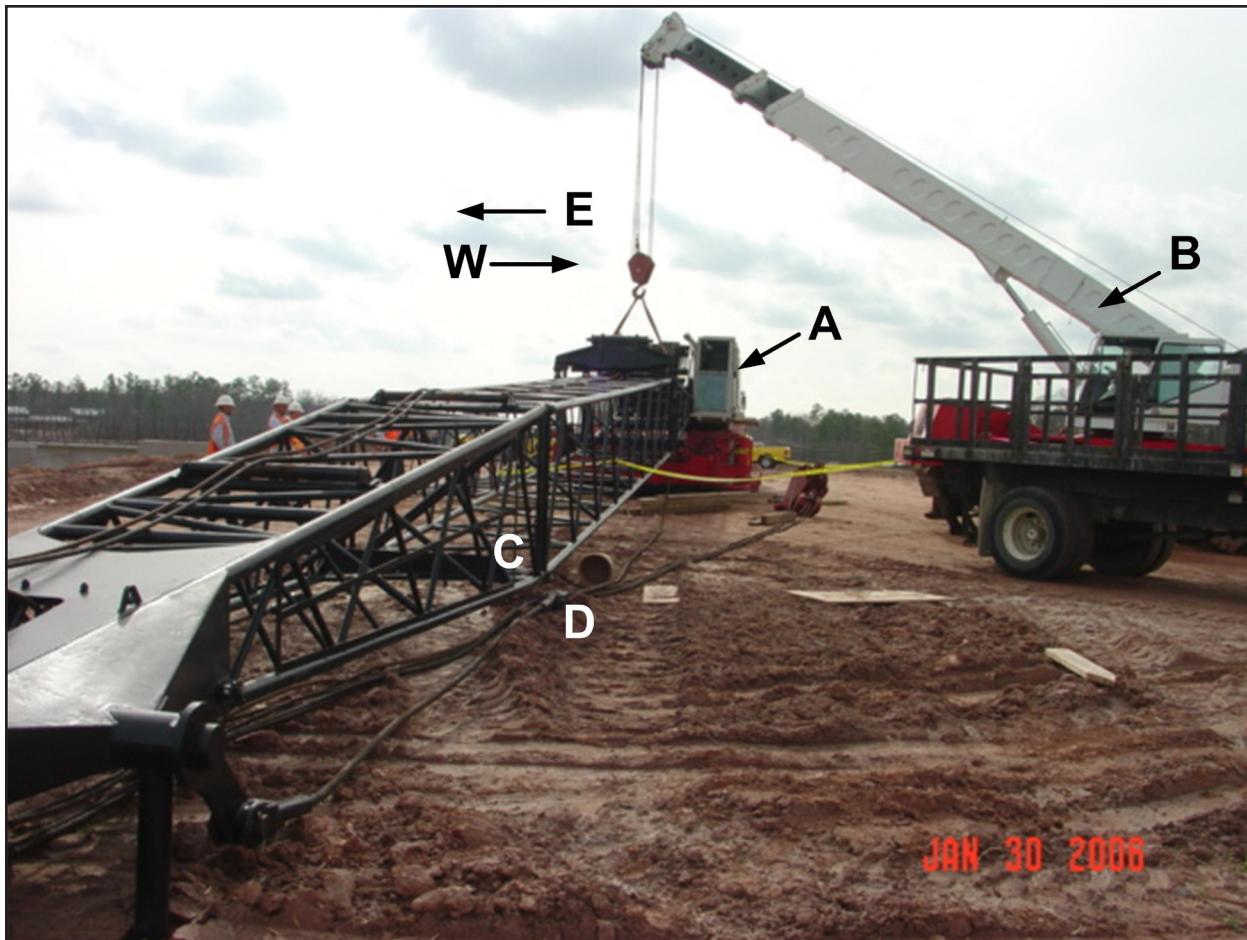
The supervisor called a coworker who immediately called 911, and then company managers. Within about 5 minutes, a hydraulic crane located nearby was positioned next to the lattice boom. The crane operator rigged a strap to the lattice boom, connected it to the hook of the hydraulic crane, and lifted the boom off the victim (Photo 4). The two pins were driven back into place to secure the boom sections.

Photo 4. This photograph illustrates the truck-mounted lattice boom crane (A) that was involved in the incident. It was taken after the hydraulic crane (B) had been used to lift the boom section off the victim and both lower pins had been replaced. The victim's location at the time of the incident is marked with a C, and a D illustrates the location of the crane operator. [Photograph courtesy of NCOSHA]

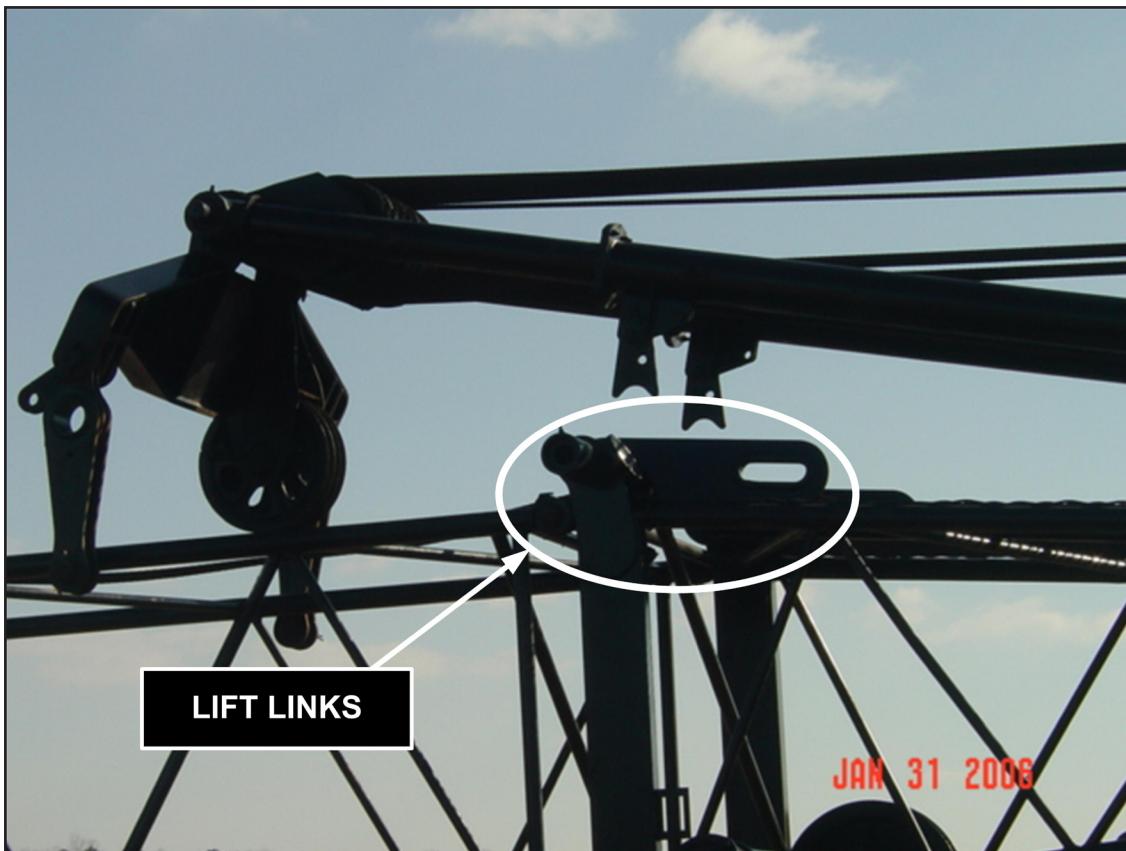
Discussion: According to the crane operator involved in the incident, the operator's manual located in the truck-mounted crane was the sole source of safety procedures for crane operation at the company. The crane operator stated that he had observed the assembly and disassembly of the boom crane with the assistance of a second or "helper crane." He stated that the "helper crane" would support the boom by hooking onto a nylon strap wrapped around the lower boom section. At other times, if the helper crane was not available, they (the crane operator and one of the team of two workers with more experience in disassembly) would use the live mast as a hoist and connect a hook from the live mast to a nylon strap wrapped around the lower boom section of the boom. Tension on the hoist cable would support the boom. Workers interviewed by NCOSHA reported that this was a common practice, that they believed these procedures were written in the operator's manual, and that the company did not have any alternative written procedures. The trainer for crane operators employed by the company agreed that this was the practice, provided that the crane boom was 80 feet or shorter. An authorized manufacturer's procedure required the retraction of the live mast to a 20-foot length, and attachment to the lower boom section with the lift links (Photo 5). As an alternative, the manufacturer's disassembly procedure recommended

Photo 5. This photograph illustrates the lift links that are used to secure the mast and the boom on booms 80 feet and under [Photograph courtesy of NCOSHA].

blocking tightly under the pin connection before removing the pins.² The crane operator involved in the incident indicated that this would be too time consuming for the task. The operator's manual did not include instructions on the use of a "helper crane," or instructions for connecting the live mast hoist to a strap wrapped around the boom, indicating that the workers were mistaken about the safety procedures written in the operator's manual for this truck-mounted crane. The company safety manager indicated that the company's written crane operation procedures were out of date and the company had made it a policy to use only the safety procedures written in the operator's manual for each crane. Supervisors should ensure that safety measures specified in the manual are followed and the procedures are reviewed with all involved workers before each assembly and disassembly. Since the operator's manual does not assign responsibility for crane assembly and disassembly tasks, company policy and retraining should also cover these responsibilities.
