Fatality Assessment and Control Evaluation Program

FACE Report Number: 2004-11

Hispanic Laborer on Roadway Construction Work Site Run Over and Killed by a Backing Flat Bed Dump Truck - North Carolina

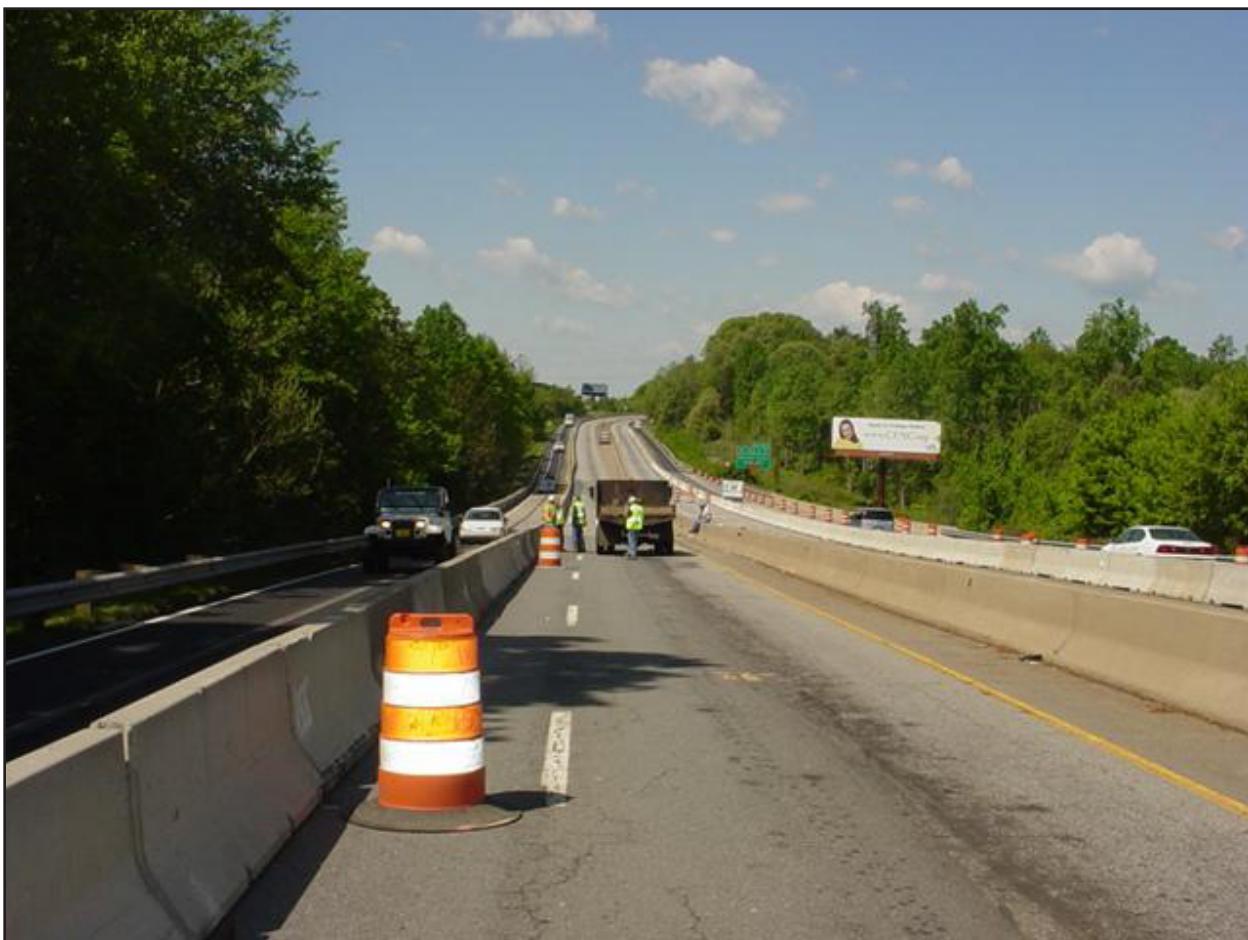
Incident Scene. The road work site was approximately 3 miles in length and was protected from public motorist traffic by concrete barriers installed on both sides of the roadway work zone (Photo 1). The width of the work zone was approximately 21 feet, and construction vehicles and equipment were to travel only westward.

Photo 1. Photo of the roadway construction work zone. [Photograph courtesy of the NCOSHA].

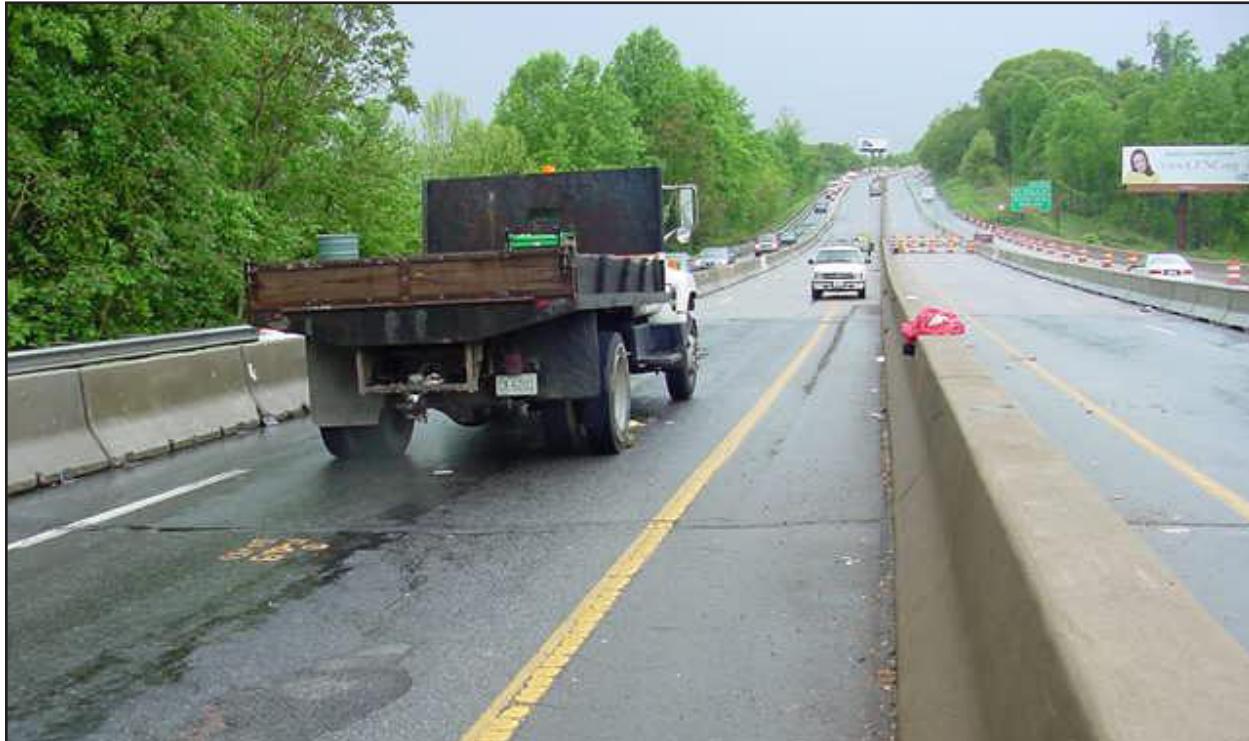
The truck was equipped with dump cylinders and the bed was approximately 14 feet in length and 12 feet wide. The bed sides of the truck bed were approximately 63 inches in height and the rear tailgate of the truck was approximately 53 inches above the ground (Photo 2).

Photo 2. Photo of the flat bed dump truck. [Photograph courtesy of the NCOSHA].

Following the purchase of the truck, the employer had a reverse alarm installed by a local mechanical garage. According to NCOSHA, the reverse alarm was inoperable at the time of the incident. Additionally, during NCOSHA interviews, workers at the site reported that the reverse alarm was inoperable most of the time over recent months. According to NCOSHA, these employees additionally reported that they were unaware of anyone reporting this defect to anyone in supervision or management. Following this incident, the employer developed a daily inspection

Recommendation #1: Employers should ensure that mobile construction vehicles are inspected daily and that defective equipment is reported and removed from service until needed repairs have been made.

Discussion: The dump truck in this incident was equipped with an audible reverse alarm, designed to activate when the vehicle was shifted into reverse. According to the investigating NCOSHA compliance officer, the alarm was not functioning correctly when tested after the incident. The federal OSHA rule 1926.601 (b) (4) states, "any construction vehicle with an obstructed rear view must have a reverse signal alarm audible above the surrounding noise level, or the vehicle is backed up only when an observer signals that it is safe to do so."¹ Additionally, all vehicles in use are required by OSHA 1926. 601 (b) (14) to be checked at the beginning of each shift.² During interviews with the NCOSHA compliance officer, workers reported that they had knowledge that the reverse alarm was not working most of the time, and that the employer did not require that mobile equipment be inspected prior to each shift. Following this incident, the employer developed a daily equipment inspection checklist, required to be completed by the operator and supervisor.

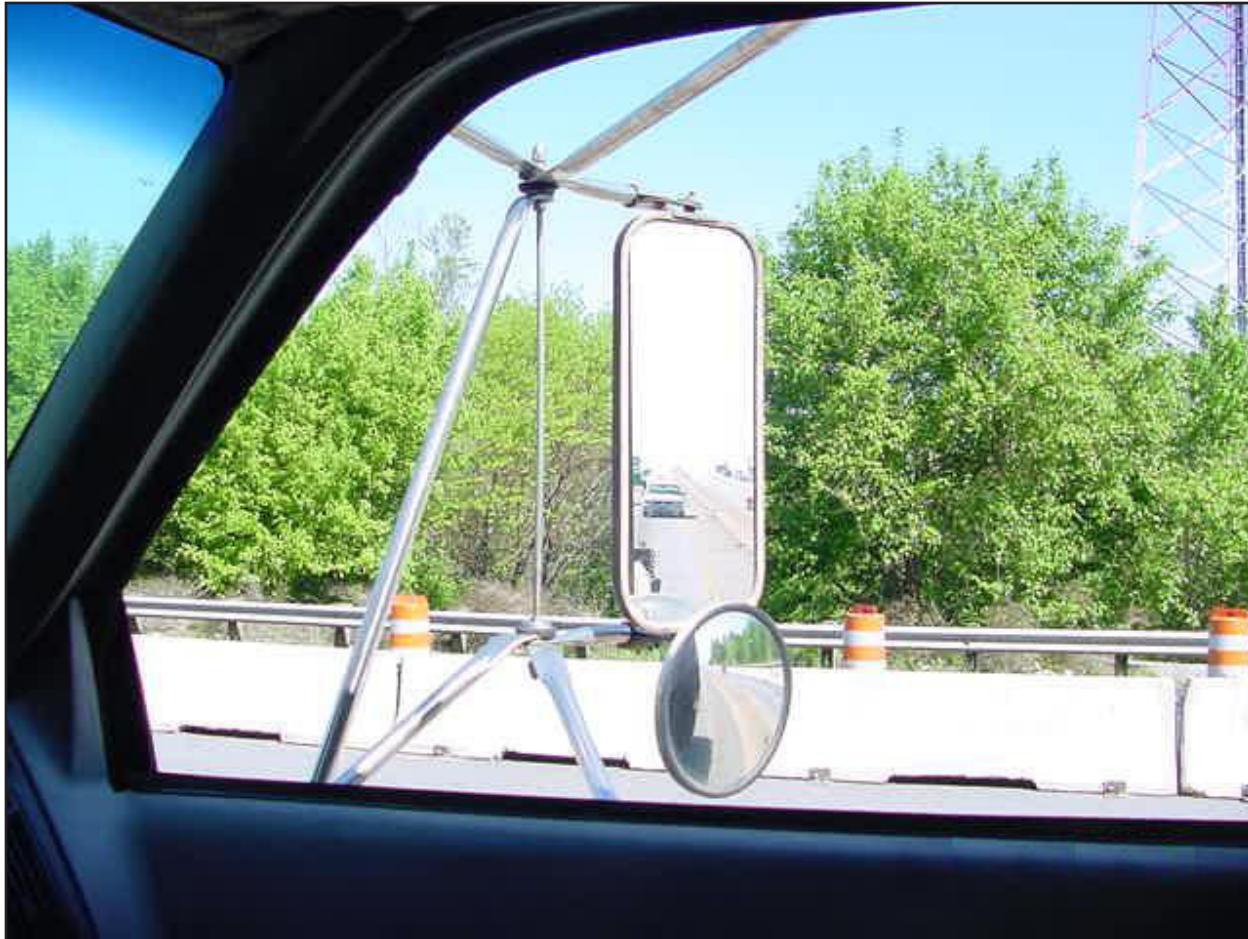
The truck on each side was equipped with mirrors approximately 7 inches wide and 16 inches in height and a round spot convex mirror mounted at the bottom of each mirror (Photo 3). The truck's rear window measured 59 inches in width and 16 inches in height. However, after purchasing the truck, the employer welded a steel plate in a vertical position on the bed which obstructed the rear window with the exception of a 4 inch by 12 inch opening of mesh screen. The steel plate was added to protect the rear window from being broken by the shifting of equipment and tools in the truck bed.

*Photo 3. Photo of the mirrors mounted on each door of the dump truck.
[Photograph courtesy of the NCOSHA].*

Recommendation #6: Employers should consider installing after market devices (e.g., camera, radar, and sonar) on construction vehicles and equipment to help monitor the presence of workers on foot in blind areas.
