Construction Worker Dies After Being Run Over By a Bulldozer at a Commercial Construction Site - North Carolina

Fatality Assessment and Control Evaluation (FACE) Program

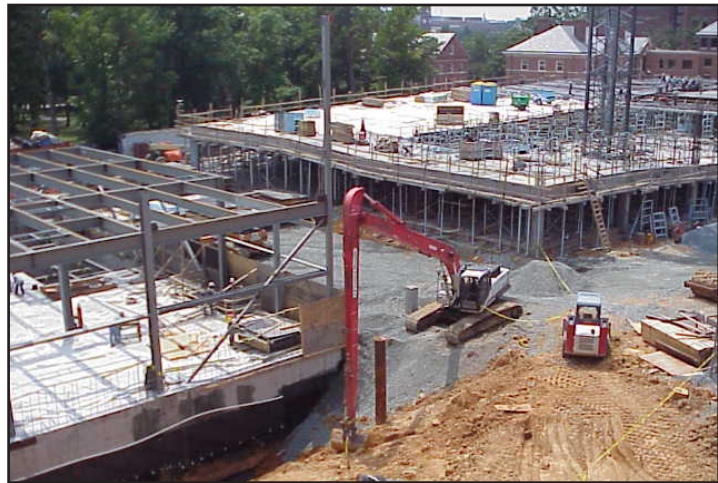
Incident Scene

The company owner did not hear the warning and the victim did not react. The track of the bulldozer struck the victim on the back of his legs and rolled over his legs and torso. The company owner, still unaware of the run over, drove the bulldozer forward about 50 feet and stopped. The coworker ran to the bulldozer operator and told him what had occurred. The company owner looked back toward the gravel pile and saw the victim lying on the ground. He called 911

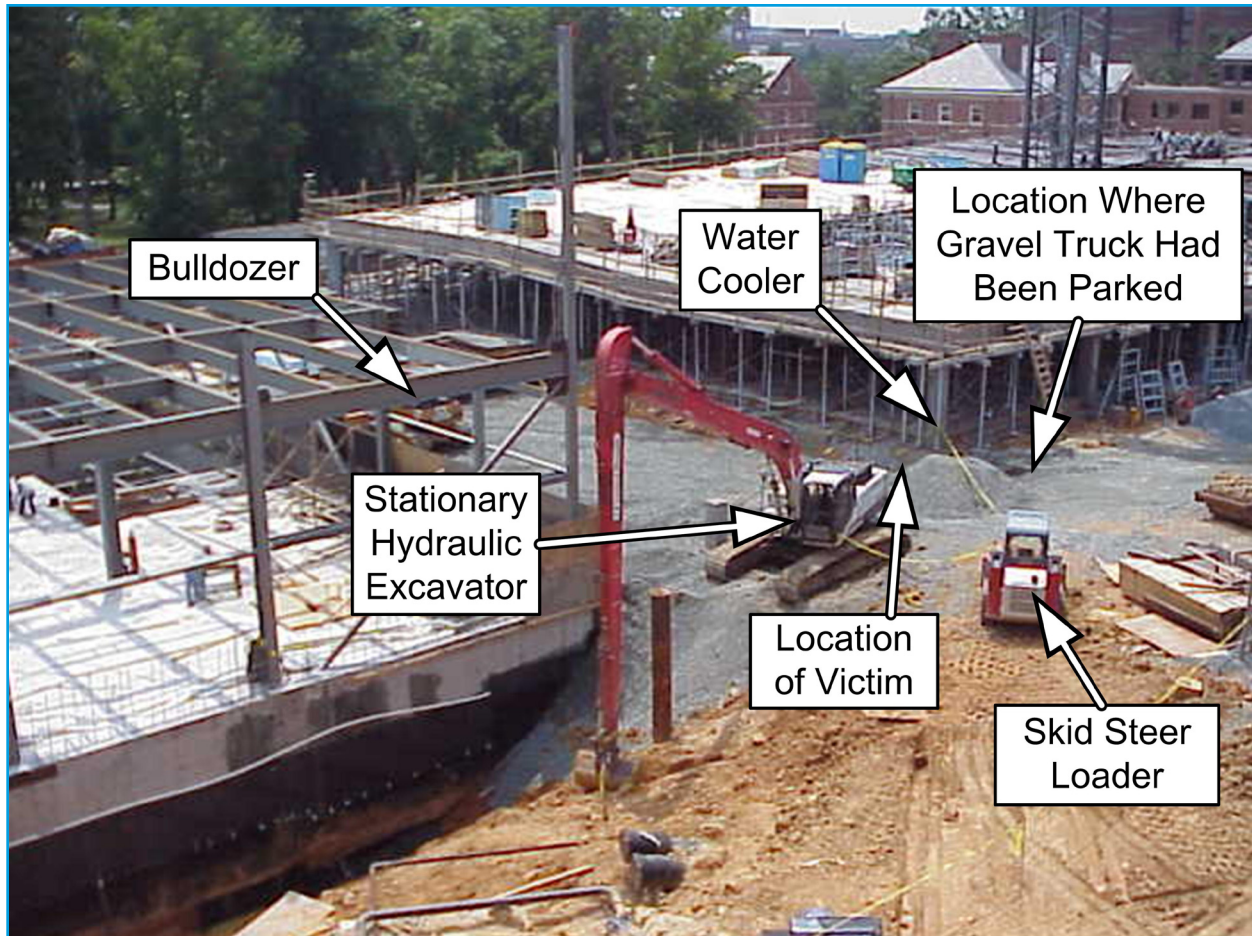
The skid steer loader operator saw the victim step out in front of the gravel pile and position himself so the truck driver could see him out of his side mirror, and signal to the truck driver to lower his truck box and move his truck. At about the same time, the skid steer loader operator saw the bulldozer backing toward the gravel pile and the victim. He yelled a warning to both the victim and the company owner. The owner did not hear the warning and backed over the victim running over his legs and torso. The company owner drove the bulldozer forward about 50 feet and then stopped the bulldozer at the far end of the lot. The skid steer loader operator ran over to the truck driver and yelled “man down” and then ran to the company owner and told him that he had backed over the victim. The owner looked back toward the gravel pile, saw the victim lying on

Photo 1: This photograph illustrates the location of the bulldozer following the incident and the location of the victim by the gravel pile. The location of other equipment, skid steer loader, hydraulic excavator, and gravel truck as well as the location of the water cooler is identified [Photograph courtesy of NCOSHA].

Recommendation #1: Employers should develop, implement, and enforce a policy that requires workers on foot to maintain a safe clearance from mobile equipment and train all workers regarding this policy.

Recommendation #2: Employers should develop, implement, and enforce a policy that requires mobile equipment operators to operate mobile equipment in accordance with safety guidance provided in the equipment operator's manual and provide additional training to all mobile equipment operators regarding this policy.
